AIRPROX REPORT No 2022073

Date: 06 May 2022 Time: 1005Z Position: 5216N 00117W Location: 4NM W Daventry

PART A: SUMMARY OF INFORMATION REPORTED TO UKAB

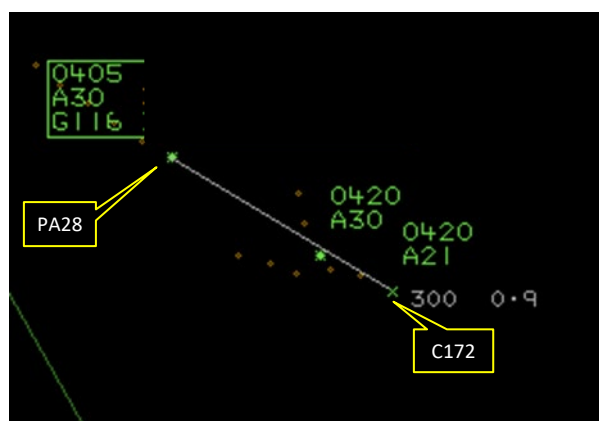
Figure 3 – 1004:00

At 1004:00 the new Radar controller asked the PA28 pilot to pass their message. The pilot responded, *“Hello [callsign] PA28 uniform from Coventry to [destination airfield], passing er just about to maintain 3000 feet QNH 1024, Traffic Service please.”* The controller responded, *“[callsign] the QNH 1025 say again your altitude.”* The pilot advised that they were at 3000ft. (Figure 3).

When the incoming Birmingham Radar controller established the flight details of the PA28 pilot at 1004:00, they did not inform the pilot that they were identified or agree the type of service. After confirming the level of the PA28 the controller immediately shifted their attention to an inbound helicopter pilot looking for an instrument approach. The PA28 was an indicated 0.9NM behind the C172 and 900ft above it at this point.

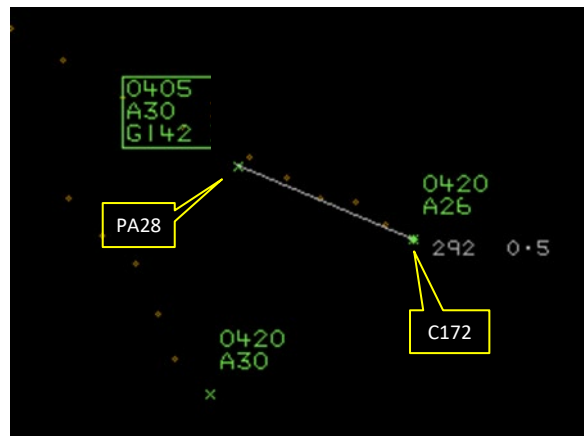
Figure 4 - 1004:40

At 1004:40 the controller advised the PA28 pilot that it would be a reduced Traffic Service with reduced Traffic Information due to controller workload. The controller then passed Traffic Information, “*you do have traffic, similar track to yourself, one is half a mile ahead of you, one is half a mile south of you, both tracking southeast, one indicates 400 feet below, the other same level.*” The pilot responded, “[callsign] *the one at the same level is in sight and Traffic Service reduced* [callsign] *thanks.*” Figure 4.

When the service agreement between the incoming Radar controller and the PA28 pilot was reached at 1004:40, the pilot was informed that it would be a reduced Traffic Service due to controller workload, and Traffic Information was passed on the C172. The Traffic Information passed was, *"you do have traffic, similar track to yourself, one is half a mile ahead of you, one is half a mile south of you, both tracking southeast, one indicates 400 feet below, the other same level."* The pilot responded, *"[callsign] the one at the same level is in sight and Traffic Service is reduced [callsign] thanks."* The pilot did not report having the C172 in sight at this point and the attention of the controller was then diverted to another aircraft in receipt of a reduced Traffic Service and back to the inbound helicopter for the instrument approach.

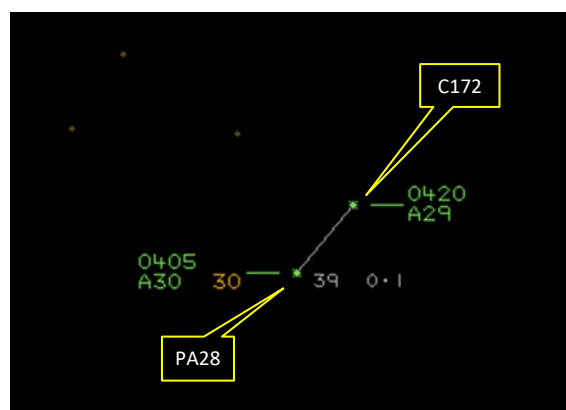
Figure 5 - 1005:02 CPA

CPA occurred at 1005:02 with the aircraft separated by 0.1NM laterally and 100ft vertically, Figure 5.

Except for the initial stages of climb-out from Coventry, the PA28 was observed to be travelling faster than the C172 and was steadily catching it up. Ten seconds prior to CPA, the PA28 was observed to be travelling at an indicated groundspeed of 146kt, the C172 was 0.2NM ahead of them at this point, indicating a groundspeed of 81kt. The PA28 subsequently passed down the starboard side of the C172 with an indicated lateral clearance of 0.1NM.
