AIRPROX REPORT No 2022082

Date: 15 May 2022 Time: 1045Z Position: 5212N 00024E Location: 1NM S Newmarket

PART A: SUMMARY OF INFORMATION REPORTED TO UKAB

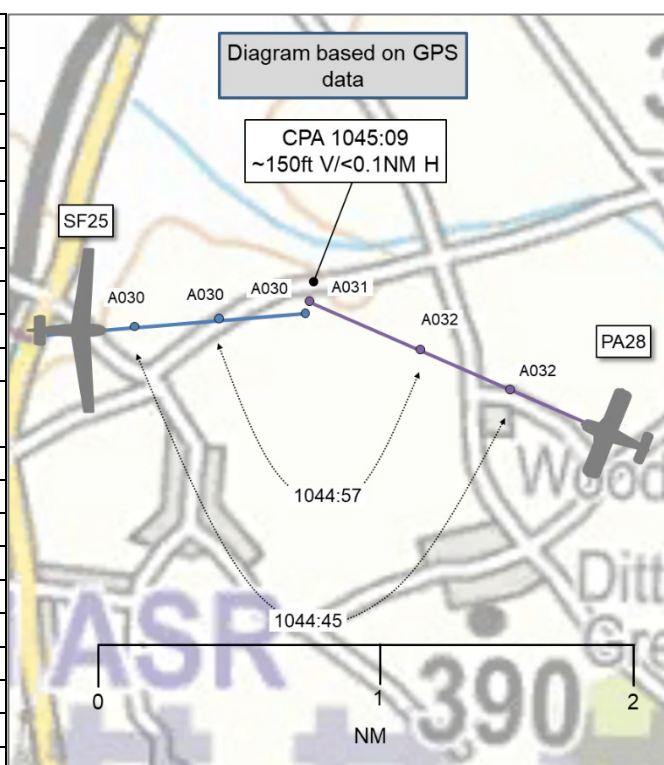
Unfortunately the SF25 did not display on the NATS radar replay, however both pilots provided GPS data which enabled the diagram above to be prepared.

The Stansted frequency (120.625MHz) was reviewed from 1025:05 (all times UTC) until 1047:57 and [PA28 C/S] did not speak on the R/T and there were no calls from the controller to the PA28. The PA28 changed SSR code from 7013 to 7000 at 1040:58 when it was at position 5210N 00038E. The radar data was reviewed and it was believed that the conflict occurred 3.6NM SE of Newmarket.

When determining the risk of collision, the Board was grateful to both pilots for having supplied their GPS log file from their flights, as this had greatly enhanced the Board's understanding of the geometry of the event. They considered that the avoiding action from the SF25 pilot had increased the separation between the two aircraft. However, given the late nature of the avoiding action and the final separation, they agreed that safety had been much reduced; Risk Category B (**CF4**).
