AIRPROX REPORT No 2022088

Date: 28 May 2022 Time: 1148Z Position: 5354N 00257W Location: Stalmine

PART A: SUMMARY OF INFORMATION REPORTED TO UKAB

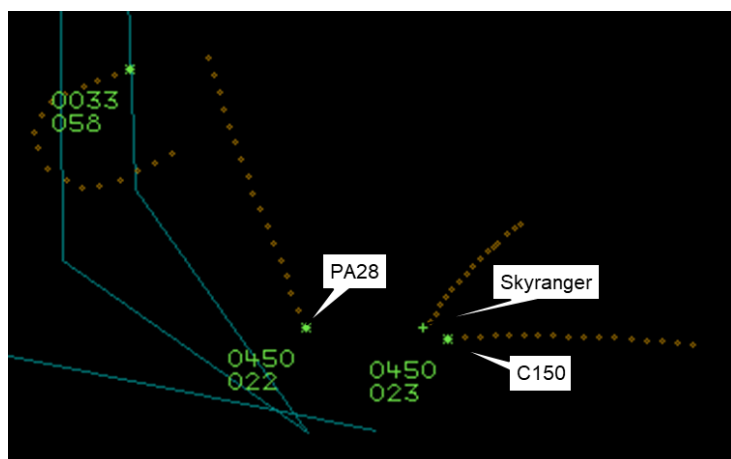
Figure 1. 1147:27

The Skyranger primary track faded at 1147:27 (Figure 1) and the PA28 crossed below and behind the C150 at 1147:47 (Figure 2).

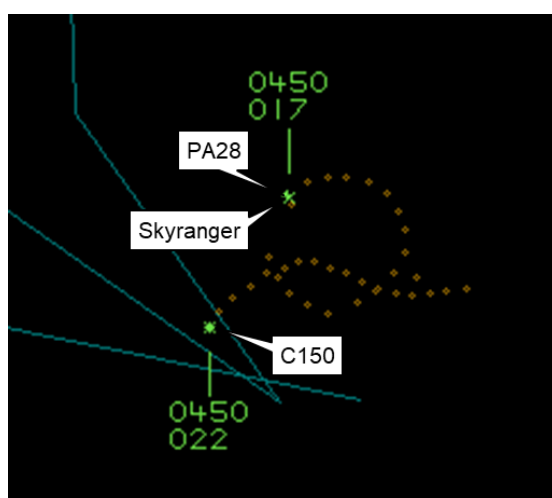
Figure 3. 1148:27

Two primary returns were displayed at CPA (Figure 3) and the Skyranger secondary return was first displayed at 1149:08 (Figure 4).
