AIRPROX REPORT No 2022089

Date: 22 May 2022 Time: 0918Z Position: 5117N 00101W Location: Old Basing

PART A: SUMMARY OF INFORMATION REPORTED TO UKAB

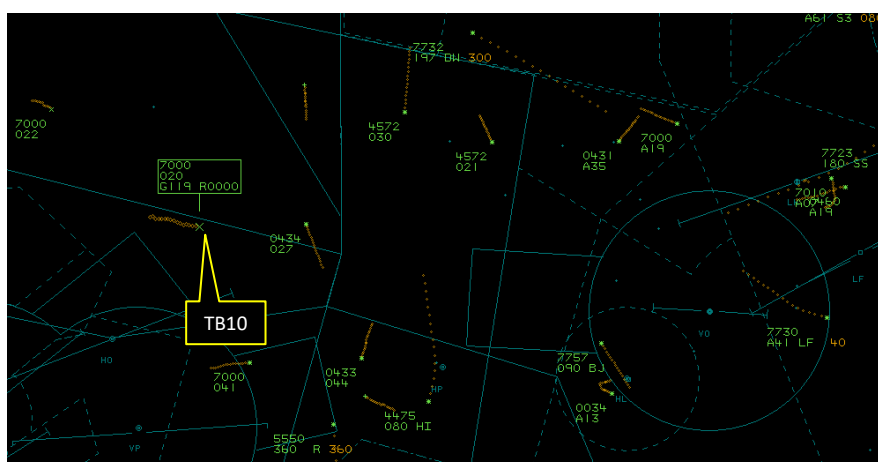
Figure 1 – 0908:35

Between the first call made by the TB10 pilot to Farnborough and the time of the Airprox, the Farnborough LARS West controller was occupied with a number of other aircraft, and the passing of Traffic Information to the pilot of an aircraft under a Traffic Service. Figure 1 above is included to show the general traffic situation in the immediate LARS West area.

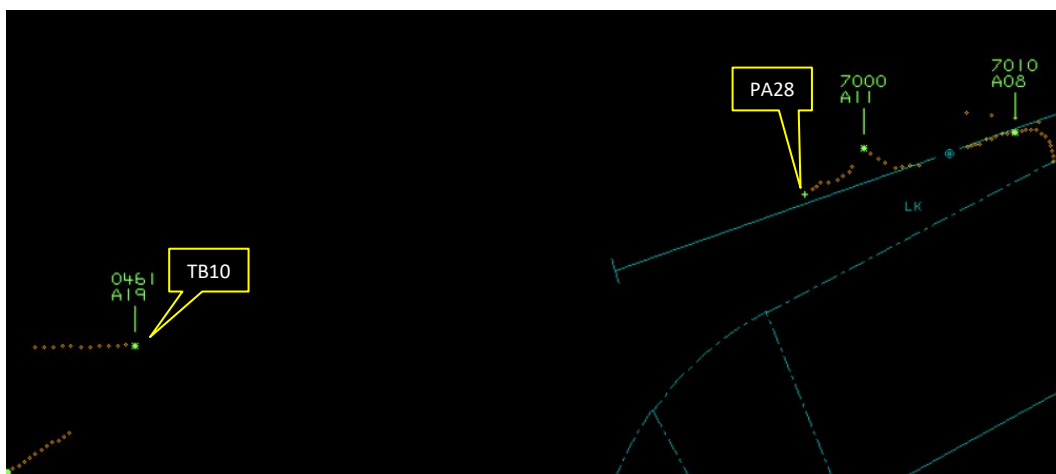
Figure 2 – 0915:02

By 0914:40 the PA28 had become visible on the area radar replay. Figure 2 illustrates the relative positions of both aircraft at 0915:02, (10 miles apart), when the PA28 pilot left the Blackbushe frequency.

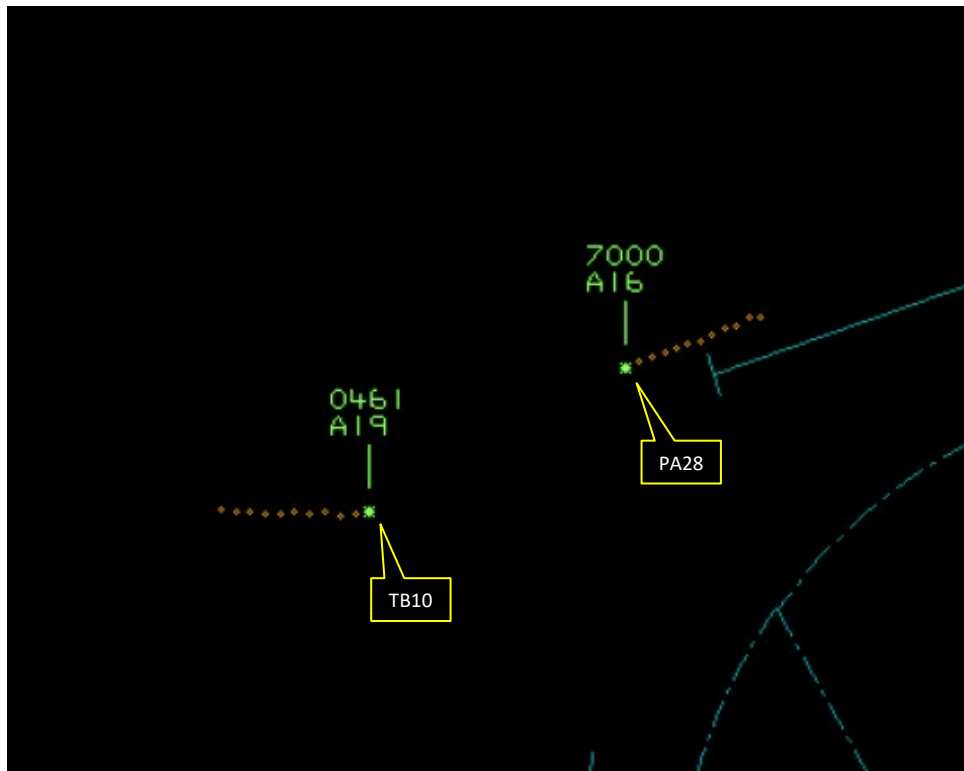
Figure 3 – 0917:10 – aircraft 2.6NM apart

At 0917:10 the Farnborough controller revised the crossing clearance for the TB10 pilot, removing a requirement to hold at the first reporting point, which was acknowledged (Figure 3).

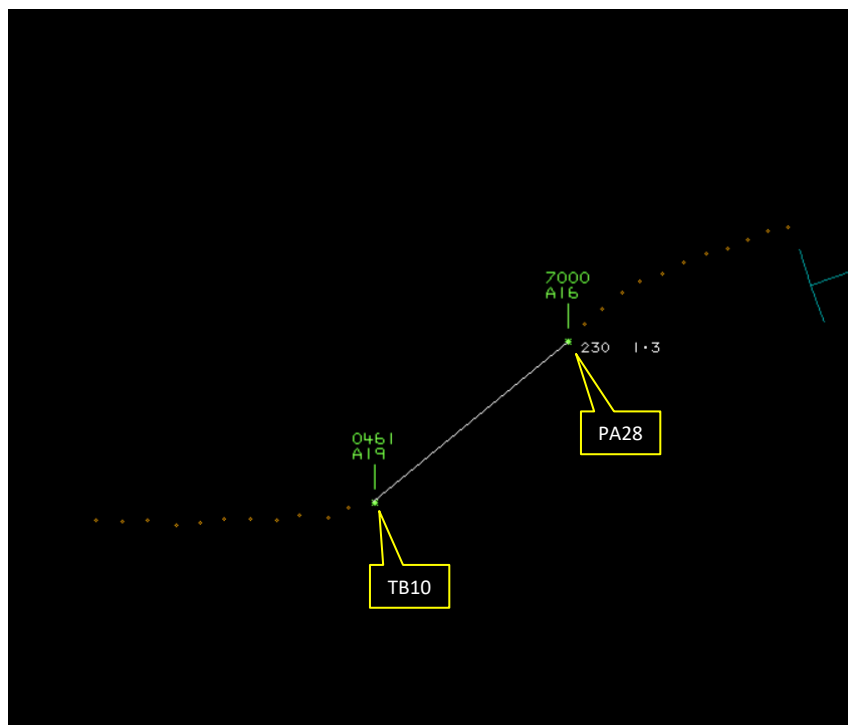
Figure 4 – 0917:30

At 0917:30 the Farnborough controller was dealing with the pilot of an aircraft under a Traffic Service who was requesting a climb (Figure 4).

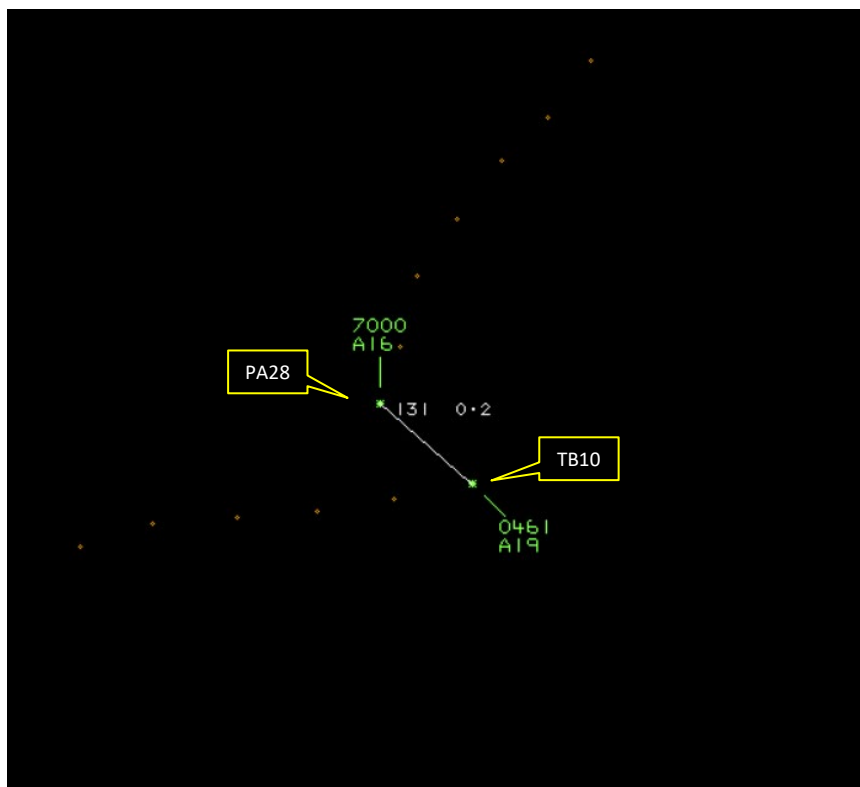
Figure 5 – 0917:55 - CPA

At 0917:55 the TB10 pilot reported that they had “a PA28 I think, just go 500ft below the wing” which was coincidental with CPA on the area radar replay (Figure 5).

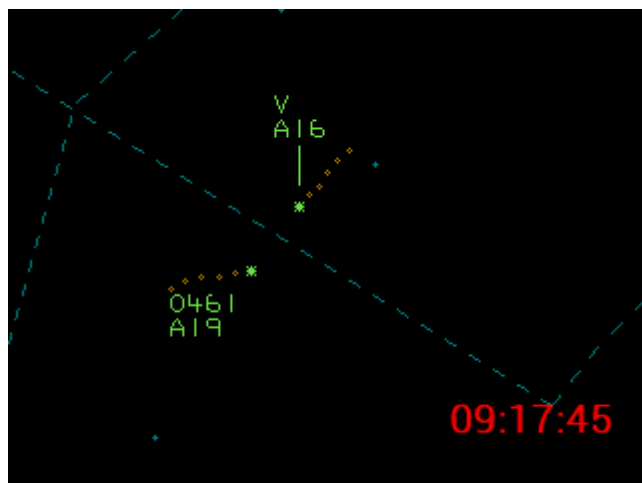
Figure 1

The watch action stated that at time 0917:58, [TB10 C/S], [squawk] 0461 overflew an [aircraft squawk] 7000 indicating 300ft below on Mode C. There is no reference made on the RT to an Airprox. This potential conflict was correlated by radar information provided by LTC Swanwick, however the conflict was positioned 9NM West of [Farnborough], see Figure 1.
