AIRPROX REPORT No 2022101

Date: 10 Jun 2022 Time: 1552Z Position: 5148N 00055W Location: 3NM SSE Westcott

PART A: SUMMARY OF INFORMATION REPORTED TO UKAB

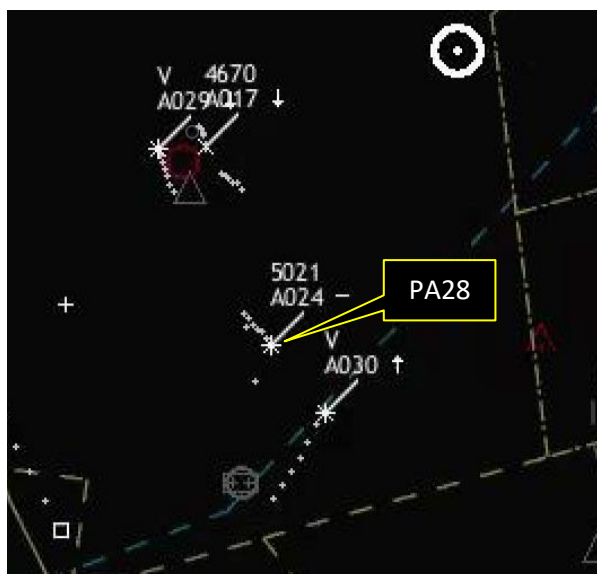
Two aircraft came in the vicinity of [the PA28], one aircraft which passed 700ft above, and another aircraft, with no transponder (intermittent primary only return).

Figure 1 – 1551:50. Primary contact merged with [the PA28].

It is believed that the aircraft that [the PA28] had an Airprox with was the intermittent primary contact.

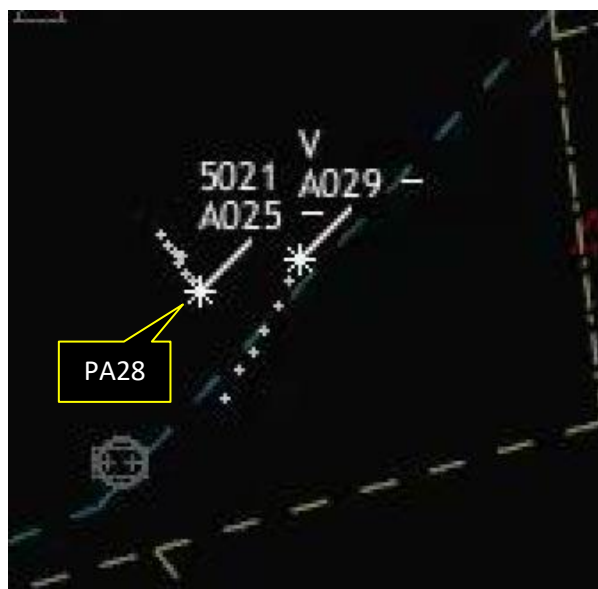
Figure 2 – 1552:00. [PA28] clear of contact.
