AIRPROX REPORT No 2022100

Date: 09 Jun 2022 Time: 1515Z Position: 5242N 00040E Location: 5NM NE RAF Marham

PART A: SUMMARY OF INFORMATION REPORTED TO UKAB

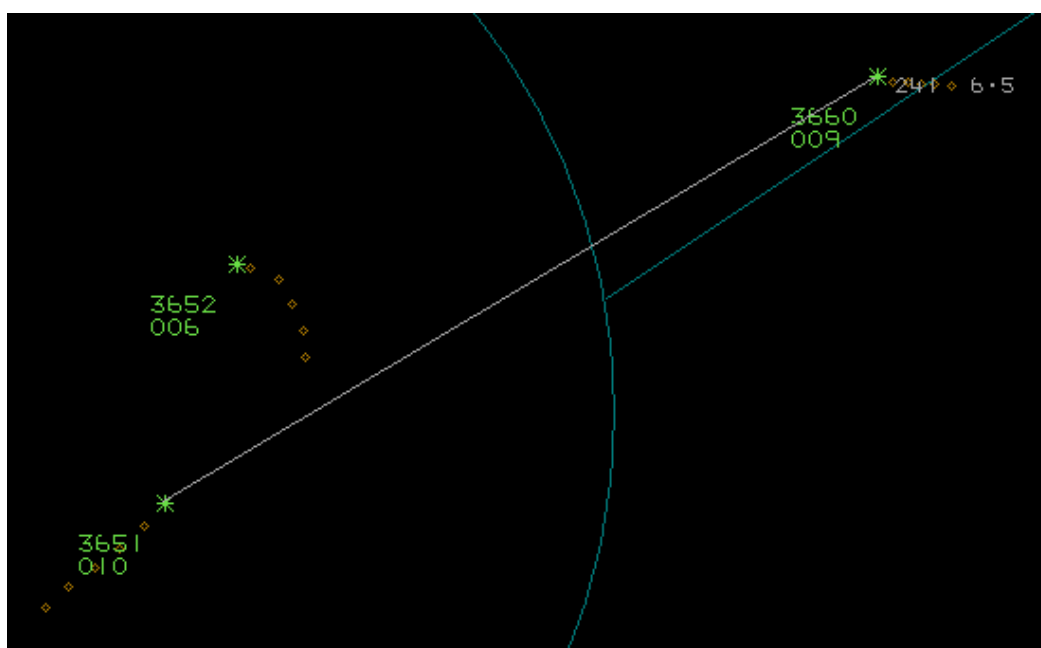
Figure 1: ATC requested F35 pilot to extend downwind.

Marham [Tower] controller requested the F35 to extend downwind for sequencing purposes against other visual circuit traffic and visual joining traffic from a straight-in PFO approach. The C182 pilot advised they would descend to 900ft and route beneath the MATZ stub. Separation was measured at 6.5NM and 100ft [Figure 1].

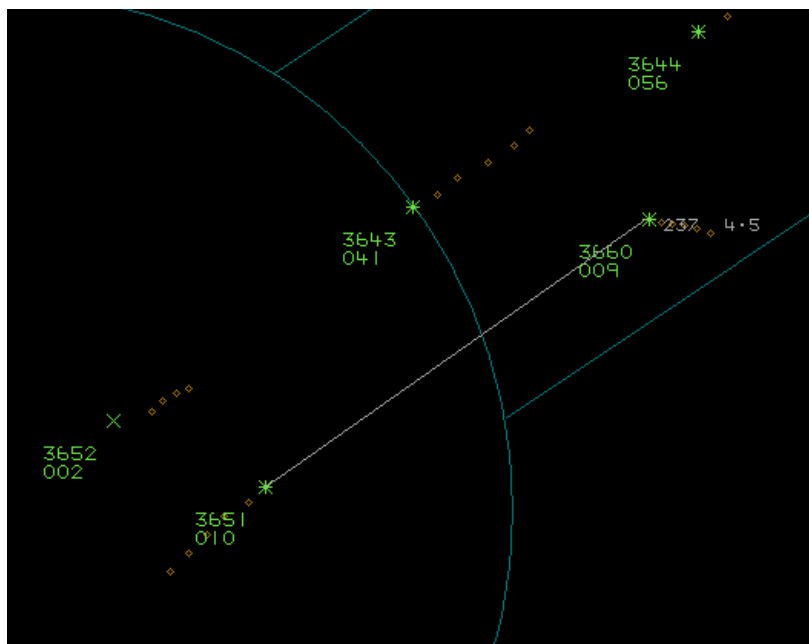
Figure 2: ATC requested F35 to maintain heading.

Twenty-three seconds later the Marham [Tower] controller requested the F35 pilot to maintain their heading for sequencing behind the second aircraft joining the visual circuit from a straight-in PFO approach. Separation decreased to 4.5NM and 100ft [Figure 2].

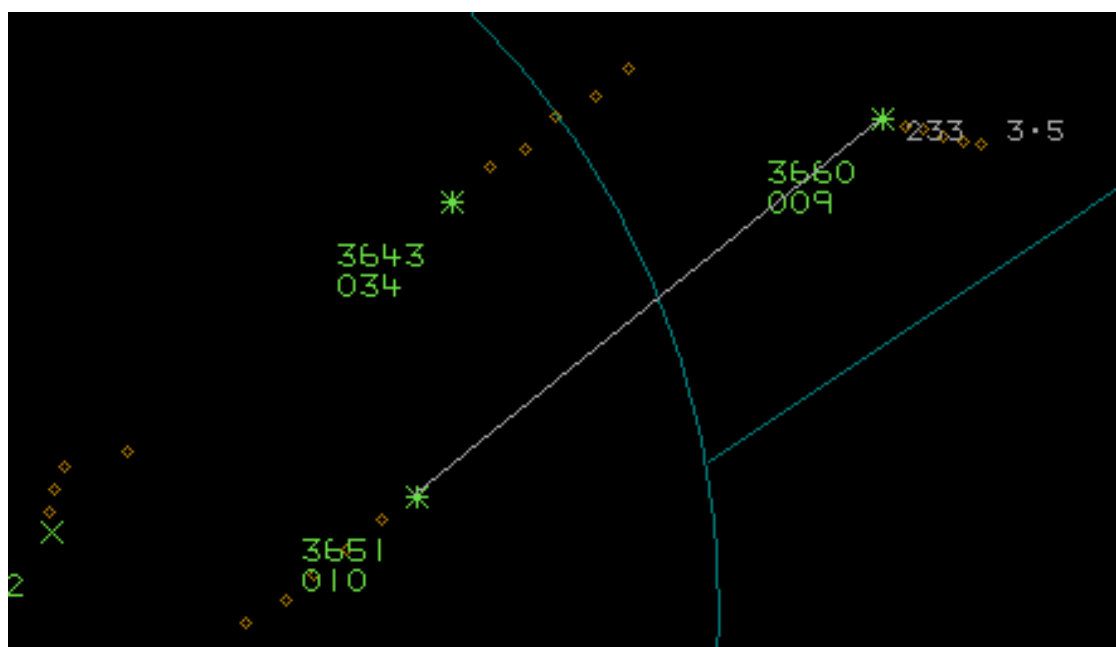
Figure 3: Traffic Information passed by the Marham [Tower] controller.

Eleven seconds later the Marham [Tower] controller passed Traffic Information to the F35 pilot regarding the C182. Five seconds prior to Figure 3, the LARS controller passed Traffic Information to the C182 pilot regarding the F35 which was acknowledged by the C182 pilot. Separation decreased to 3.5NM and 100ft [Figure 3].

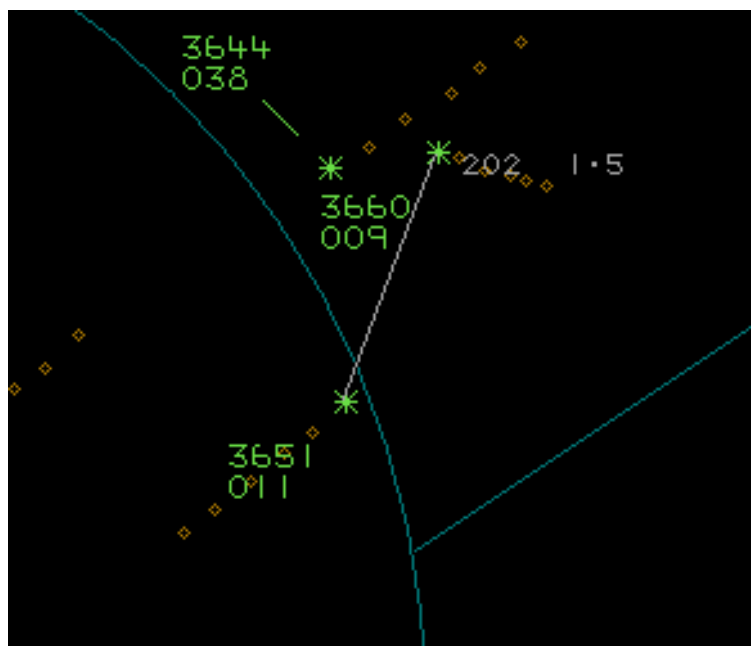
Figure 4: F35 Pilot turns inbound.

After passing Traffic Information to the C182 pilot the LARS controller passed Traffic Information to the ADC controller via the Supervisor. After passing the Traffic Information, the Marham [Tower] controller issued instructions to the first PFO recovery aircraft before requesting confirmation that the F35 pilot was visual with the second PFO recovery aircraft. The F35 pilot confirmed they were and reported turning inbound. This was acknowledged by the Marham [Tower] controller who updated the Traffic Information on the C182. Separation decreased to 1.5NM and 200ft [Figure 4].

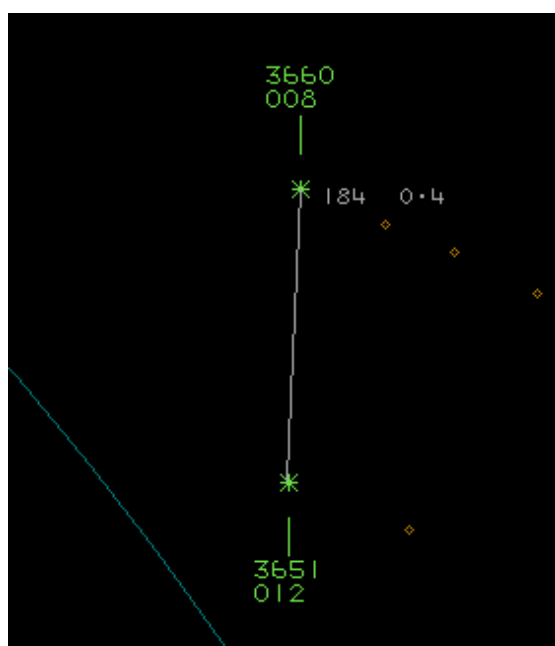
Figure 5: CPA.

Sixteen seconds prior to CPA the LARS controller updated the Traffic Information to the C182 pilot, however it is unknown whether the traffic was sighted as the RT was clipped. The F35 pilot appeared to climb as they turned inbound and did not report visual with the C182. Four seconds prior to CPA, the LARS controller requested the C182 pilot to “pick up a northerly heading” to maintain clear of the visual circuit. CPA was measured at 0.4NM and 400ft [Figure 5]. Shortly after CPA, the Marham [Tower] controller informed the F35 pilot they were clear of conflict.
