**AIRPROX REPORT No 2022111**

Date: 21 Jun 2022 Time: 1430Z Position: 5209N 00247W Location: 5.5NM NNW Hereford

An Airprox was reported when a SZD Junior and a C130 flew into proximity 5.5NM north-northwest of Hereford at 1430Z on Tuesday 21<sup>st</sup> June 2022. Both pilots were operating under VFR in VMC, neither pilot in receipt of an ATS.

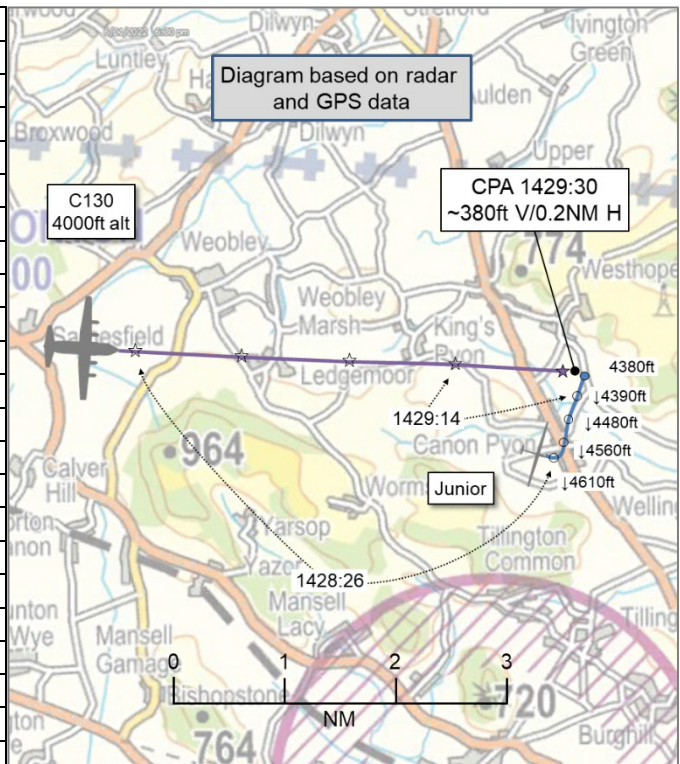
Radar and GPS data have been combined to produce the diagram and to measure CPA however, as a result of combining differing data sources, the vertical separation has been recorded as an approximation.
