AIRPROX REPORT No 2022110

Date: 21 Jun 2022 Time: 1445Z Position: 5106N 00255W Location: Middlezoy village

PART A: SUMMARY OF INFORMATION REPORTED TO UKAB

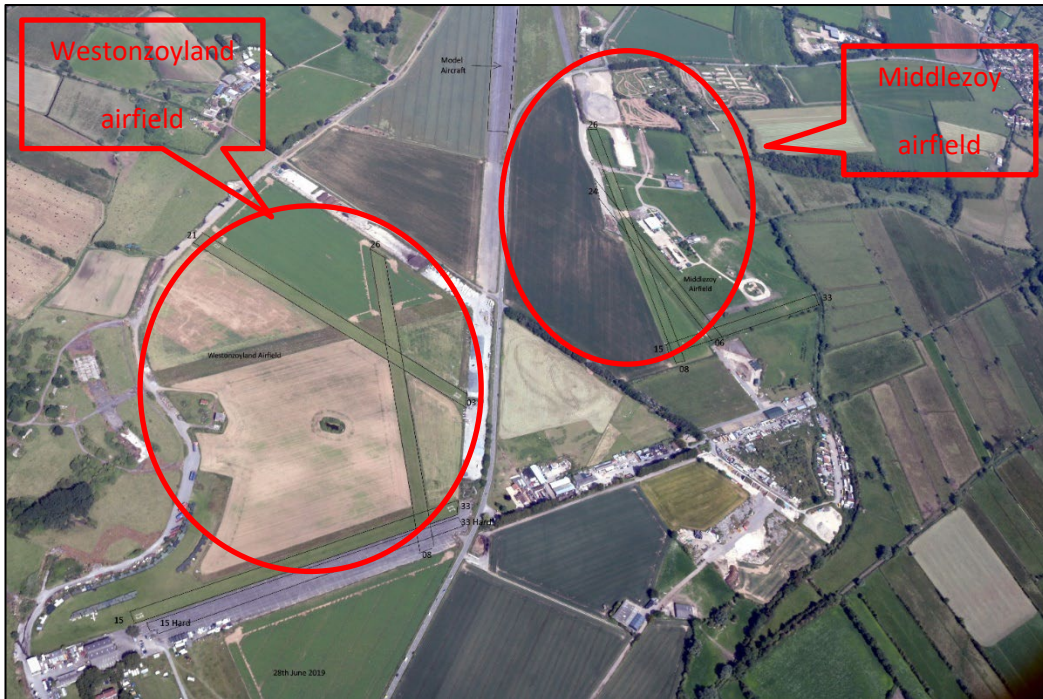
At Figure 1 is a satellite picture showing the location of the two airfields.

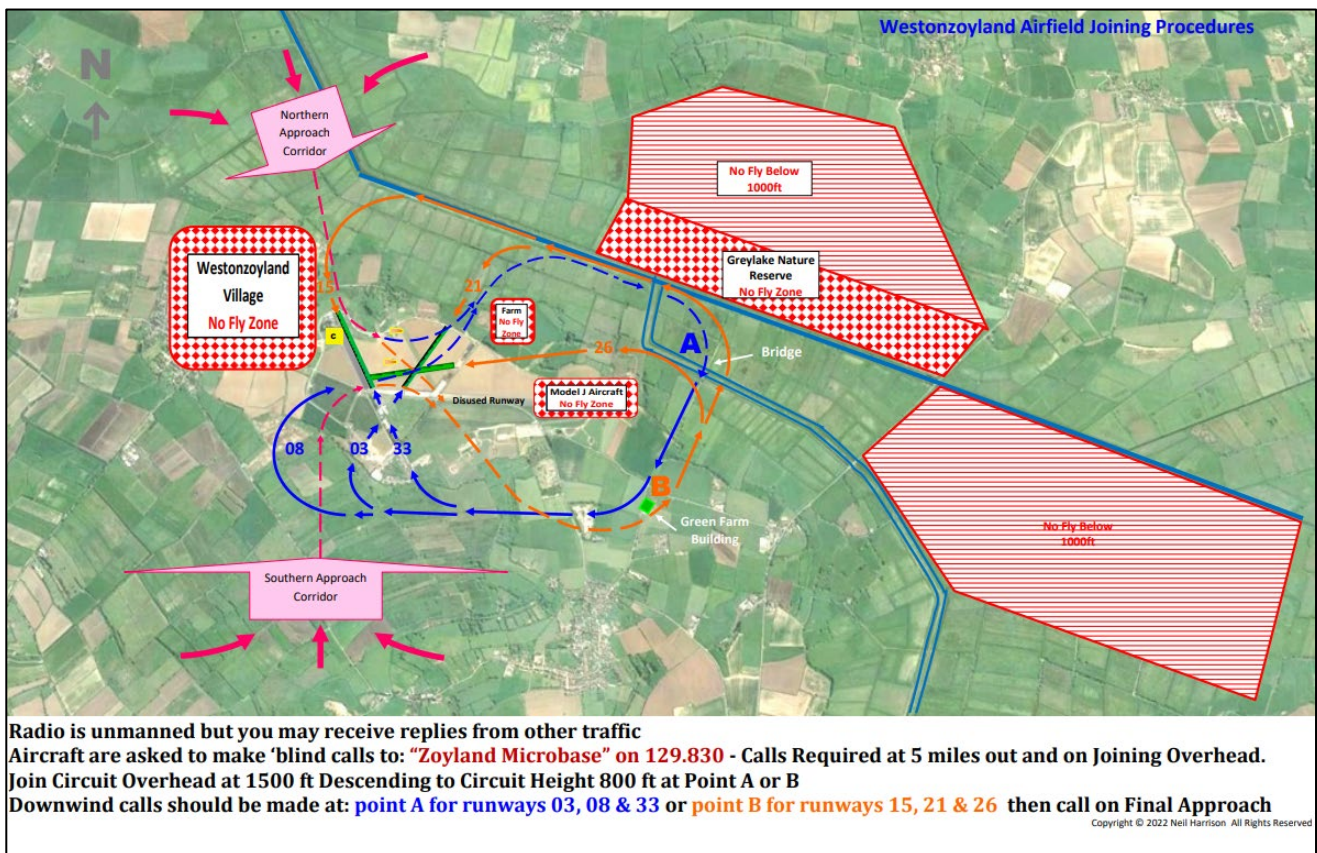
Figure 2

The following circuit information was found on the Westonzoyland website:

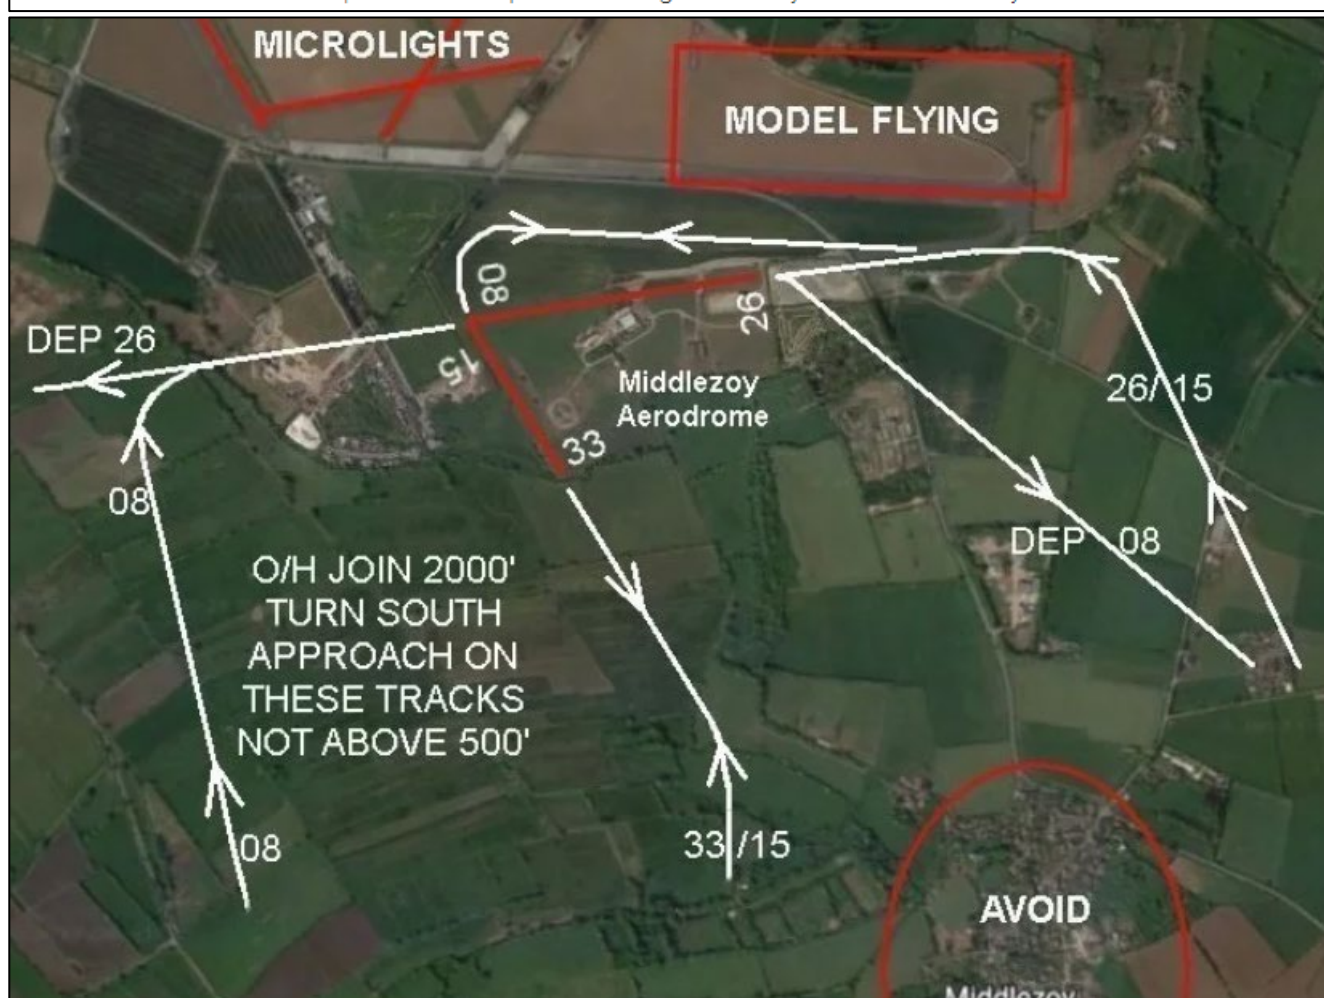
Figure 3: taken from the Middlezoy airfield website

The following information was found on the Middlezoy website:
