AIRPROX REPORT No 2022109

Date: 21 Jun 2022 Time: 1530Z Position: 5350N 00246W Location: 6.5NM NE Warton

PART A: SUMMARY OF INFORMATION REPORTED TO UKAB

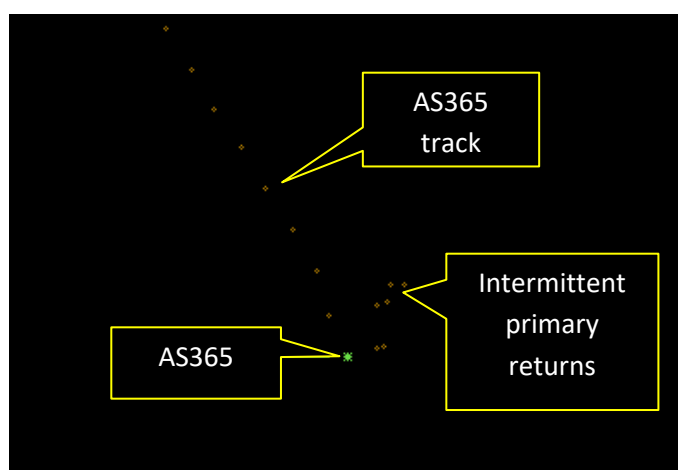
Figure 1 – NATS radar image at CPA

The AS365 pilot reported an Airprox after having flown into proximity with the first of two microlights. An analysis of the NATS radar replay was undertaken and the AS365 was detected and identifiable using Mode S data. Intermittent primary-only returns were also present in the area, see Figure 1. It cannot be determined whether these returns were generated by either of the microlights mentioned in the AS365 pilot's report; however, the pilot of the microlight involved kindly provided the UKAB Secretariat with a GPS data file from their flight which has been used within this report.

The radar and GPS data have been combined to produce the diagram and measure CPA which, because differing data sources have been used, is recorded as an approximation.
