AIRPROX REPORT No 2022108

Date: 20 Jun 2022 Time: 1031Z Position: 5207N 00003E Location: Barrington

PART A: SUMMARY OF INFORMATION REPORTED TO UKAB

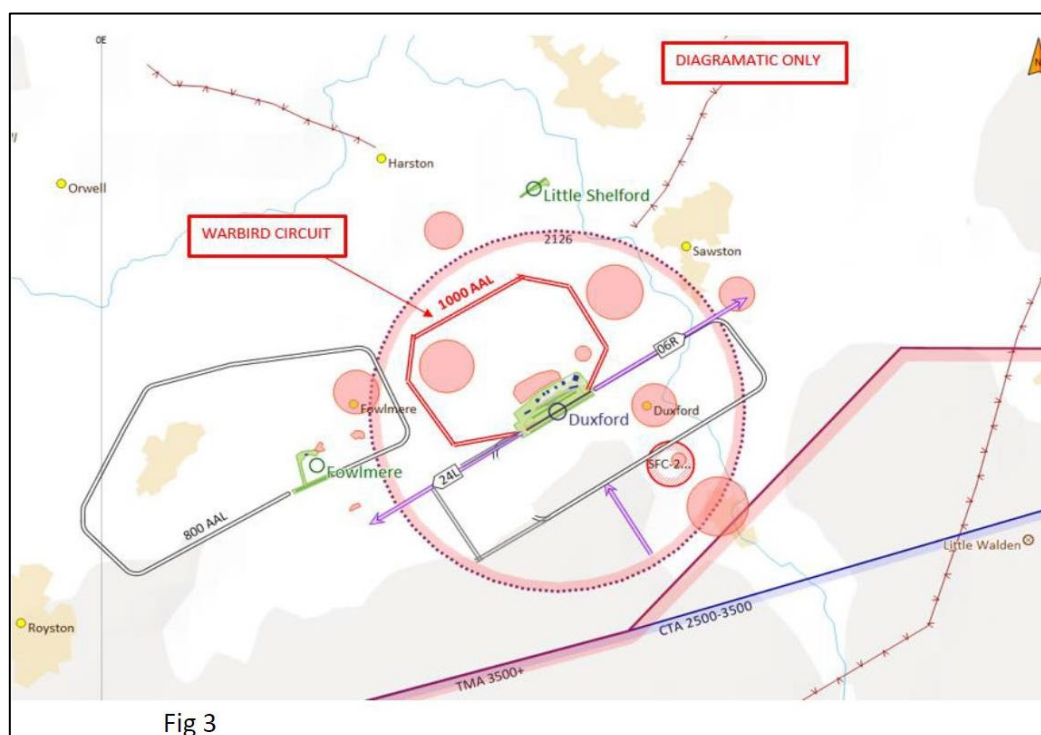
Fowlmere departures and circuit traffic from RWY 07 shall not exceed 500ft AGL until clear of the Duxford ATZ (see fig 3). Once airborne traffic is to contact Duxford 122.080Mhz for traffic information.'

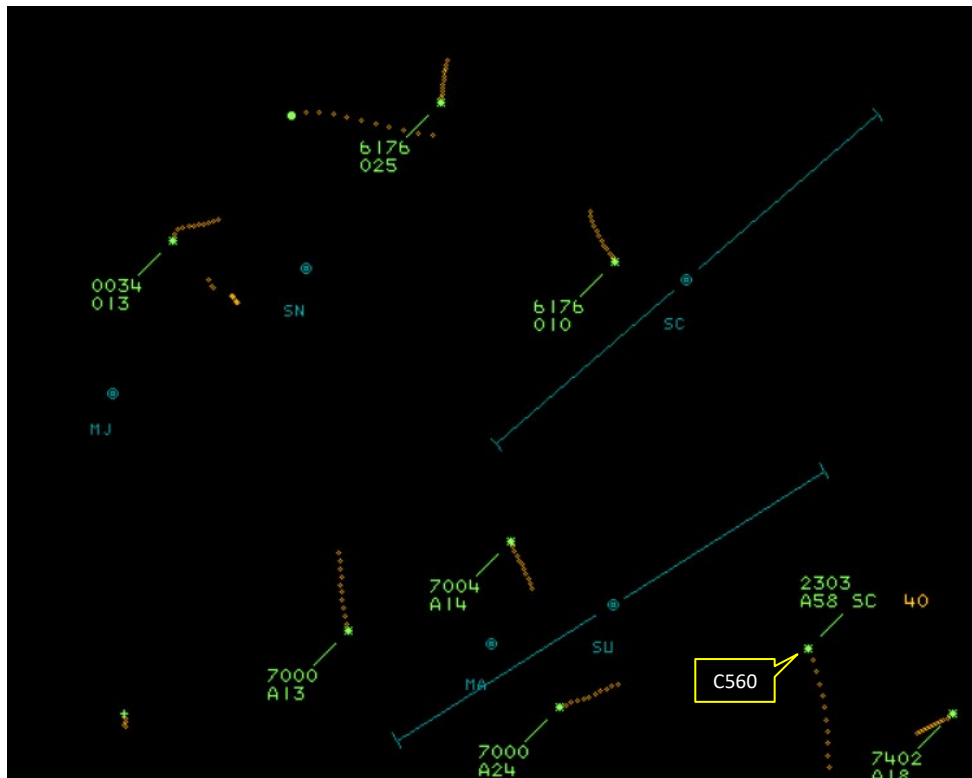
Figure 1 – 1024:35

At 1024:35 the pilot of the C560 contacted Cambridge Approach advising that they were in the descent to an altitude of 4000ft direct to the CAM (NDB). The Approach controller confirmed that it was a Procedural Service, passed the QNH and latest ATIS letter and reaffirmed their clearance to the CAM in a descent to 4000ft which was read-back by the pilot (Figure 1).

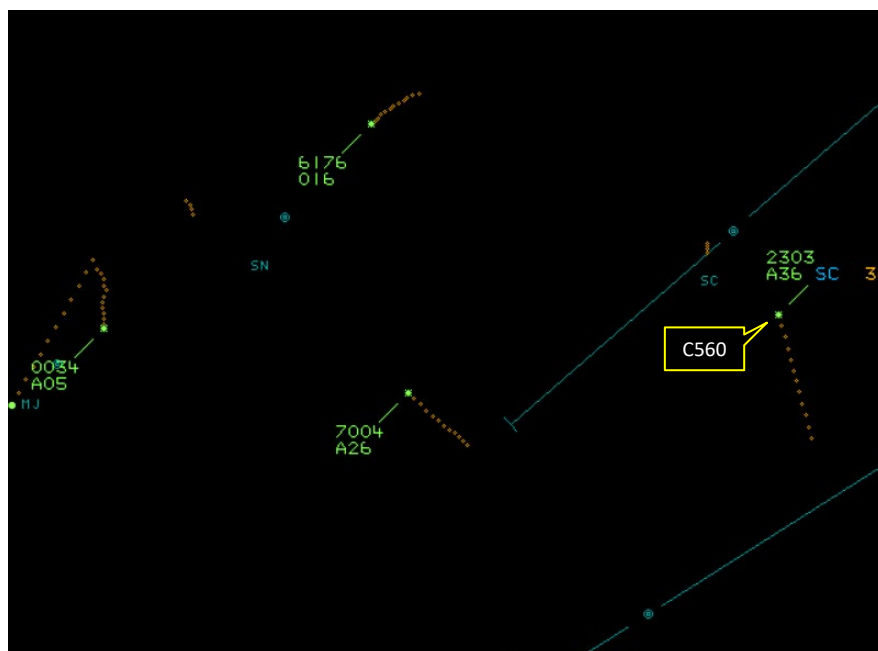
Figure 2 – 1026:30

At 1026:30 the pilot reported passing 4000ft and also the beacon outbound. The controller cleared the pilot for the NDB approach and requested a base turn complete call (Figure 2).

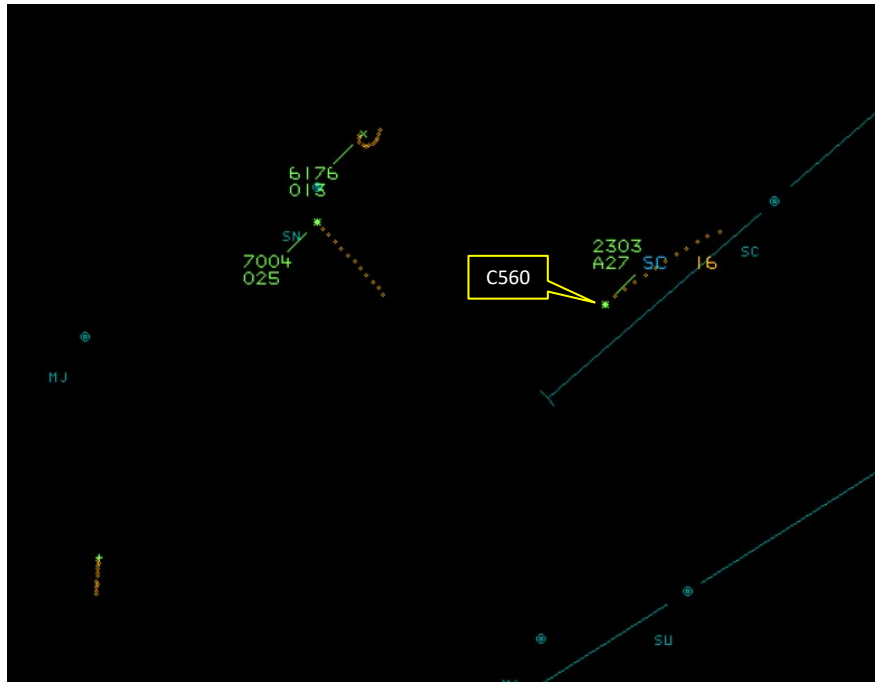
Figure 3 – 1027:58

At 1027:58 the controller requested a passing level from the pilot which was given as 2700ft (Figure 3).

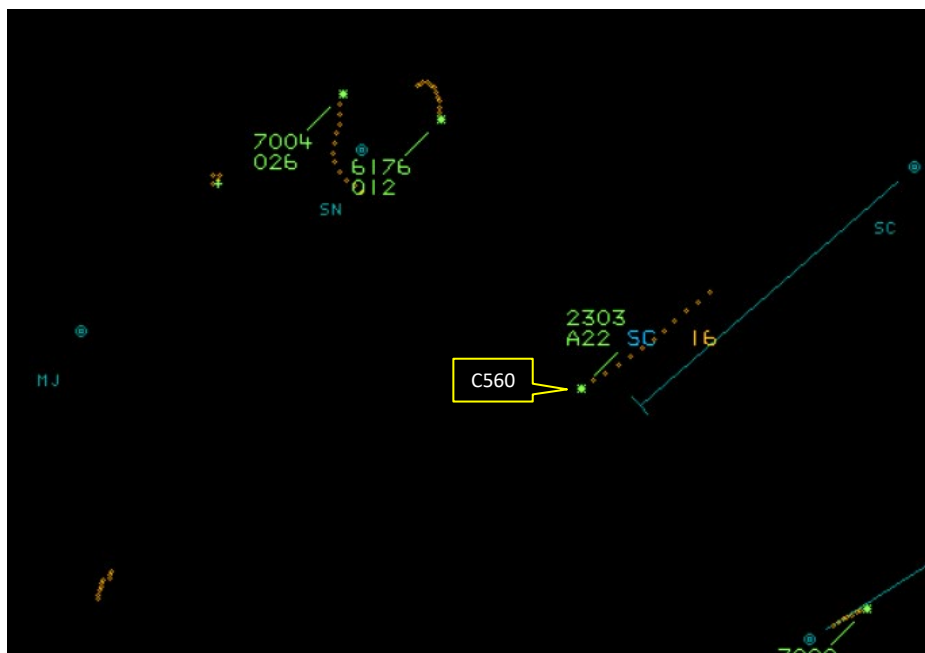
Figure 4 – 1028:42

At 1028:42 the controller advised the pilot that the Gransden Lodge gliding site was active with up to ten gliders, stating that those gliders should be staying relatively local to the site (Figure 4).

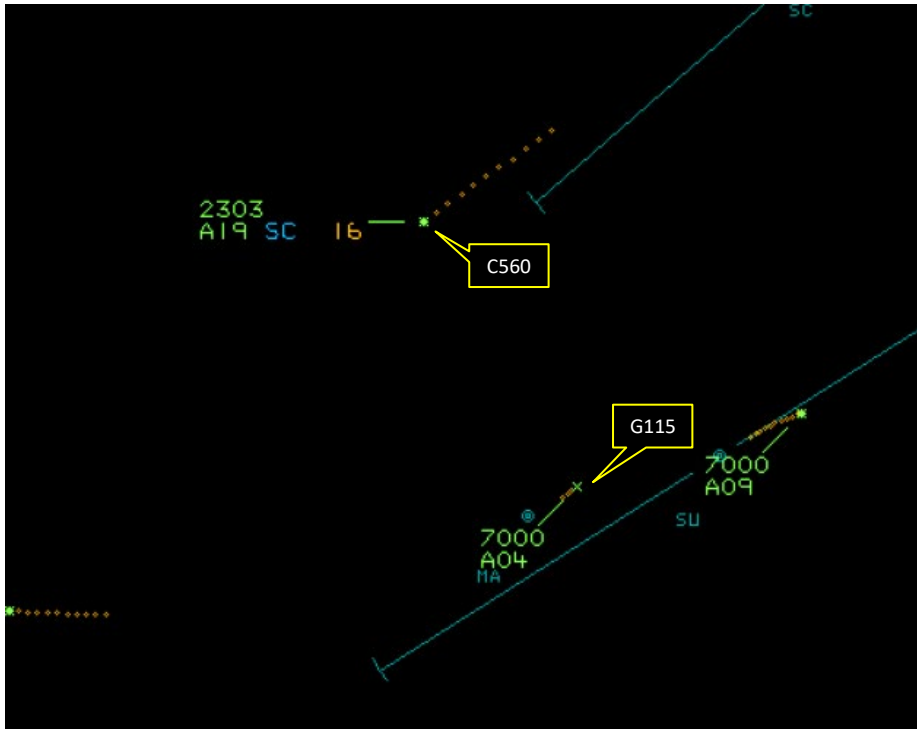
Figure 5 – 1029:00

At 1029:00 the G115 became visible on the area radar replay, having apparently just got airborne from Fowlmere (Figure 5).

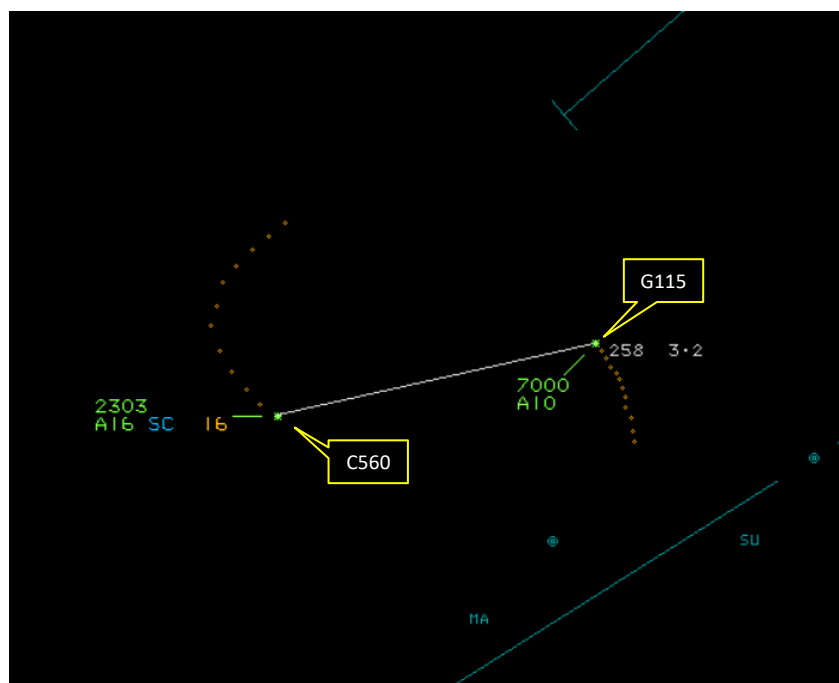
Figure 8 – 1030:10

At 1030:10 the Cambridge controller advised the pilot of the C560: *“Just caution sir I am non-radar. I can see a return on the ATM believed to be southwest of Cambridge, believed to be north-westbound indicating 1000ft. Just advise if you wish to discontinue the approach, keep a very good lookout”* (Figure 8).

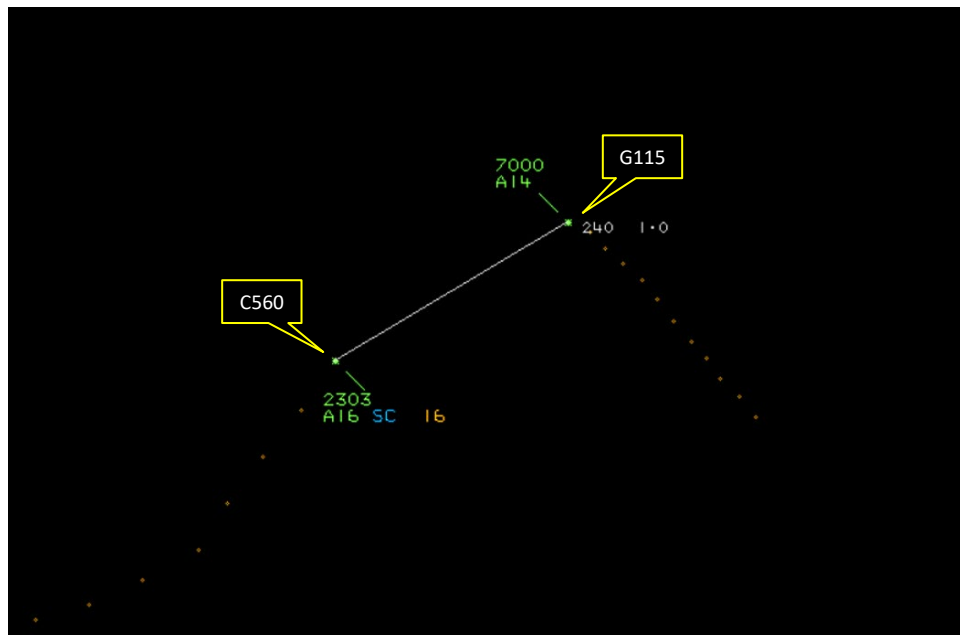
Figure 10 – 1030:58

At 1030:58 the pilot started to transmit their callsign but then stopped (Figure 10).

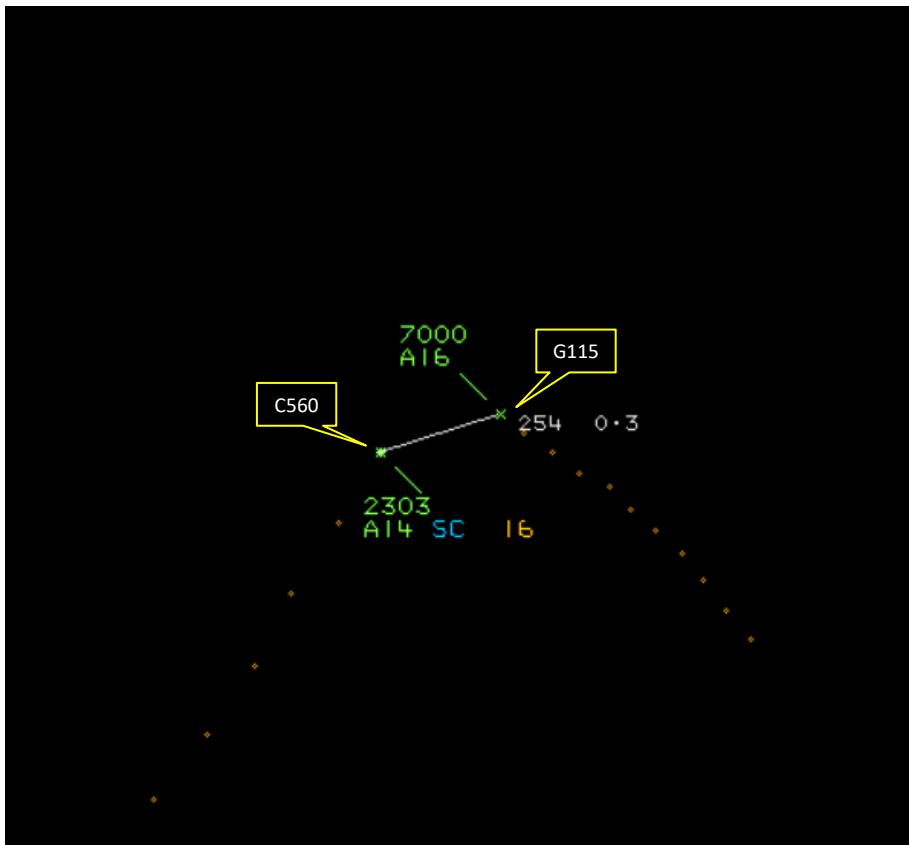
Figure 11 – 1031:02

Then at 1031:02 the pilot reported a TCAS RA which the controller acknowledged (Figure 11).

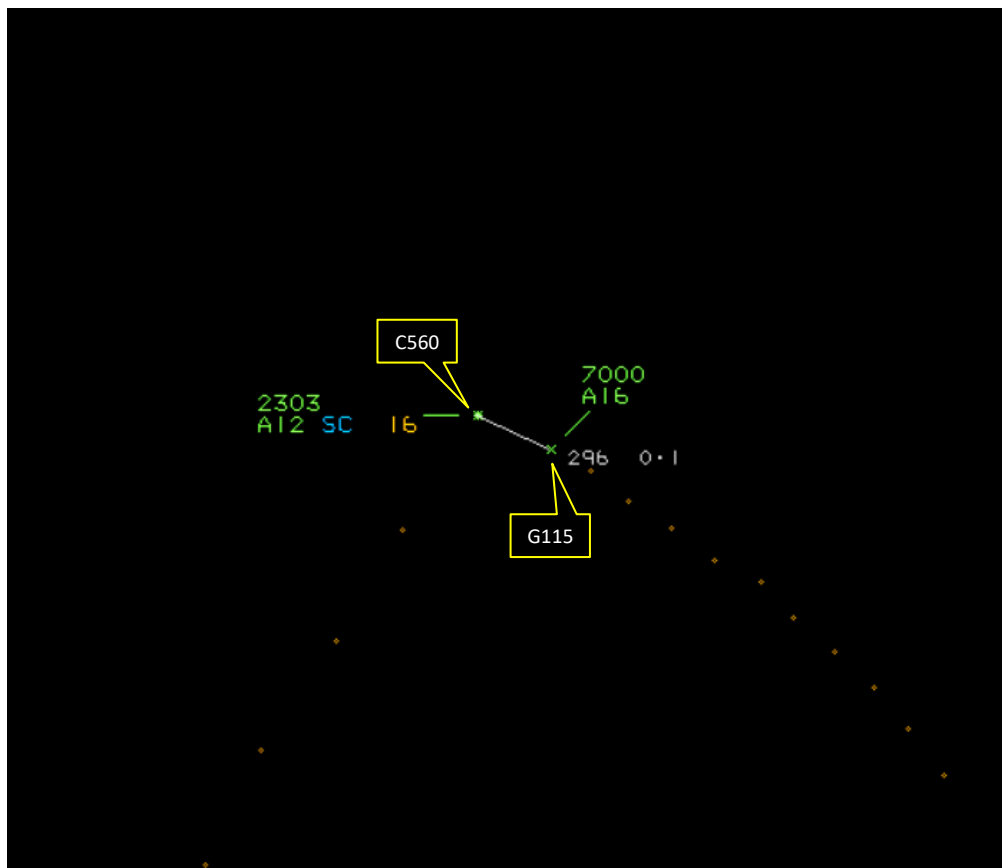
Figure 12 – 1031:07 CPA

CPA occurred at 1031:07 with the C560 passing 0.1NM ahead of, and 400ft below, the G115 (Figure 12).
