AIRPROX REPORT No 2022113

Date: 22 Jun 2022 Time: 1331Z Position: 5209N 00052W Location: 7NM NE Silverstone

PART A: SUMMARY OF INFORMATION REPORTED TO UKAB

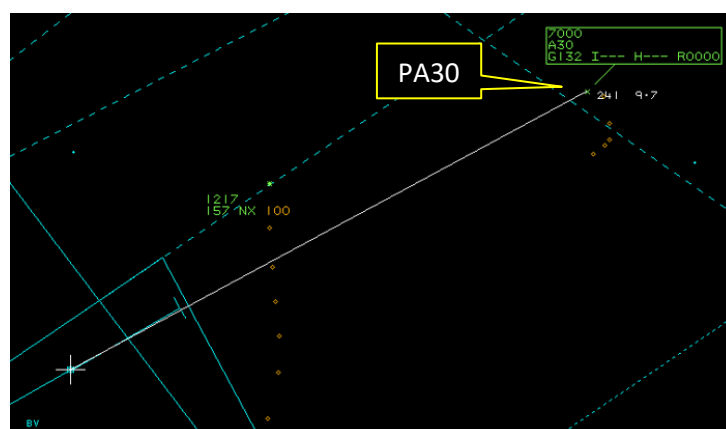
The radar replay identified several aircraft in the vicinity of the reported Airprox at the time given although only one was a twin-engine aircraft (a PA30). The PA30 was observed to turn left to head northwest (the direction assessed by the ASH31 pilot during the Airprox) approximately 10NM from Silverstone (see Figure 1).

Figure 1: 1329:59 – The PA30 turned NW, 9.7NM from Silverstone

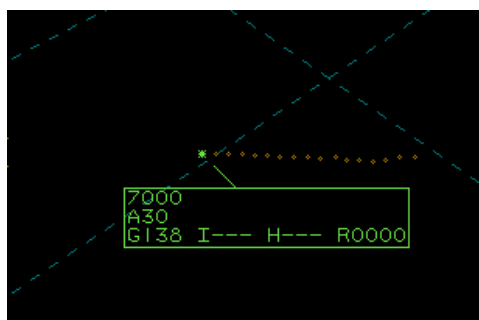
The radar replay showed that the track of the PA30 crossed the GPS track of the ASH31 and the diagram and CPA were determined from these two data sources (see Figure 2).

Figure 2: CPA at 1331:23
