AIRPROX REPORT No 2022120

Date: 03 Jul 2022 Time: 0952Z Position: 5210N 00057W Location: 6NM E DTY VOR

PART A: SUMMARY OF INFORMATION REPORTED TO UKAB

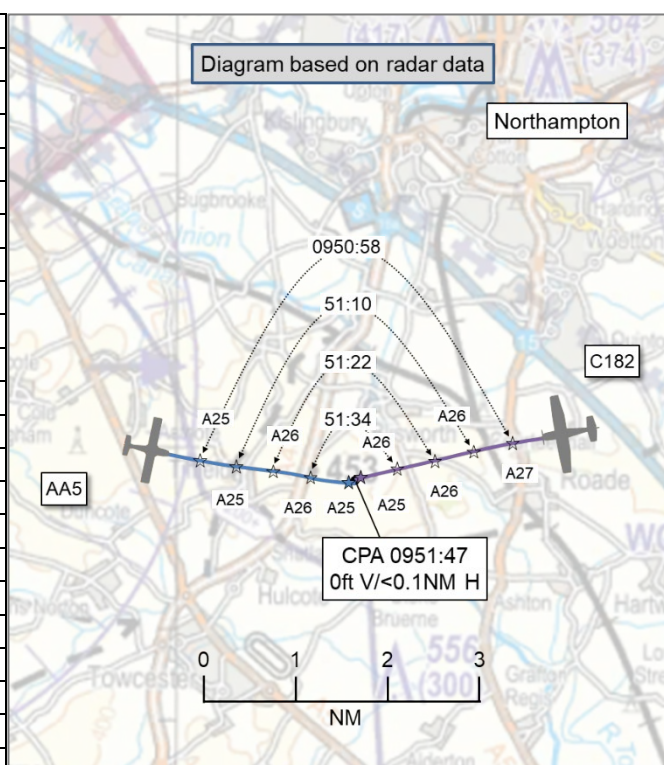
THE C182 PILOT reports approaching the Daventry VOR, when they briefly looked into the cockpit to change the radio frequency to Brize Radar to ask for a Basic Service. When they looked up, they saw another aircraft, opposite direction, almost at the same level and extremely close and avoiding action was taken by turning to the right.

THE AA5 PILOT reports flying with a highly experienced pilot passenger. The planned route avoided all CTAs and the British Grand Prix (GP) at Silverstone with its associated intense aerial traffic. With this in mind, they activated their EC device after passing DTY. They changed to Cranfield, expecting them to be busy with GP traffic. They maintained a listening watch and could see much traffic on SkyDemon, particularly around Silverstone. They then received an alert pop-up of approaching traffic, which they both saw, about 1.5NM ahead. They assessed the aircraft was on a reciprocal heading, but below. They climbed, maintained visual, and were sure the other aircraft would pass left and below. Having assessed minimal threat they continued and, needing to maintain visual, they did not want to make a sharp turn right. The other aircraft passed closer than expected and, equally, made no avoiding action, which prompted the comment that they did not believe they had seen them. The passenger concurred. Cranfield made no comment on the Airprox. They continued their flight. With the other aircraft being high wing, they were unable to get details and, without information, did not feel able to report the incident. On reflection they should have moved right to avoid the potential threat but, when seen, they did not consider the course was such and also needed to remain visual, which would be compromised with a sharp turn, as they made no move either.

An Airprox was reported when a C182 and an AA5 flew into proximity 6NM east of the DTY VOR at 0952Z on Sunday 3rd July 2022. Both pilots were operating under VFR in VMC, neither pilot in receipt of a FIS.
