AIRPROX REPORT No 2022127

Date: 03 Jul 2022 Time: 0917Z Position: 5128N 00119W Location: 4NM N Newbury

PART A: SUMMARY OF INFORMATION REPORTED TO UKAB

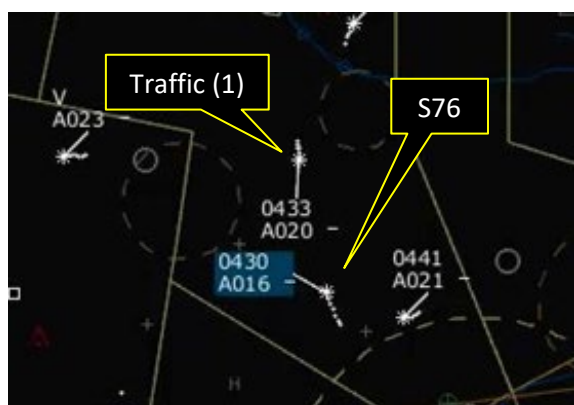
Figure 1 – 0910:53

0910:54 '[S76 callsign] traffic [(1)] 12 o'clock 3 miles reciprocal track indicating 400ft above you.'

0910:56 'Looking out [S76 callsign].'

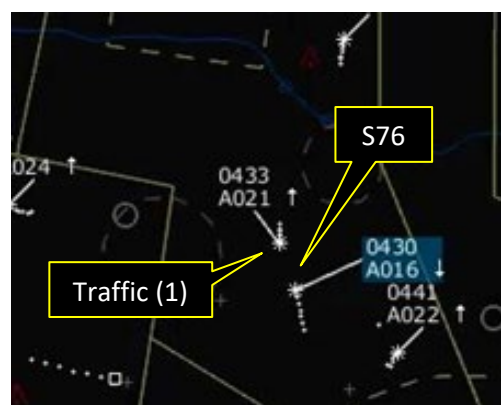
Figure 2 – 0911:28

0911:25 '[S76 callsign] 12 o'clock now 1 mile reciprocal heading 400ft above.'

0911:28 'Traffic in sight [S76 callsign].'

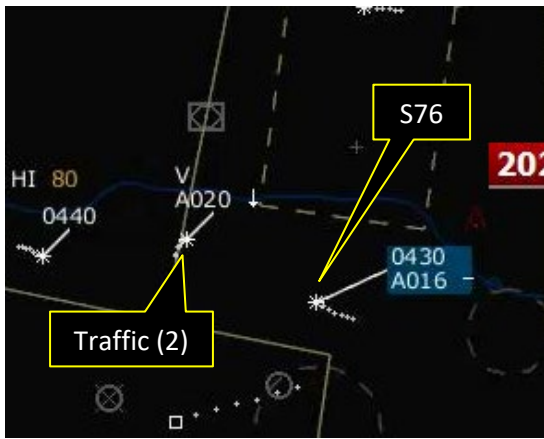
Figure 3 - 0913:45

0913:54 '[S76 callsign] traffic [(2)] 12 o'clock range of 3 miles manoeuvring indicating 2000ft. Further traffic [(3)] left 11 o'clock 4 miles reciprocal track no altitude information.'

0913:54 'Looking out [S76 callsign].'

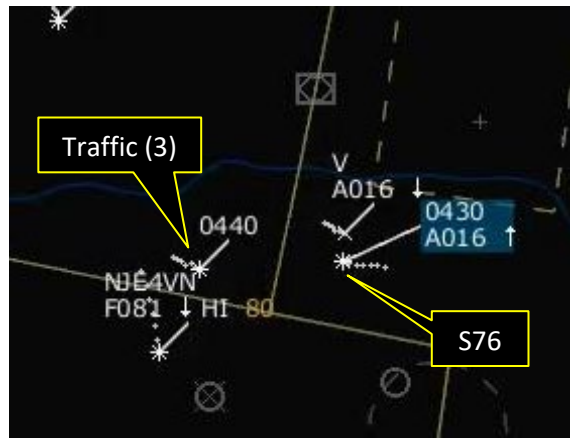
Figure 4 – 0914:40

0914:43 '[S76 callsign] traffic in sight.'

0914:44 '[S76 callsign] roger the other previously called traffic is now left 11 o'clock 2 miles eastbound no altitude.'

0914:49 'Traffic in sight [S76 callsign].'

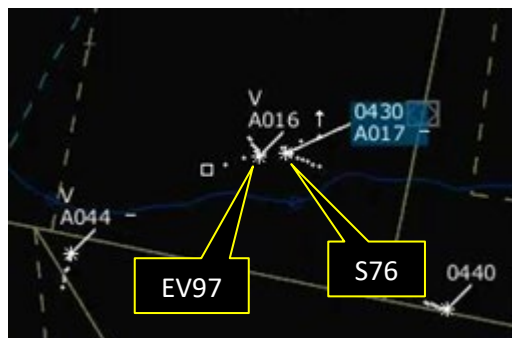
Figure 5 – 0916:49

[UKAB note: The next Traffic Information to be passed was that of the EV97 involved in the Airprox (see Figure 5)]

0915:51 '[S76 callsign] traffic 12 o'clock range 4 miles right-to-left indicating similar altitude.'

0915:56 'Looking out [S76 callsign].'

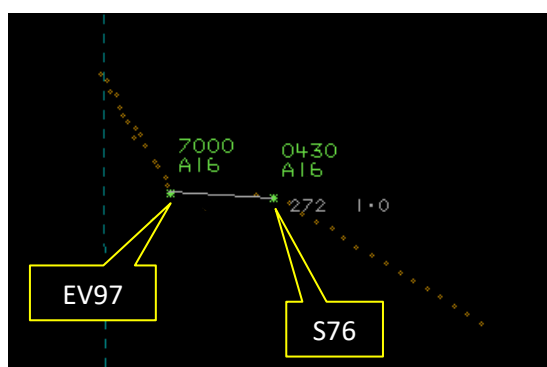
Figure 6 - 0916:44

An analysis of the NATS radar replay was undertaken and both aircraft could be positively identified (see Figure 6). It was seen that the S76 began a left turn and passed behind the EV97 (see Figure

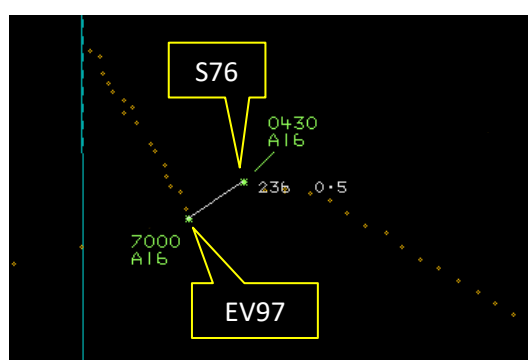
Figure 8 – CPA at 0916:56

7). CPA occurred at 0916:56 with no vertical separation and 0.5NM horizontal separation (see Figure 8).
