AIRPROX REPORT No 2022139

Date: 13 Jul 2022 Time: ~1106Z Position: 5249N 00247W Location: Sleaf ATZ

PART A: SUMMARY OF INFORMATION REPORTED TO UKAB

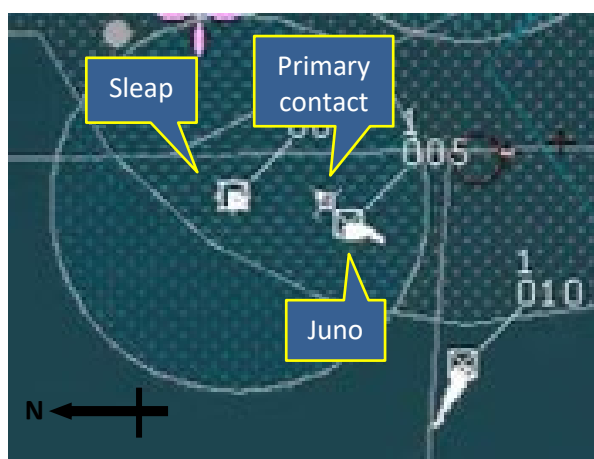
Figure 1 – 1105:51

An analysis of the NATS radar replay was undertaken and, although the Juno was visible and identifiable using Mode S, the Europa was not detected. However, for a brief time, the radar employed at RAF Shawbury had detected a primary-only return in the vicinity of the Juno at the approximate time of the Airprox, see Figures 1 and 2. Although it cannot be confirmed, this return is likely to have been the Europa. Please note that the radar data kindly supplied by RAF Shawbury is orientated 'east-up'. The time of CPA has been determined by combining this data with the NATS area radar replay and cross-referenced with the reports submitted by the pilots, however a measurement of separation has not been possible.

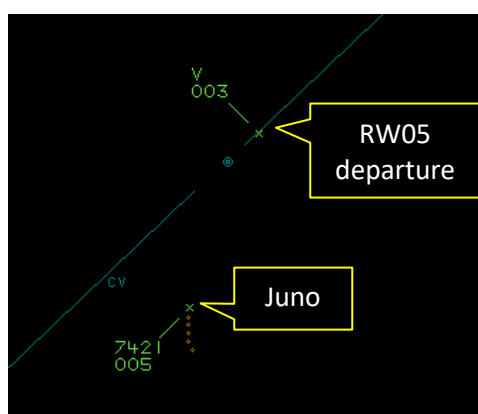
Figure 3 – 1106:15, unrelated RW05 departure

Shortly after the time at which the Airprox is believed to have occurred, at 1106:15, the NATS radar detected an unrelated aircraft departing from Sleap, the track of which suggests that it had departed from RW05, Figure 3.
