AIRPROX REPORT No 2022145

Date: 11 Jul 2022 Time: 1548Z Position: 5208N 00033W Location: 4NM NE Cranfield

PART A: SUMMARY OF INFORMATION REPORTED TO UKAB

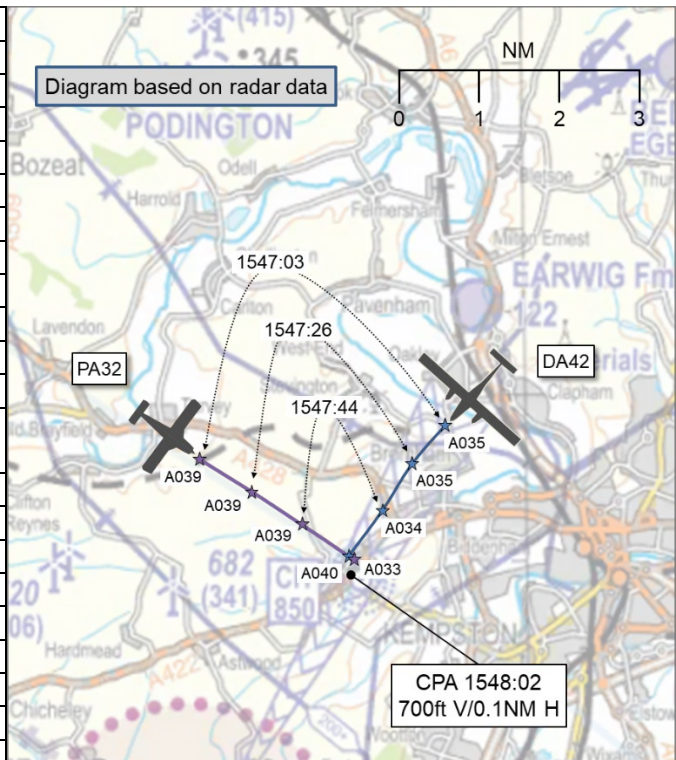
An analysis of the NATS radar replay was undertaken and both aircraft could be positively identified from Mode S data. The diagram was constructed and the CPA was calculated from the radar replay. Due to the periodicity of the radar sweeps, the CPA was assessed with the aircraft in their positions at 1548:02 (see Figure 3), albeit at a point momentarily after the aircraft tracks had crossed. The separation at the actual CPA may have been marginally closer.

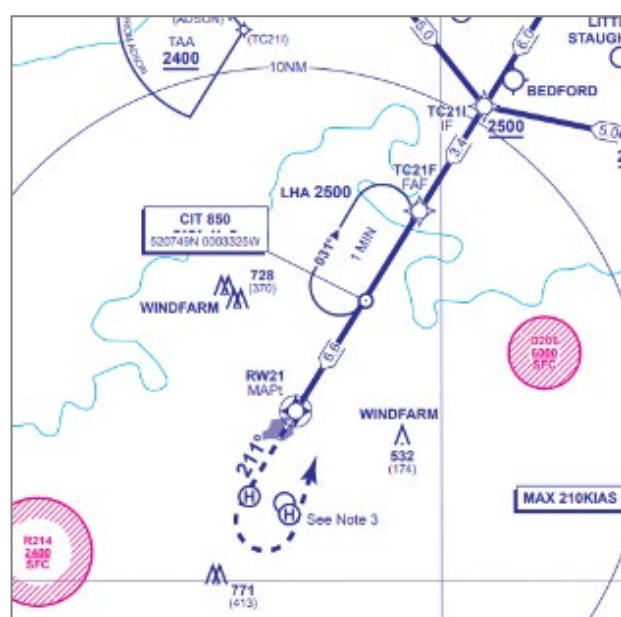
Figure 1 – excerpt from the Cranfield RNAV approach chart for RW21

[The DA42] was operating in the vicinity of Cranfield and displaying the IFR conspicuity Mode A code 2000. The pilot reported that they were receiving a Procedural Service from Cranfield. At the time of the event, [the PA32] was north of Cranfield tracking southeast. The pilot was receiving a Basic Service from the London FISO and had selected Mode A code 1177 accordingly. The Mode C of [the PA32] indicated 4000ft. No transmissions were recorded between the pilot of [the PA32] and the FISO in the 20min prior to the Airprox. On reviewing the radar recordings covering the time of the Airprox, both aircraft were identified by Mode S to the northeast of Cranfield. The radar track of [the DA42] correlated with the aircraft following the Cranfield CIT holding pattern shown in Figure 1.

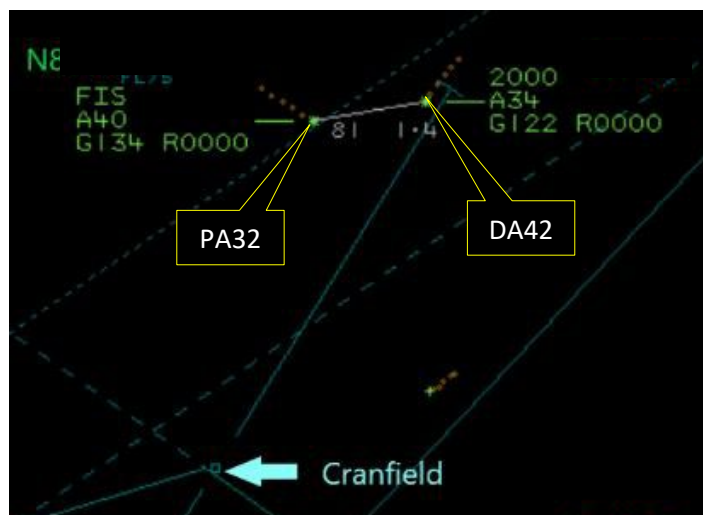
Figure 2 – 1547:34

The Airprox occurred approximately 4.6NM northeast of the airfield and was reported at 3500ft. This was outside the Cranfield ATZ both laterally and vertically. Figure 2 shows an annotated radar image of where the event took place and the relative positions of both aircraft prior to the Airprox.

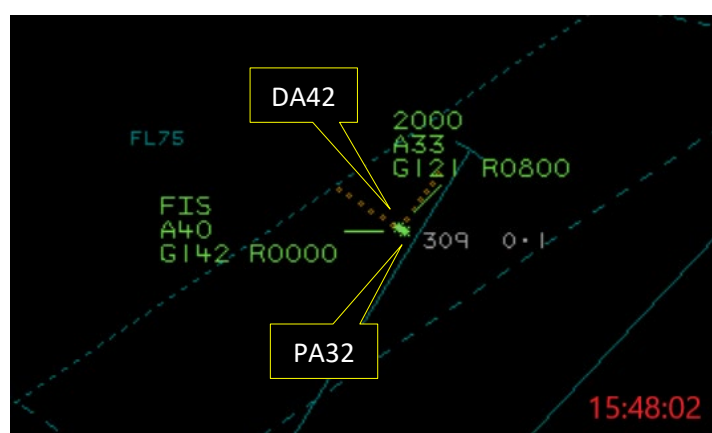
Figure 3 – CPA at 1548:02

Both aircraft continued along the same trajectories as above; the Mode C of [the PA32] displayed 4000ft throughout whilst that of [the DA42] varied between 3300ft and 3500ft. The [CPA] occurred at 1548:02 and was recorded as 700ft and 0.1NM (see Figure 3).

Conclusion: The Airprox occurred when the track of [the PA32] crossed that of [the DA42] which was in a holding pattern close to Cranfield airport. The CPA occurred at 1548:02 and was recorded on multi-track radar as 700ft and 0.1NM. The pilot of [the DA42] made a vertical manoeuvre in response to sighting [the PA32].
