AIRPROX REPORT No 2022147

Date: 23 Jul 2022 Time: 1534Z Position: 5205N 00051W Location: 9NM W Cranfield

PART A: SUMMARY OF INFORMATION REPORTED TO UKAB

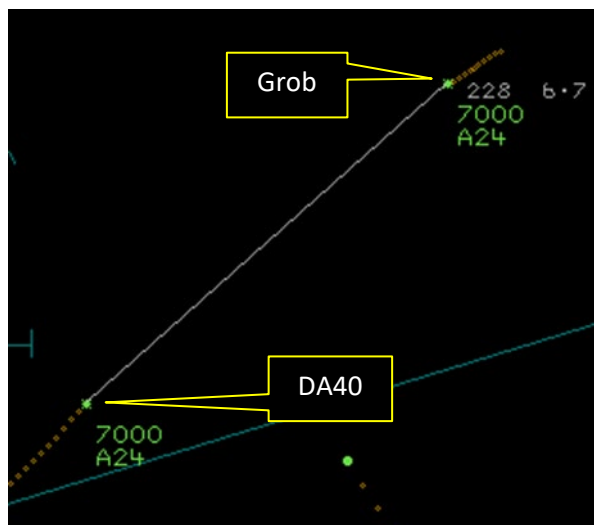
Figure 1 – 1532:00

1017hPa was confirmed. The pilot was instructed to report passing Olney. This full RTF exchange concluded at 1532:00, Figure 1.

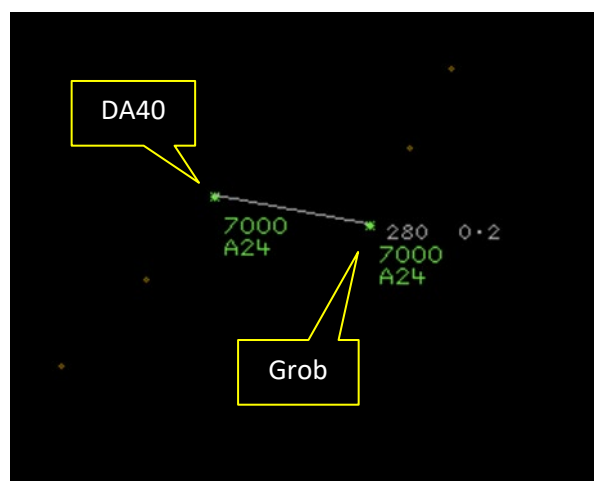
Figure 2 – 1533:57. CPA.

CPA occurred at 1533:54, with the aircraft separated by 0.2NM laterally and indicating 0ft vertically, Figure 2.

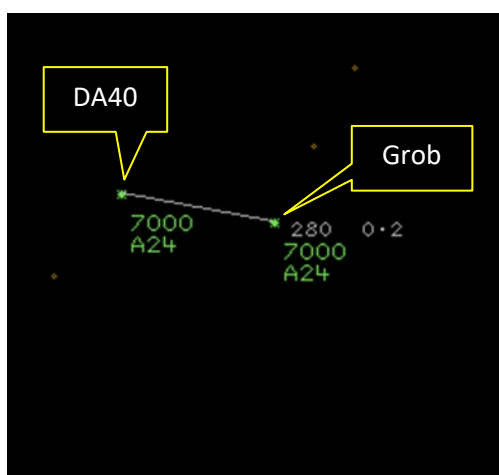
Figure 3 – 1533:54. Radar CPA.

An analysis of the NATS radar replay was undertaken and both aircraft were detected and identified using Mode S data. It could be seen that both aircraft had been relatively straight and level in the lead-up to the Airprox. Radar CPA occurred at 1533:54, measured at 0.2NM horizontally and 0ft vertically, Figure 3. However, on the next radar sweep at 1533:58, although the aircraft had passed, the separation was again recorded as 0.2NM horizontally and 0ft vertically, Figure 4. Therefore, actual CPA would have occurred between radar sweeps with a horizontal separation of less than 0.2NM.

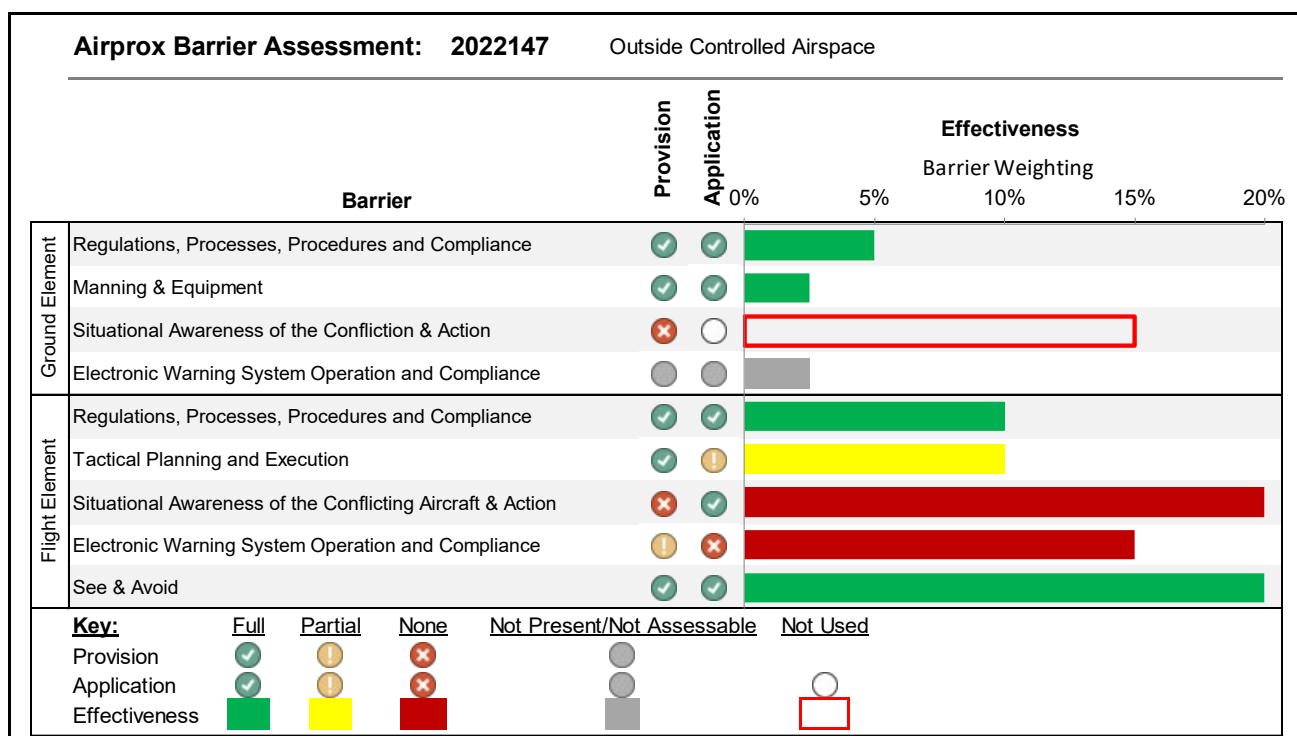
Situational Awareness of the Confliction and Action were assessed as **not used** because, when providing a Basic Service, the controller is not required to monitor the flight.

Tactical Planning and Execution was assessed as **partially effective** because the Grob pilot had not made contact with Cranfield approach when operating within the vicinity of the airfield.

Situational Awareness of the Conflicting Aircraft and Action were assessed as **ineffective** because neither pilot had any prior awareness of the presence of the other aircraft.

Electronic Warning System Operation and Compliance were assessed as **ineffective** because the EC equipment carried by the Grob pilot would have been expected to have alerted to the presence of the DA40 however no alert was reported.
