AIRPROX REPORT No 2022141

Date: 16 Jul 2022 Time: 0855Z Position: 5558N 00356W Location: Cumbernauld

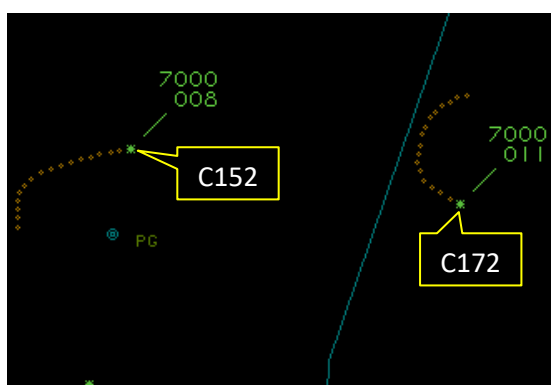
Figure 2 - 0850:03

An analysis of the NATS radar replay was undertaken. Both aircraft could be seen and identified using Mode S information; altitude information on the screenshots below is displayed in flight level. At 0850:03 the C152 could be seen downwind and the C172 was orbiting to the northeast of the airfield (Figure 2). The C152 made an approach to the runway and at 0853:53 could be seen once again climbing back into the circuit. At the same time, the C172 had reversed a turn at Denny and was heading toward the airfield (Figure 3).

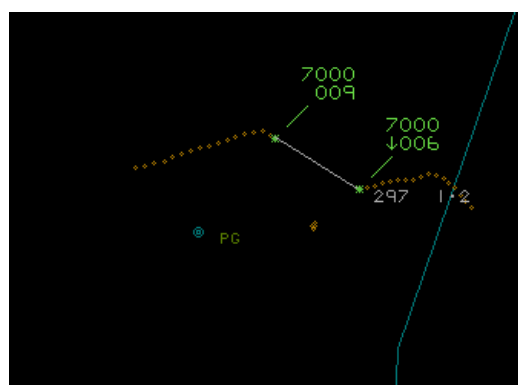
Figure 4 – 0855:11

At Figure 4, the C172 was on a long final and indicated an altitude of FL006 (radar QNH 1026hPa) and the C152 appeared to have turned onto a base leg; the two aircraft were 1.2NM apart by this point. The two aircraft continued until the C172 crossed ahead of the C152 by 0.4NM, with an indicated 400ft separation (Figure 5).

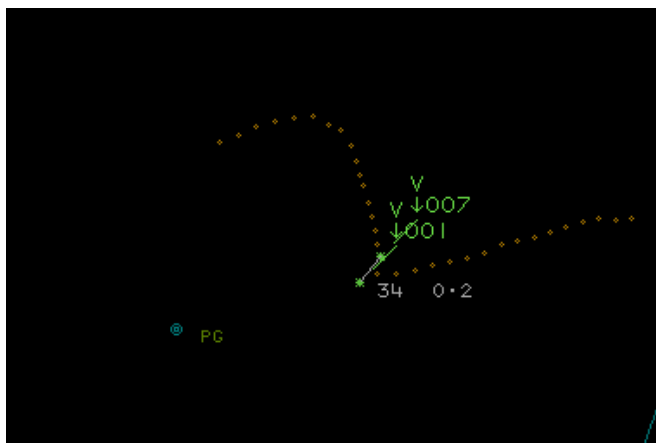
Figure 5 – Radar CPA

Radar CPA occurred at 0855:47 with an indicated separation of 0.2NM and 600ft.
