**AIRPROX REPORT No 2022153**

Date: 01 Aug 2022 Time: 1049Z Position: 5413N 00115W Location: 1.7NM WSW Sutton Bank

**PART A: SUMMARY OF INFORMATION REPORTED TO UKAB**

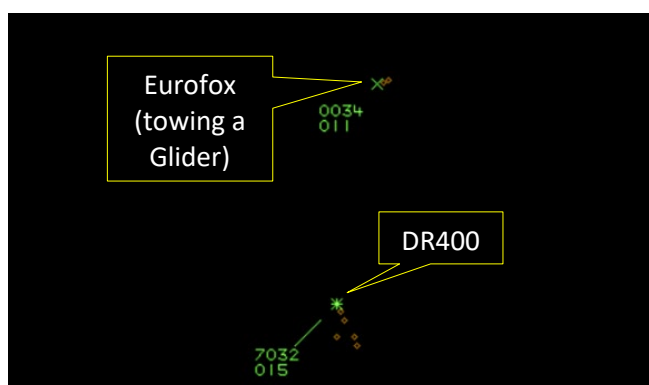
Figure 1 – 1047:14

At 1047:14, the Eurofox appeared on the area radar replay, 2.6NM northeast of the DR400 (see Figure 1).

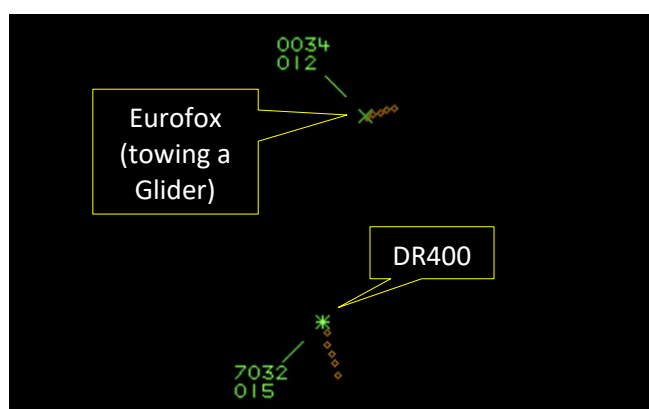
At 1047:30 the Teesside controller requested the DR400 pilot's altitude, which was given as 1700ft [QNH 1017hPa] (see Figure 2).

Figure 2 – 1047:30. The aircraft are 2NM apart

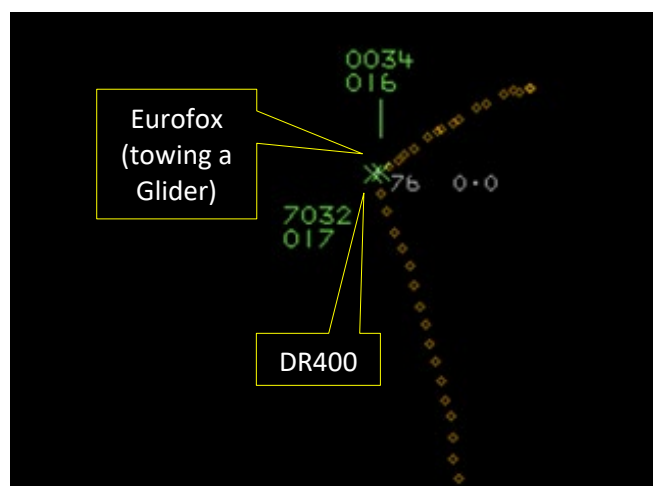
CPA occurred at 1048:32 with the aircraft separated by 100ft and less than 0.1NM (see Figure 3). There had been no further communications between the Teesside controller and the DR400 pilot.

Figure 3 - 1048:32 CPA

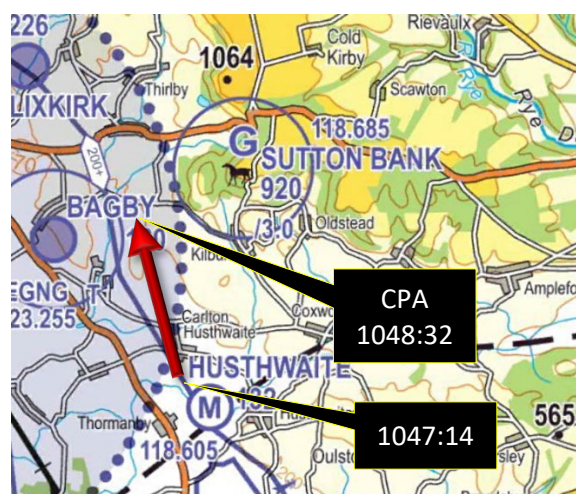
Figure 4 – Track of the DR400

The DR400 pilot reported that it had been their plan to pass through the Topcliffe MATZ (see Figure 4). However, having failed to establish communications with Topcliffe or Leeming, the pilot appears to have then tried to avoid the MATZ. The UK AIP ENR 2.2 advises that compliance with MATZ procedures are not compulsory for civil pilots, however they are “strongly advised” to obtain a MATZ crossing approval. A track further to the west through the Topcliffe MATZ would have been possible, potentially keeping the aircraft away from the Sutton Bank ‘climb-out’.
