AIRPROX REPORT No 2022154

Date: 02 Jun 2022 Time: 1557Z Position: 5130N 00015W Location: 3.5NM NW London Heliport

PART A: SUMMARY OF INFORMATION REPORTED TO UKAB

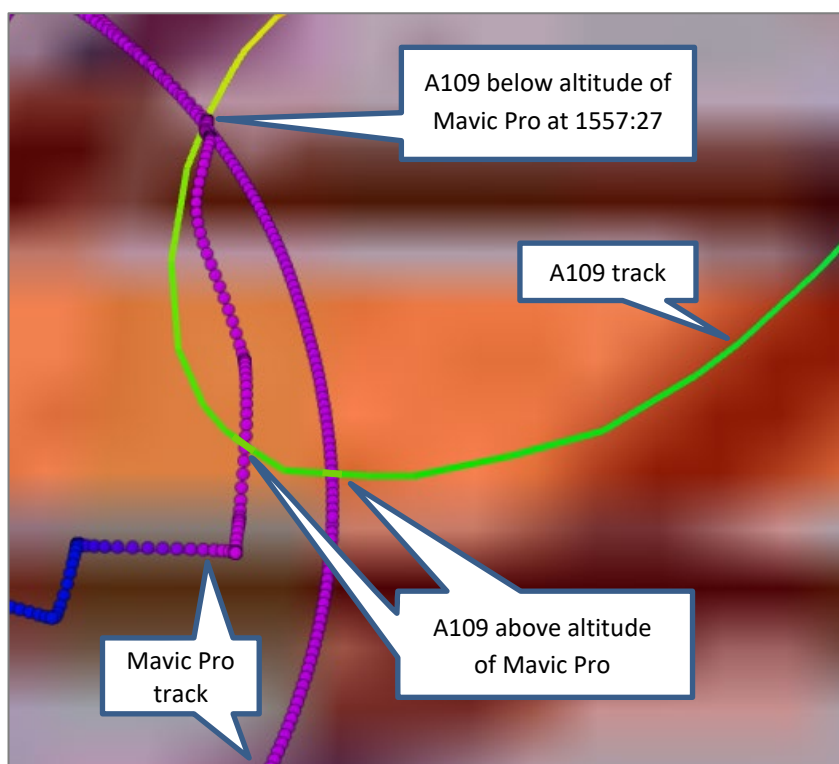
Figure 1 – Aircraft tracks cross

The A109 pilot descended through 410ft, the altitude of the Mavic Pro, at approximately 1557:25, 2sec before the tracks crossed which is taken to be CPA, with 40ft vertical separation. Although exact measurement of horizontal separation has not been possible, due to the near parallel nature of the aircraft tracks before crossing, it is assessed that it was less than 100m, which aligns with the separation stated by the pilots.
