AIRPROX REPORT No 2022152

Date: 29 Jul 2022 Time: 1128Z Position: 5139N 00204W Location: Kemble Aerodrome

PART A: SUMMARY OF INFORMATION REPORTED TO UKAB

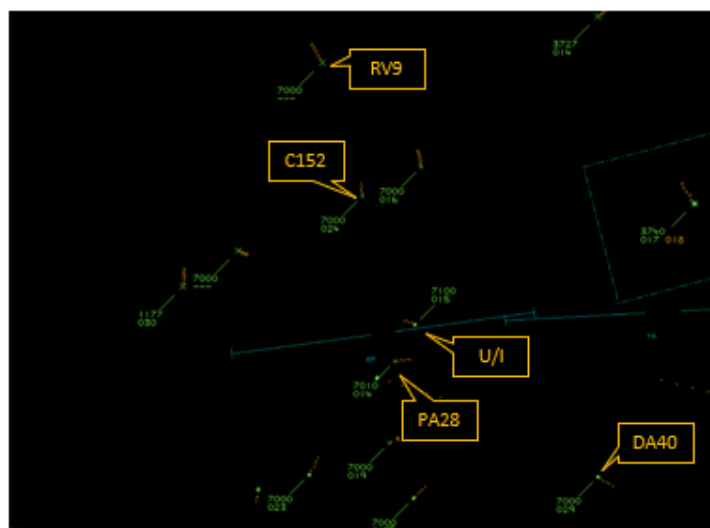
Figure 1 – 1122:00

At 1122:00 the pilot of the RV9 called Kemble advising that they had copied that it was RW08 in use with a right-hand circuit. The AFISO confirmed the QFE and requested a call in the overhead advising “*we have two others joining*” which the RV9 pilot acknowledged, passing their position as “*nine miles to run from the north-northwest*” (Figure 1).

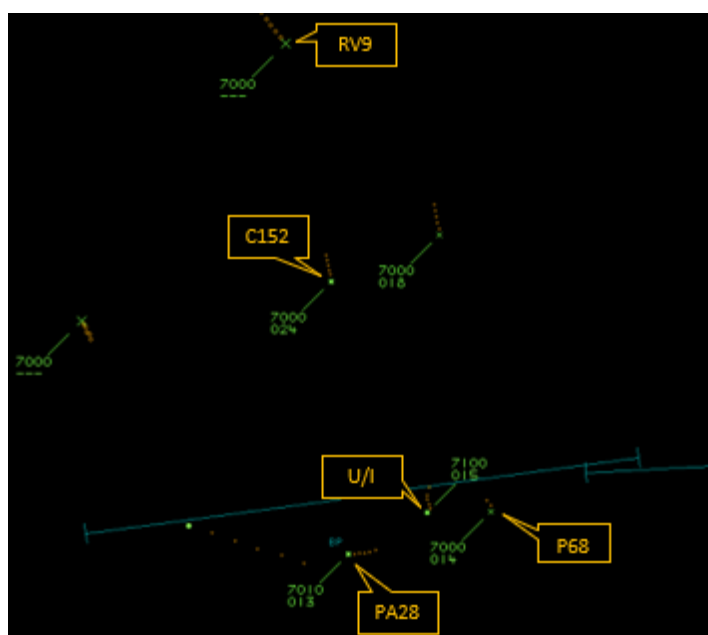
Figure 2 – 1122:25

At 1122:25 two pilots transmitted simultaneously. The first was the pilot of the PA28 in the circuit who reported downwind for a touch-and-go. The second transmission, the beginning of which was blocked by the PA28 pilot’s transmission, was the pilot of a previously departing aircraft, a P68, advising “... 2000ft and will continue orbits at 2000ft over the airfield”. The AFISO replied to the pilot of the PA28 instructing them to report final. The AFISO did not reply to the pilot of the P68 as immediately following their reply to the PA28 the pilot of the U/I aircraft also in the circuit reported downwind (Figure 2).

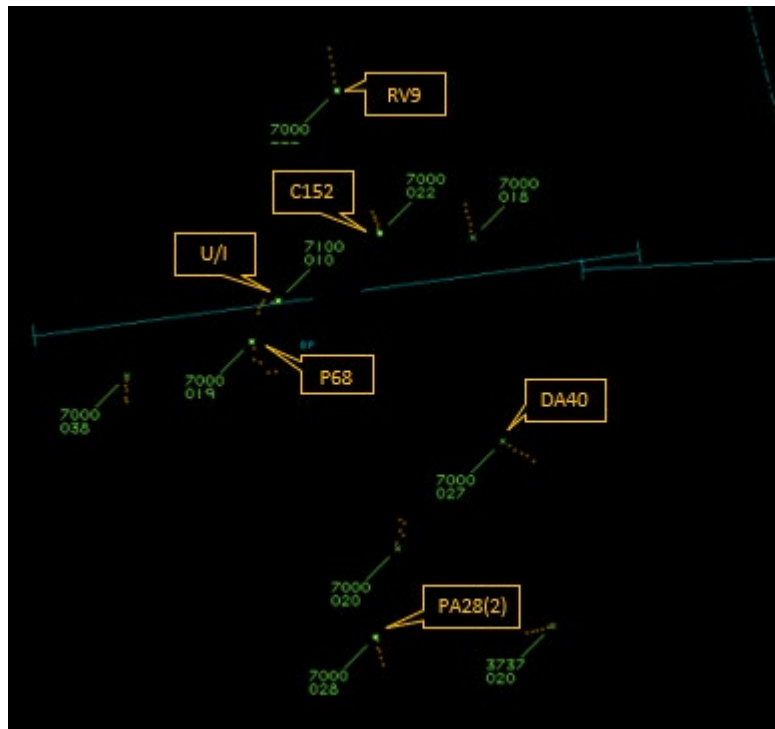
Figure 4 – 1124:50

At 1124:50 the pilot of the U/I aircraft reported on final for a landing and was given the runway by the AFISO (Figure 4).

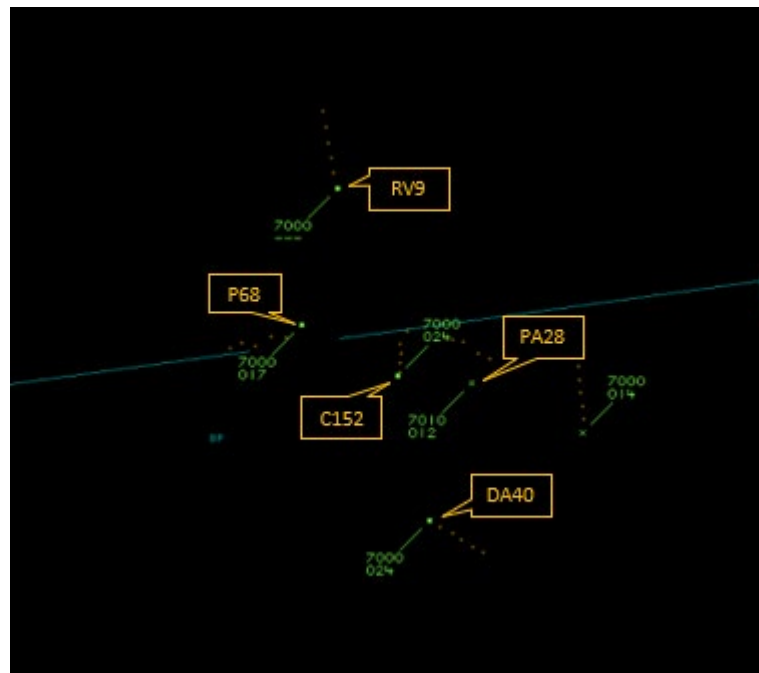
Figure 5 – 1125:50

At 1125:50 the pilot of the C152 reported in the overhead and was instructed to report crosswind (Figure 5).

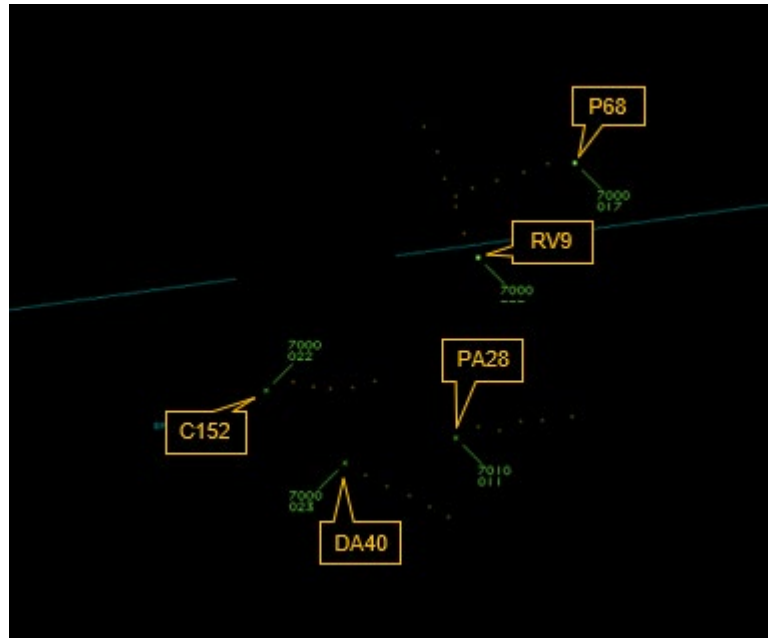
Figure 7 – 1126:30

At 1126:30 the pilot of an R44 helicopter called for re-join from the north and was passed joining instructions by the AFISO.

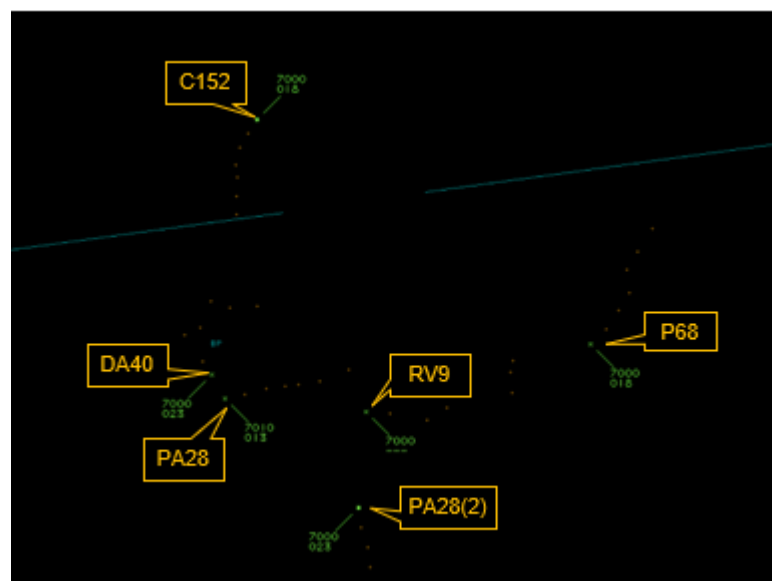
Figure 8 – 1127:20

At 1127:20 the pilot of a second aircraft on the ground called up. At this point on the radar replay, the DA40 was seen to have commenced a left-hand orbit (Figure 8).

Irrespective of the lack of specific Traffic Information, it was the non-standard, left-hand orbit completed by the DA40 pilot which appears to have brought them into conflict with the RV9. Their experience of orbiting in the circuit at [home airfield] where an air traffic control service is provided and where this can be utilised to better and more safely space traffic in the circuit by controllers, led the pilot to believe that it was a safe and appropriate manoeuvre to conduct at a unit where the service is Aerodrome Flight Information. An alternative manoeuvre may have been to remain in the overhead in a right-hand pattern and reassess the traffic situation before then attempting to integrate once more.

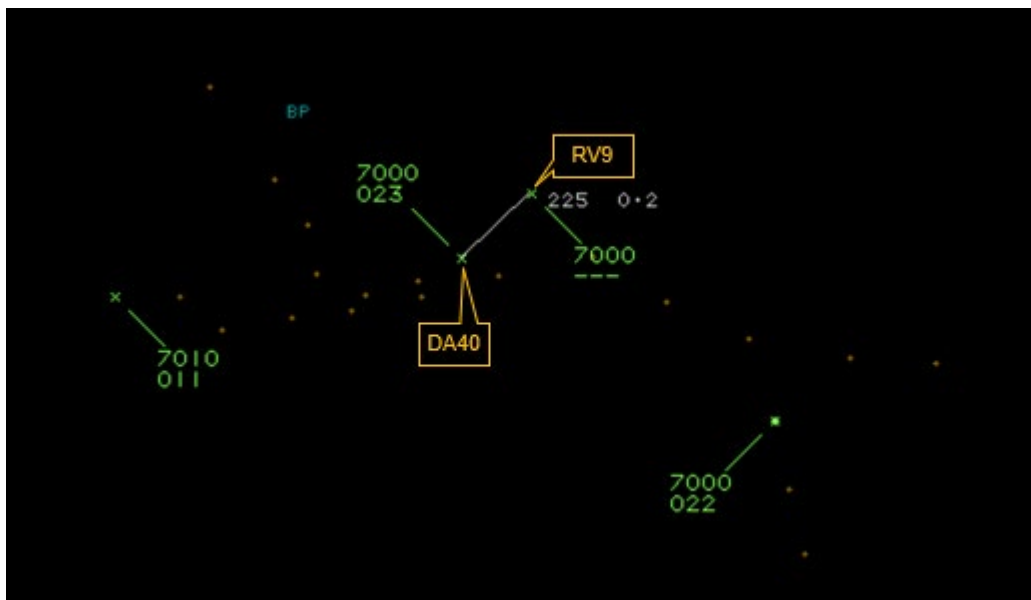
Figure 9 – 1127:35 - CPA

CPA occurred at 1127:35 just as the AFISO was responding to another pilot, calling for re-join from the south (Figure 9).

The pilot of the DA40 carried out a left-hand orbit whilst conducting an overhead join, bringing them into conflict with the RV9 joining in the overhead behind them.

Recommendation: Cotswold Airport reviews published procedures and considers creation of circuit occupancy limitations to ensure that traffic complexity levels are appropriate.
