AIRPROX REPORT No 2022150

Date: 27 Jul 2022 Time: 1135Z Position: 5411N 00113W Location: 6NM E of Topcliffe

PART A: SUMMARY OF INFORMATION REPORTED TO UKAB

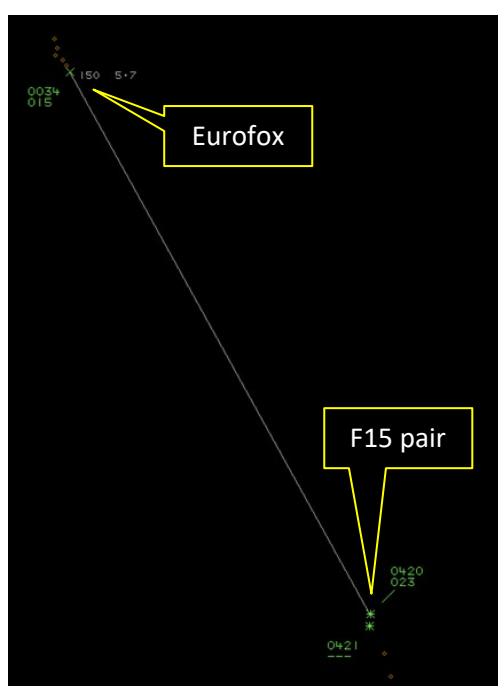
Figure 1: 1134:32 Traffic Information provided with F15s in the vicinity of the Eurofox.

The Leeming Approach controller called three contacts to the F15 pilots (who were squawking 0420 and 0421) in their 12 o'clock, 4NM. Only one contact can be seen in Figure 1, squawking 0034, the Eurofox aircraft. Separation was measured at 5.7NM and 800ft.

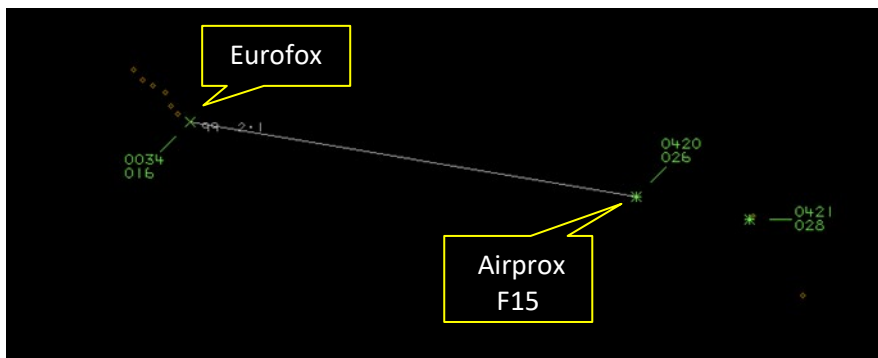
Figure 2. 1135:10 - Further Traffic Information with F15s provided in the vicinity of the Eurofox.

The Leeming Approach controller passed further Traffic Information to the F15 pilot, with three contacts, left, manoeuvring with no height information, range 1NM. Only the Eurofox can be seen in Figure 2, with separation between the lead F15 and Eurofox measured at 2.1NM and 1000ft.

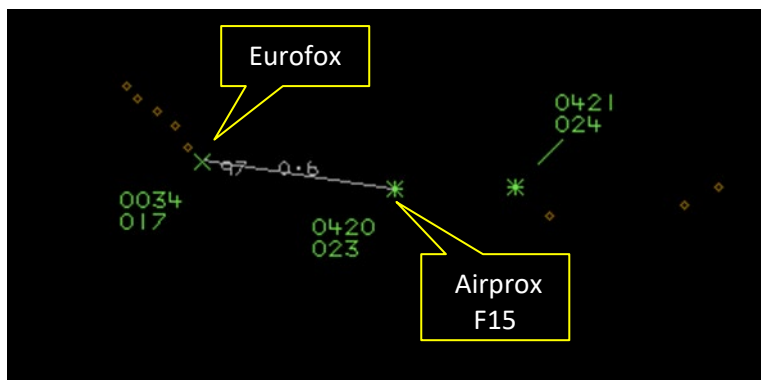
Figure 3. 1135:23 - Final radar sweep prior to CPA.

At 1135:23, no Traffic Information was passed [to the F15 pilot at this time]. Separation decreased to 0.6NM and 600ft Figure 3. It is not known if the Eurofox was displayed on the Leeming radar.

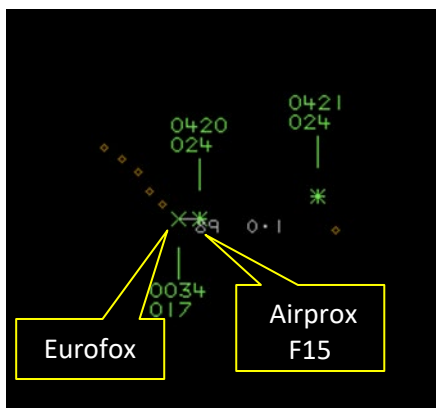
Figure 4. 1135:26 - CPA of lead F15, squawking 0420.

At 1135:26, no Traffic Information was passed [to the F15 pilot at this time]. CPA between the lead F15 and 0034 (Eurofox) was 0.1NM and 700ft Figure 4.

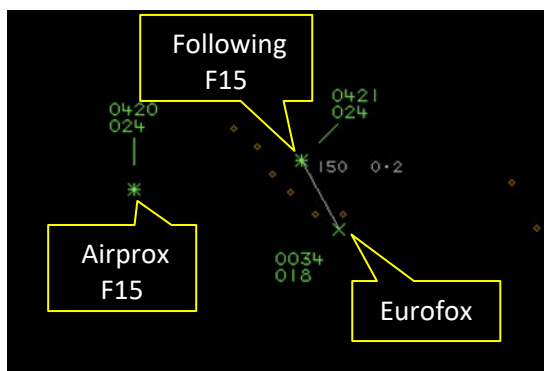
Figure 5. 1135:31 - second F15 aircraft squawking 0421.

At 1135:31, no Traffic Information was passed to the F15 pilot [at this time]. Separation between 0421 ([following] F15) and 0034 (Eurofox) was 0.2NM and 600ft, Figure 5.

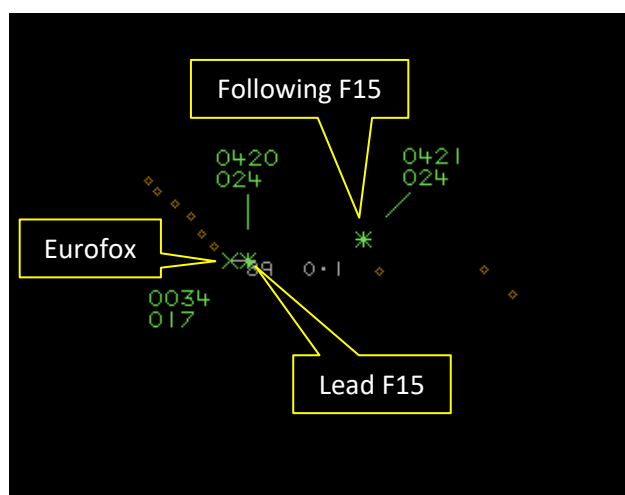
In the lead-up to the Airprox the Eurofox was recorded maintaining a reasonably constant heading and a slow steady climb. The F15s could be seen to be operating in an altitude band between 2500ft and 2800ft, with a groundspeed in the region of 400kt. The minimum distance between the Eurofox and the lead F15 observed on the radar, radar CPA, was 0.1NM horizontally and 700ft vertically, see Figure 6. However, the lead F15 went on to pass behind the Eurofox, resulting in the actual horizontal separation being less than that recorded by the radar and as such has been recorded as <0.1NM.

Figure 6 – 1135:26. Radar CPA

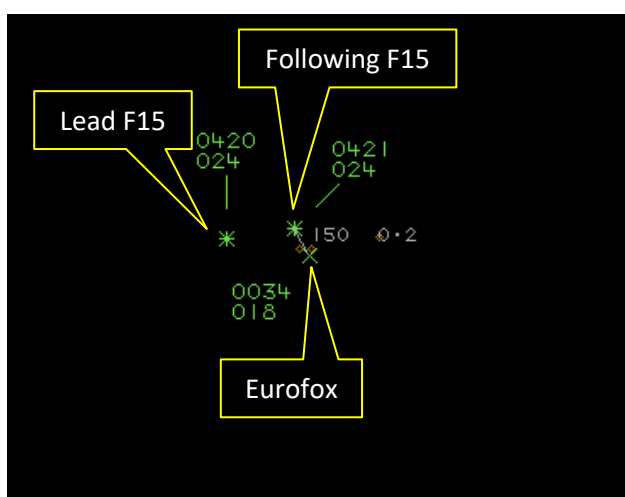
On the next radar sweep, approximately 4sec later, the radar showed that the second F15 had also passed behind the Eurofox, but at a greater range than the first F15, with the separation between them measuring 0.2NM and 600ft, Figure 7.

Figure 7 – 1135:30. Second F15 passed behind the Eurofox.
