**AIRPROX REPORT No 2022159**

Date: 31 Jul 2022 Time: 1412Z Position: 5726N 00149W Location: IVO Cruden Bay

**PART A: SUMMARY OF INFORMATION REPORTED TO UKAB**

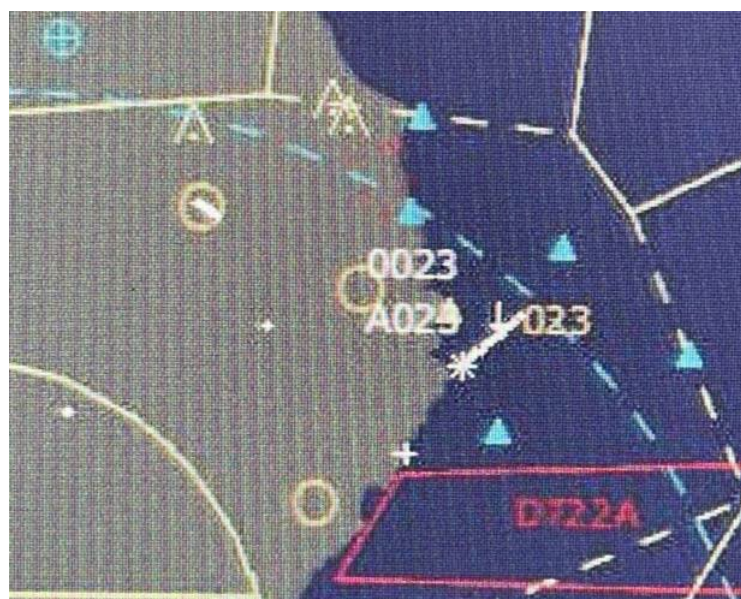
Figure 1

1411:24 A '+' symbol (PSR-only contact) appeared on the RDP display to the north of Cruden Bay, changing to a single dot a few seconds later and fading altogether approximately 60sec later. This dot was in the 10 o'clock position from [S92 C/S] at a range of approximately 1NM.

1411:36 - The aircraft crossed the coast in the vicinity of Peterhead tracking southwest towards Aberdeen Airport with Mode C indicating 2200ft.

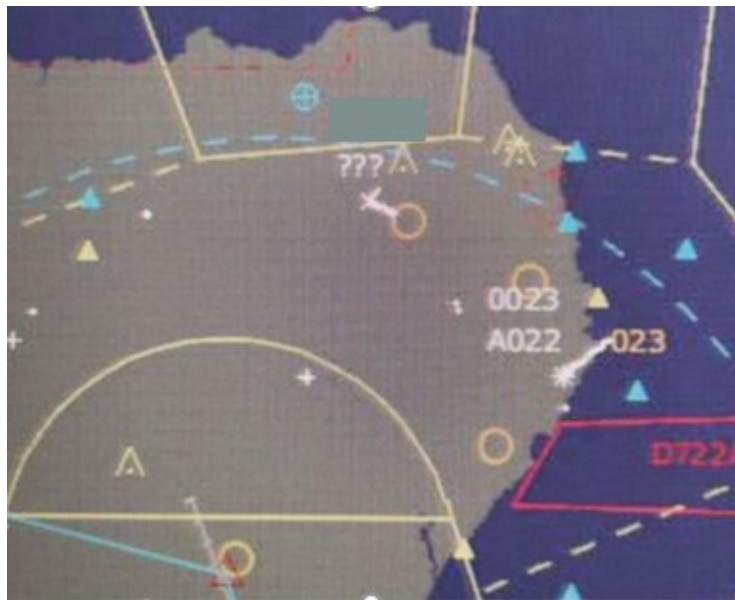
Figure 2 - 1412:26

S92: “Yeah, just for your information, there is traffic there, we came quite close to him and he is a microlight.”

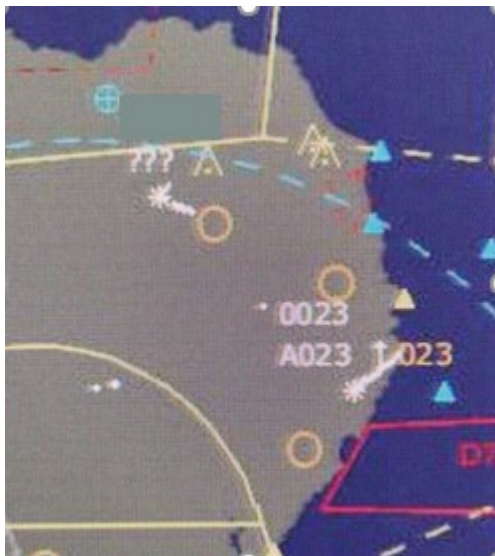
Figure 3 - Allanshill data

At this time the previous PSR 'dot' displayed on the lower RDP screen had disappeared with no contact or clutter present on either the Allanshill (top RDP display) or the Perwinnes radars.
