AIRPROX REPORT No 2022133

Date: 10 Jul 2022 Time: ~1920Z Position: 5120N 00055E Location: 2NM NE Faversham

PART A: SUMMARY OF INFORMATION REPORTED TO UKAB

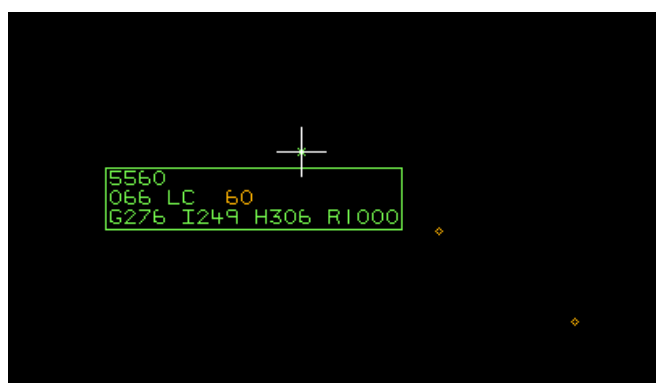
Analysis of the NATS radar replay was undertaken and the E190 could be positively identified. There was no trace of any conflicting aircraft (see Figure 1). With assistance from the BHPA, it was determined that the other aircraft involved was most likely to have been a paramotor. The paramotor could not be identified on radar and could not be traced. The diagram and measurement of the CPA is an estimation based on the Airprox narrative provided by the E190 pilot.

Figure 1: CPA at approximately 1920:34 – no conflicting traffic visible
