## AIRPROX REPORT No 2022158

Date: 04 Aug 2022 Time: 1525Z Position: 5210N 00046W Location: ivo OLNEY VRP

### PART A: SUMMARY OF INFORMATION REPORTED TO UKAB

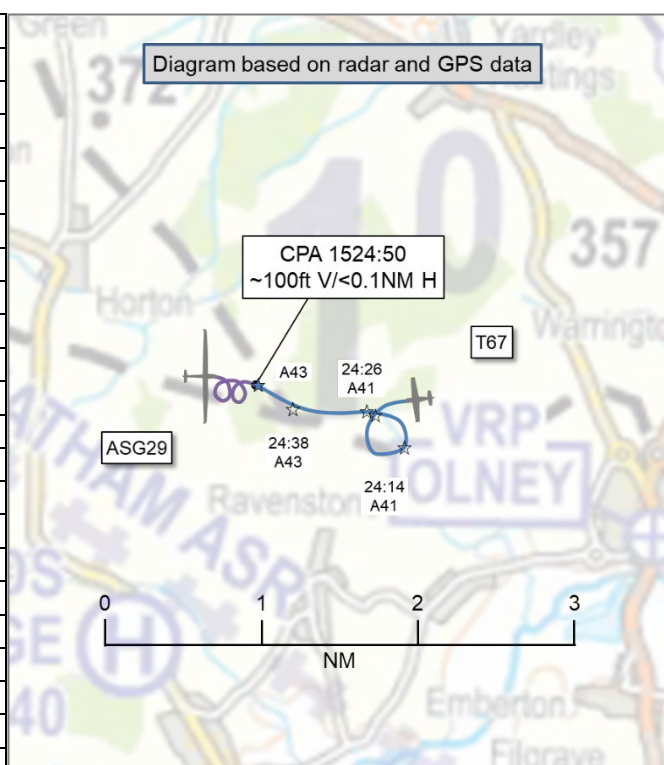
**THE T67 PILOT** reports performing a steep turn for demonstration purposes, also taking the opportunity to look out for other traffic before starting a sequence of dynamic manoeuvres including aerobatics. They didn't see the glider until they were rolling towards wings level, by which time it was about 200ft below them and about 300m away, in a right turn towards them. The T67 pilot elected to keep turning left, checking for other gliders as they sometimes converge on the same thermal, before they applied full power, climbed to a higher altitude and vacated the area. They heard no RTF transmissions from a glider pilot reporting at or transiting near or via Olney VRP, and nor did the onboard EC equipment give an indication of there being other traffic nearby. The EC equipment aerials were pointing towards the glider moments before, so the T67 pilot considered it unlikely there was a blanking issue. It was an unpleasant shock to find a glider continuing to turn towards them at relatively close range and they were unable to determine if it was climbing, level or descending in its turn before they lost sight of it.

The Board members first discussed the pilots' actions and agreed, given the radar/GPS tracks picture and the T67 pilot's assessment of separation at first sighting, that they had probably seen the ASG29 about 15-20sec after rolling out of their turn. This sighting had occurred at a late stage (**CF6**), compounded by the intrinsic difficulty of seeing a glider due to its low conspicuity and, in this case, the lack of a TAS alert (**CF5**). Members wondered why neither aircraft's compatible TAS equipment had alerted and could only surmise that aerial placement in one or both aircraft had been such that a signal had not been received. Members noted that the T67 TAS had the capability to detect both the glider TAS and its SSR transponder, but that the ASG29 transponder had been selected off at the time of the Airprox (**CF2**) rendering it incompatible (**CF4**). It was acknowledged that some gliders' battery fits could not support a long flight with the SSR transponder remaining selected on with all Modes, but Board members urged glider pilots to prioritise their EC capability by fitting sufficient high-capacity modern batteries to support such long flights. The Board commended the ASG29 pilot for fitting an SSR transponder but observed that the preponderance of the airborne MAC threat to gliders – powered aircraft – used TAS that alerted from SSR transponder signals and hence that the operation of the transponder should be prioritised. A gliding member commented that the winter months provided an ideal opportunity for glider pilots to check that their TAS installation was correct and as efficient as could be achieved. A GA member pointed out that powered aircraft operated under a Permit to Fly required a TAS installation to be signed-off by a certified engineer, thereby providing a degree of assurance as to airborne performance, but that this was not a requirement for gliders. With neither of the pilots in receipt of a surveillance based FIS, SA could not have been provided from the ground (**CF1**), and the lack of TAS alerting left the only remaining barrier to MAC as see-and-avoid (**CF3**). A non-sighting by the ASG29 pilot (**CF7**) had degraded the barrier but the T67 pilot had seen the glider, albeit at a late stage, and had taken avoiding action. The Board noted the information provided by the BGA, essentially that whilst normally aspirated piston-engine aircraft climb performance can reduce markedly with altitude, thermal strength, and hence glider climb performance, could be equally strong at higher altitudes. In effect, the difference between powered aircraft and glider climb performance narrowed with altitude. Some members felt that the T67 pilot may have been better served by turning away from the glider to the right, rather than continuing their left turn and then climbing. Members discussed the risk and agreed that it appeared neither pilot had been sighted on the other aircraft at CPA. The glider pilot did not report hearing another aircraft but, given the estimated separation at CPA, the Board agreed that safety had been much reduced (**CF8**). Finally, members pointed out that the glider pilot's assertion that '... a powered aircraft should, under SERA, in any case have avoided them.' was incorrect. Whilst a powered aircraft pilot is required to give way to a glider on a converging course, under all circumstances both pilots share an equal responsibility for collision avoidance, i.e. avoiding action, and not to operate in such proximity to other aircraft as to create a collision hazard, i.e. taking action to resolve a potential collision hazard if it is perceived.
