AIRPROX REPORT No 2022160

Date: 04 Aug 2022 Time: 1622Z Position: 5121N 00142W Location: 3.5NM S Marlborough

PART A: SUMMARY OF INFORMATION REPORTED TO UKAB

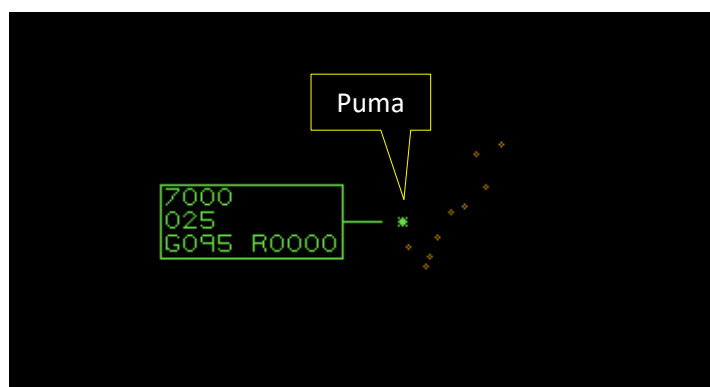
Analysis of the NATS radar replay and of the GPS flight logs kindly provided by both the Puma pilot and the Tiger Moth pilot was undertaken. The Puma appeared on the radar replay, albeit sporadically, but could be positively identified from Mode S data (see Figure 1). The flightpath of the Puma could not be fully reconstructed as the radar returns were too fragmented. The Tiger Moth was not observed on the radar replay. The timestamps within the GPS data for the Puma were assessed not to be accurate and construction of the diagram was based on the GPS data and an integration of the event narratives from each pilot. An estimation of the timing, and separation of the aircraft at CPA was determined from these separate data sources.

Figure 1 – CPA at 1621:58
