**AIRPROX REPORT No 2022166**

Date: 04 Aug 2022 Time: 1355Z Position: 5155N 00130W Location: 2NM SE Chipping Norton

**PART A: SUMMARY OF INFORMATION REPORTED TO UKAB**

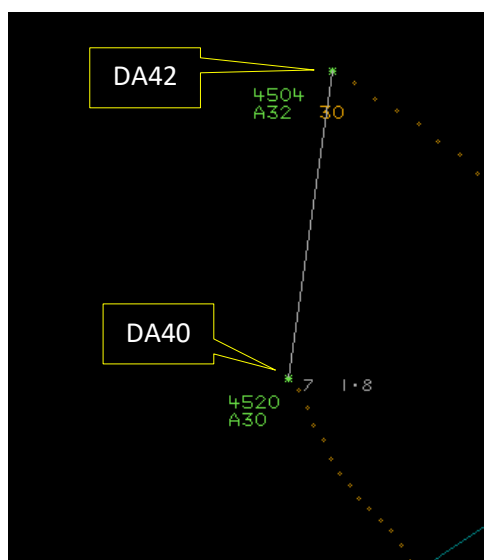
Figure 1 - 1354

At that point in time, [the DA40] was in [the DA42]'s 9 o'clock position at approximately 2NM range with the aircraft flying on similar but slowly converging tracks, west-northwest bound. [The DA40] Mode C indicated 3000ft and [the DA42] Mode C indicated 2100ft.

At 1353, [the DA42] Mode C readout appeared to level at 3000ft, [the DA40]'s Mode C indication remained at 3000ft. By 1354, [the DA40] had turned onto a more northwesterly heading, converging with [the DA42].

An analysis of the NATS radar replay was undertaken and both aircraft could be positively identified from Mode S data (see Figure 1). The diagram was constructed and the CPA measured from the radar replay (see Figure 2).

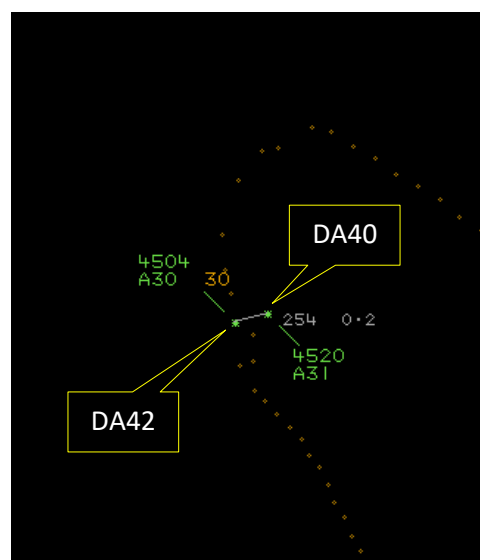
Figure 2 - CPA at 1354:52

The CPA occurred at 1354:[52], with the contacts merging, Mode C of [the DA40] indicating 3000-3100ft and the Mode C of [the DA42] indicating 3000ft. It appears (although is difficult to confirm) that the pilot of [the DA40] turned right in an attempt to avoid. Both aircraft then tracked north-westbound.

The DA40 and DA42 pilots shared an equal responsibility for collision avoidance and not to operate in such proximity to other aircraft as to create a collision hazard.<sup>1</sup> If the incident geometry is considered as head-on or nearly so then both pilots were required to turn to the right.<sup>2</sup>
