## AIRPROX REPORT No 2022175

Date: 12 Aug 2022 Time: ~1202Z Position: ~5353N 00113W Location: 1.5NM E Tadcaster

### PART A: SUMMARY OF INFORMATION REPORTED TO UKAB

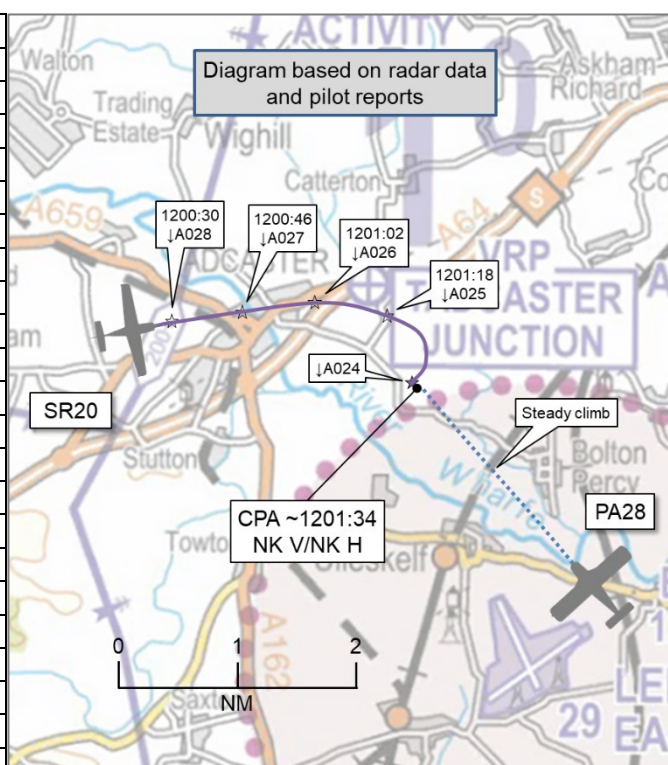
An analysis of the NATS radar replay was undertaken. The SR20 was detected and their descent and arrival track aligned with the description from the pilot report. The PA28 was not detected by the NATS radar and so their track, as depicted in the diagram, is an estimation based on pilot reports. In the absence of recorded track information it has not been possible to determine an exact time of CPA or to measure the separation.
