AIRPROX REPORT No 2022201

Date: 29 Aug 2022 Time: 1219Z Position: 5112N 00116W Location: 1NM W Popham

PART A: SUMMARY OF INFORMATION REPORTED TO UKAB

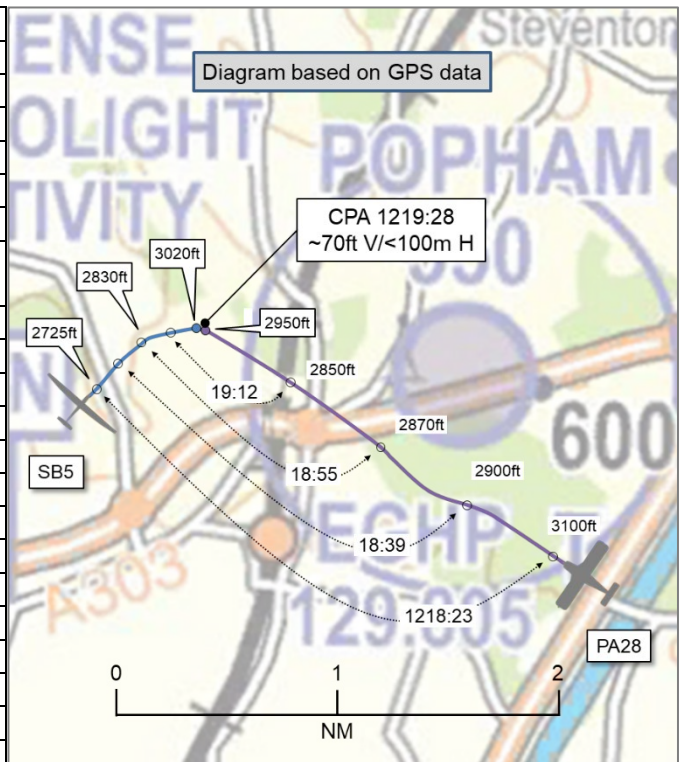
Recorded	Aircraft 1	Aircraft 2
Aircraft	SB5	PA28
Operator	Civ Gld	Civ FW
Airspace	London FIR	London FIR
Class	G	G
Rules	VFR	VFR
Service	Listening Out	Basic
Provider	Popham Radio	Farnborough LARS West
Altitude/FL	3020ft	2950ft
Transponder	Not fitted	A, C, S
Reported		
Colours	Yellow, White	White, Blue
Lighting	None	'Not on'
Conditions	VMC	VMC
Visibility	>10km	>10km
Altitude/FL	3281ft ¹	~2800ft
Altimeter	QFE (NK hPa)	QNH (NK hPa)
Heading	~100°	'Northwest'
Speed	60kt	~100kt
ACAS/TAS	FLARM	SkyEcho
Alert	None	None
Separation at CPA		
Reported	50ft V/0m H	Not seen
Recorded	~70ft V/<100m H

An analysis of the NATS radar replay was undertaken and, whilst the PA28 was reliably detected, the SB5 was not. However, both pilots kindly provided the UKAB Secretariat with GPS data files detailing their flights which have been used to construct the diagram and measure the CPA.

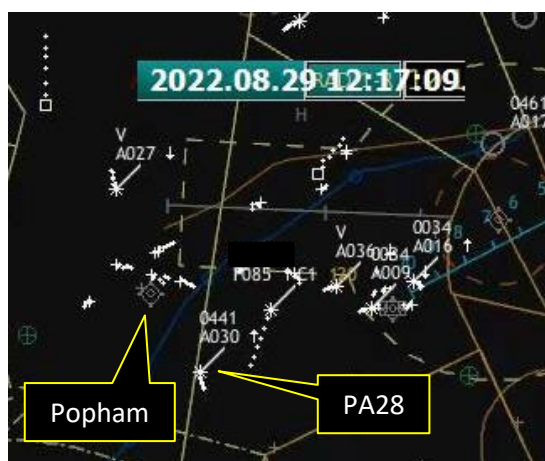
Figure 1 – 1217:10

At 1217, following [the PA28] vacating controlled airspace, and then being under a Basic Service, the controller issued a warning to [the pilot] describing intense aerial activity in the vicinity of Popham, it was acknowledged by the pilot, (Figure 1):

1217:10: '[PA28 c/s] *keep a very good lookout as you continue northbound, multiple primary-only contacts seen north of your position, believed to be gliders and traffic from Popham.*'

The area around Popham and between Popham and Lasham was observed to be very busy throughout the recording with multiple persistent primary-only contacts observed, in addition to a series of aircraft routing between Popham and Lasham.

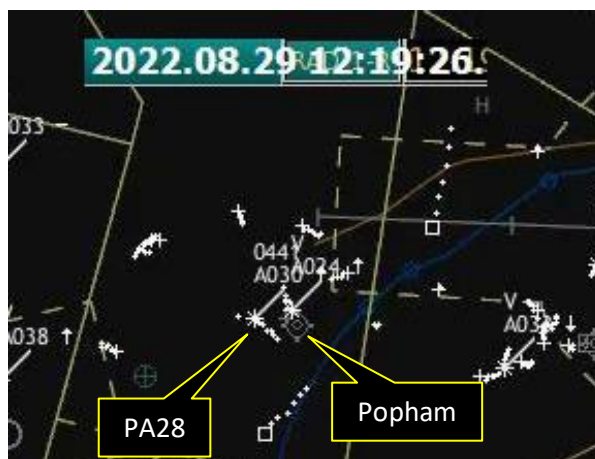
Figure 2 - 1219

At 1219, a merge between [the PA28] and a primary contact occurred, approximately 0.5NM west of Popham. At the time of the merge, the Mode C of [the PA28] was displaying 3000ft, Figure 2 (the Mode C had been validated and verified).

At the same time, another aircraft squawking 7000 was observed less than 0.5NM to the west of Popham, indicating 2500ft. They routed anti-clockwise round Popham and then appeared to position for final, north of the field. There was not a primary-only return (or any other contact observed) in the vicinity [of this other aircraft] but this occurred at the same time as the reported Airprox.

[The PA28 pilot] transited through an area of high traffic density. It was not possible to determine the distance between the aircraft as [one return was] primary-only. The radar often does not consistently detect all primary-only glider contacts due to their profile, so it was not possible to positively identify the Airprox.
