AIRPROX REPORT No 2022202

Date: 26 Aug 2022 Time: 1021Z Position: 5256N 00242W Location: 1.5NM SW Whitchurch

PART A: SUMMARY OF INFORMATION REPORTED TO UKAB

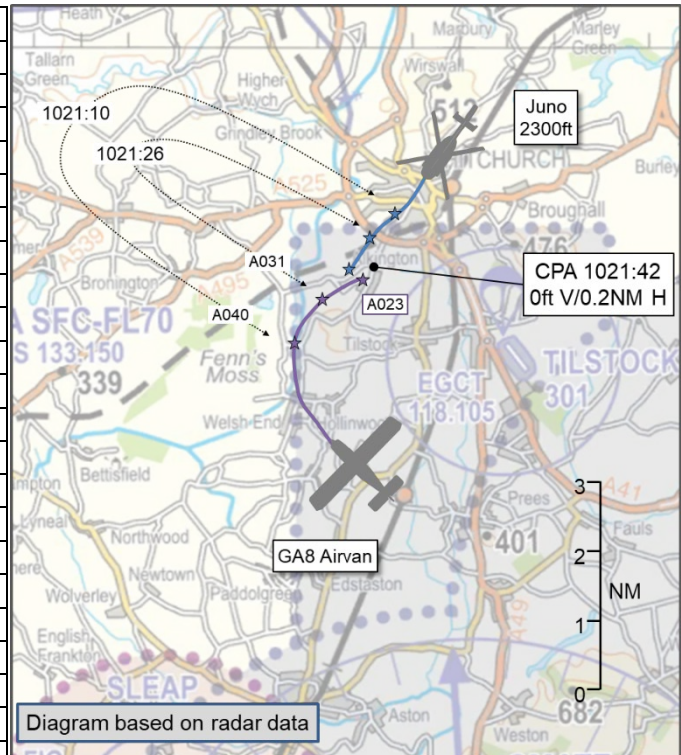
Recorded	Aircraft 1	Aircraft 2
Aircraft	Juno	GA8 Airvan
Operator	HQ Air (Trg)	Civ FW
Airspace	Shawbury MATZ	Shawbury MATZ
Class	G	G
Rules	IFR	VFR
Service	Traffic	Basic
Provider	Shawbury	Shawbury
Altitude/FL	2300ft	2300ft
Transponder	A, C, S	A, C, S
Reported		
Colours	Black, Yellow	White
Lighting	NK	NK
Conditions	VMC	NK
Visibility	5-10km	NR
Altitude/FL	2000ft	~2000ft
Altimeter	QFE (1010hPa)	NR
Heading	220°	NE
Speed	90kt	NR
ACAS/TAS	TAS	Unknown
Alert	TA	Unknown
Separation at CPA		
Reported	NR V/1-200m H	Not Seen
Recorded	0ft V/0.2NM H

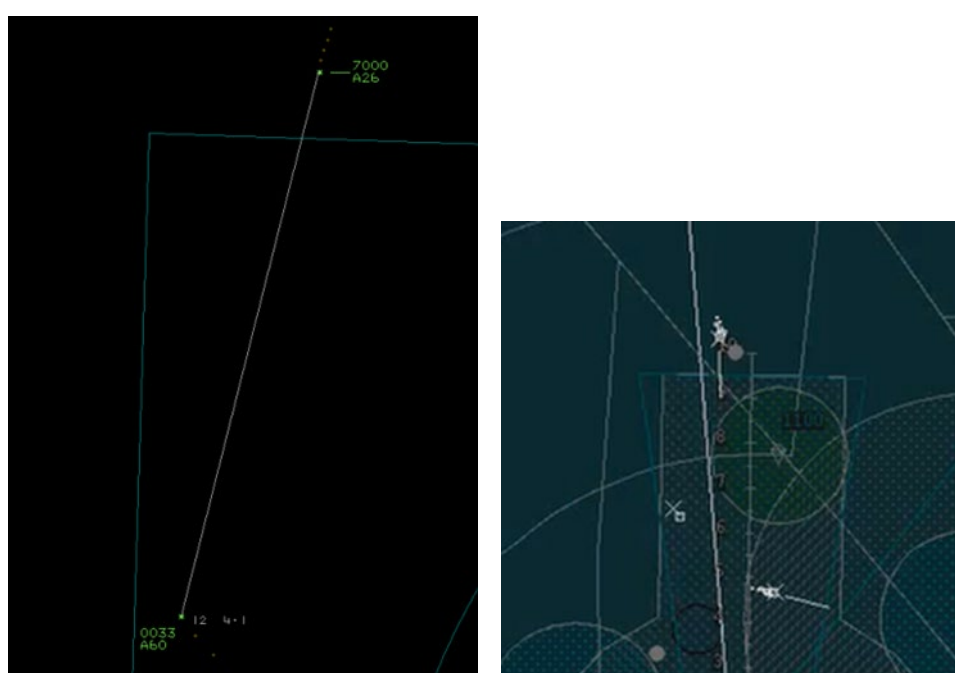
Figure 1: Traffic Information passed to the Juno pilot (squawking 7000) 1020:31.

The Shawbury Approach controller passed Traffic Information to the Juno pilot "*Traffic south, southwest four miles tracking northwest no height information*". No Traffic Information was passed to the GA8 pilot (Figure 1).

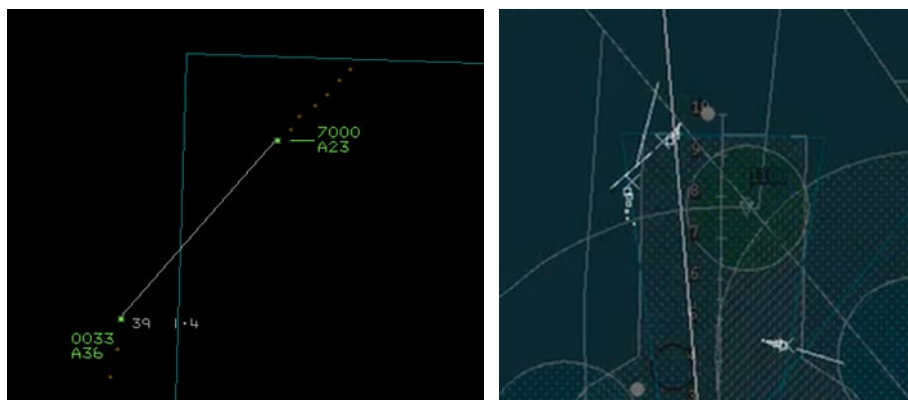
Figure 2: Further Traffic Information passed to the Juno pilot (7000) 10:21:18

The Shawbury Approach controller passed additional Traffic Information to the Juno pilot “*Previously called traffic southwest one mile tracking northeast converging no height information, do you require deconfliction advice*”. No Traffic Information was passed to the GA8 pilot (Figure 2).

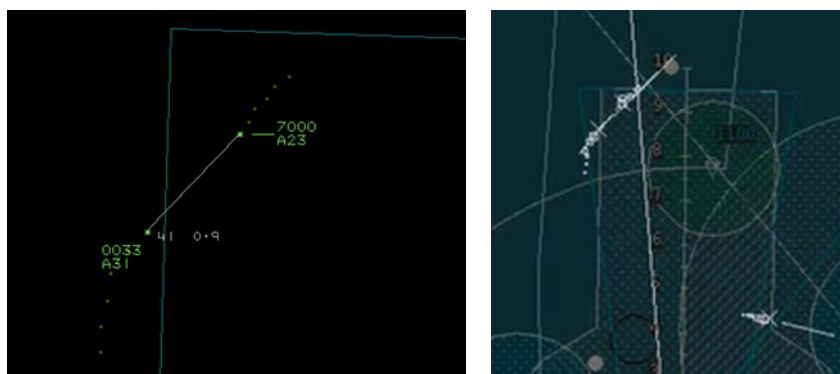
Figure 3: Traffic Information passed to the GA8 (0033) pilot 10:21:27.

The Shawbury LARS controller passed Traffic Information to the GA8 pilot “*Traffic believed to be you has traffic southwest one mile manoeuvring no height information*” (Figure 3).

An increased workload due to working non-cooperative surveillance resulted in the Shawbury LARS controller mis-identifying the GA8 aircraft. Although Traffic Information was passed to the GA8 pilot, it was incorrectly passed, which resulted in the pilot looking right, on the understanding the traffic was behind the aircraft.

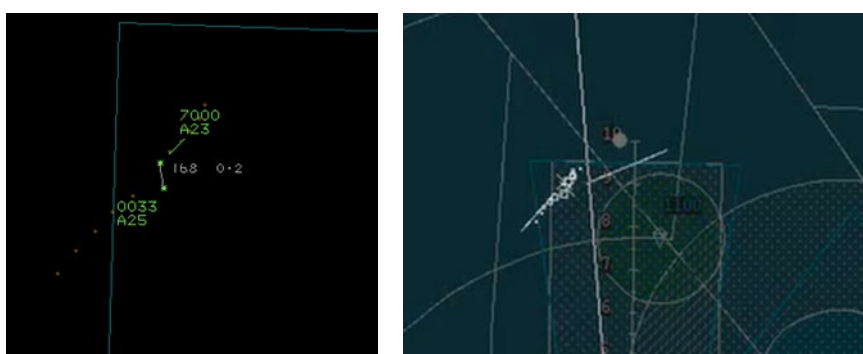
Figure 4: 10:21:38 CPA.

Figure 4 shows CPA measured at 0.2NM and 200ft.¹ The Shawbury LARS controller requested the altitude passing. The GA8 pilot did not report visual with the Juno helicopter.

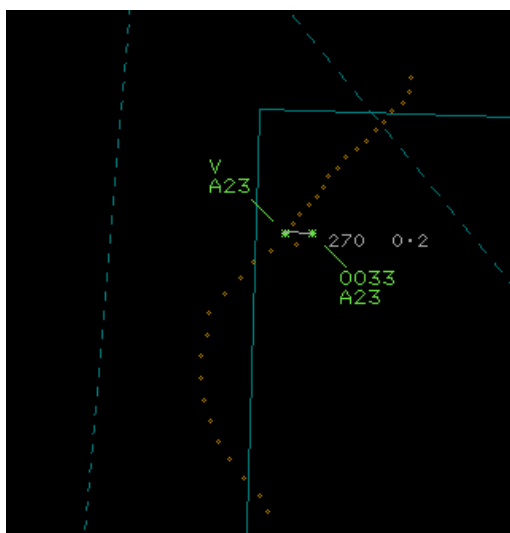
Figure 5: 1021:43

¹ The following radar sweep indicates the separation as 0ft vertically and 0.2NM horizontally see Figure 5.

An analysis of the NATS radar replay was undertaken and on the radar sweep following Figure 4, although the two aircraft had passed one another and were still 0.2NM apart, both indicated the same altitude (2300ft), see Figure 5. This CPA has been used in the diagram at the top of the report.
