AIRPROX REPORT No 2022205

Date: 03 Sep 2022 Time: 1145Z Position: 5202N 00107W Location: Turweston aerodrome

PART A: SUMMARY OF INFORMATION REPORTED TO UKAB

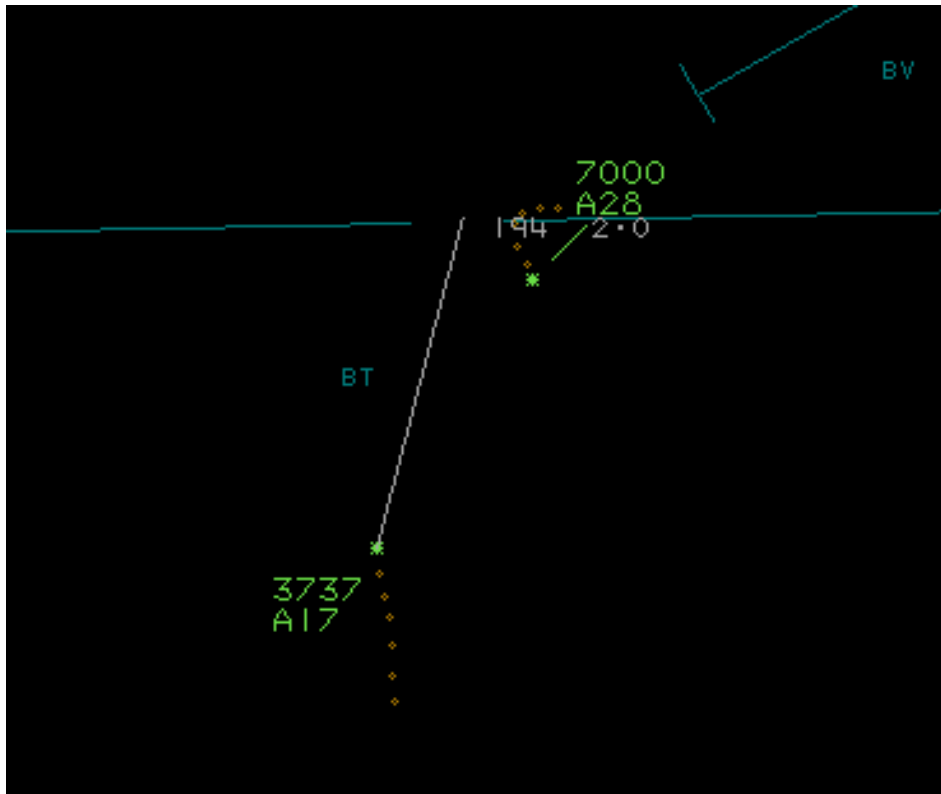
Figure 1: 11:44:00

Figure 1 representing the point at which the RV7, squawking 3737, would have penetrated the ATZ, had Turweston had one.

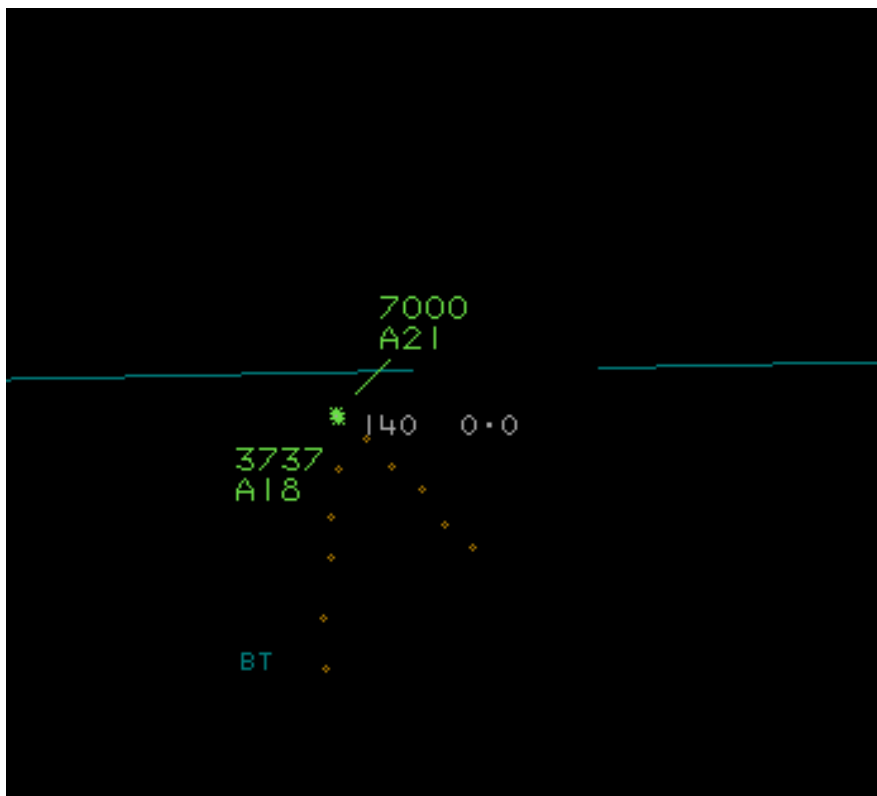
Figure 2: 11:44:47 CPA

Figure 2 shows CPA, measured at 0.0NM and 300ft. No Traffic Information was passed by the Brize Norton LARS controller. At 1147:05 the Brize Norton LARS controller passed Traffic Information on a different aircraft, indicating one mile east, similar direction, with no height information.

The Brize Norton LARS controller was operating at the limit of their radar coverage, however, traffic was probably still displayed, despite the range, and therefore it is most likely the Brize Norton LARS controller's division of attention (with a scan ranging from Gloucester to Wycombe to Turweston due to other traffic requesting a service at the time of the occurrence) resulted in traffic not sighted by the controller.
