## AIRPROX REPORT No 2022206

Date: 31 Aug 2022 Time: 1007Z Position: 5158N 00043W Location: 7.5NM SW Cranfield

### PART A: SUMMARY OF INFORMATION REPORTED TO UKAB

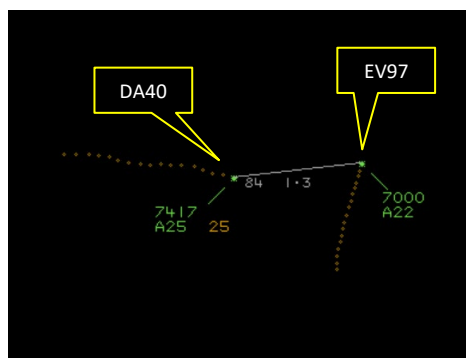
Figure 1 – 1004:47

At 1004:47, the DA40 had been on an intercept heading for the Final Approach Track at 2500ft with the EV97 1.3NM away at 2200ft, 300ft below, which matches the report of the DA40 pilot, Figure 1.

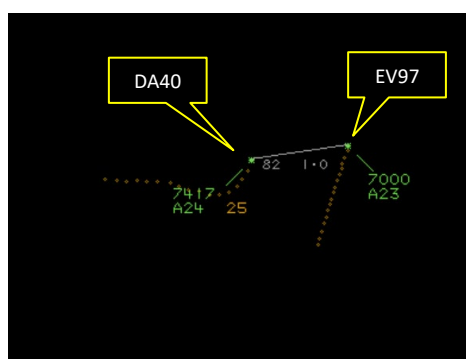
Figure 2 – 1005:11

The DA40 pilot then turned on to their Final Approach Track, rolling wings level at approximately 1005:11. From this point the difference in heading of the two aircraft was approximately 20° causing the aircraft to converge as the faster DA40 slowly overtook the EV97. The EV97, at this point, had been slowly climbing, Figure 2.

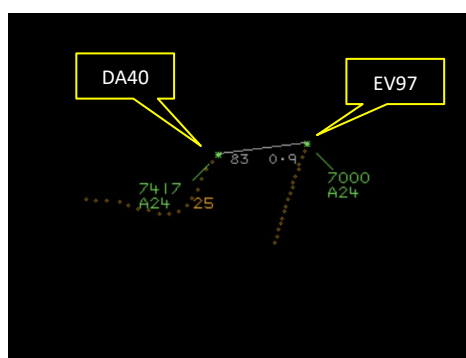
Figure 3 – 1005:23

The EV97 reached a maximum altitude of 2400ft, level with the DA40, at 1005:23, after which the EV97 commenced a slow descent, Figure 3.

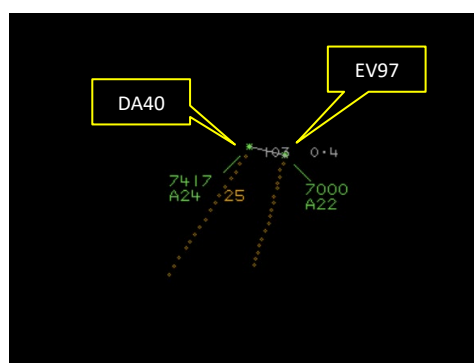
Figure 4 – 1006:31

The DA40 passed abeam the EV97 at 1006:31 at which time the separation was 0.4NM horizontally and 200ft vertically, Figure 4. Although the DA40 was then ahead of the EV97, the separation continued to decrease until 1007:03 when it reached a minimum of 0.1NM and 200ft, the CPA, Figure 5.
