AIRPROX REPORT No 2022207

Date: 01 Sep 2022 Time: 1233Z Position: 5135N 00106W Location: Benson

PART A: SUMMARY OF INFORMATION REPORTED TO UKAB

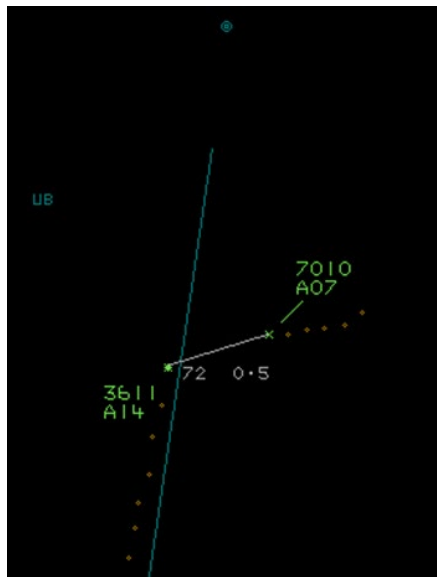
Figure 1: 12:33:06 CPA.

Figure 1 shows the position of the Merlin and the Tutor at radar CPA. The screenshot was taken from a replay using the NATS radars which are not utilised by the Benson controllers, therefore may not be entirely representative of the picture available.

Figure 1 shows radar CPA measured at 0.5NM and 700ft, the next radar sweep loses radar contact on the Merlin (squawking 7010).

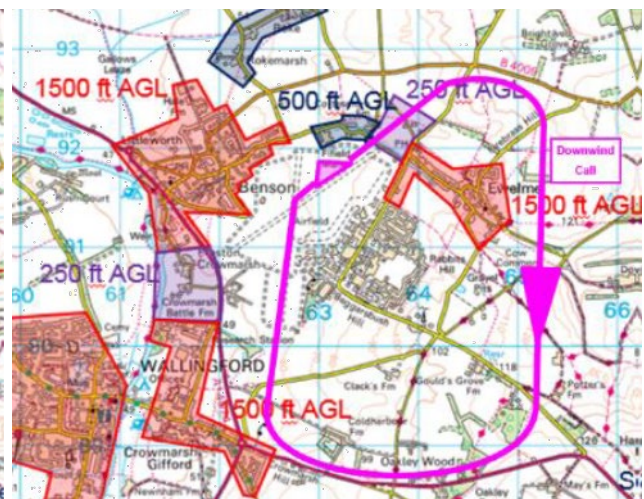
Figure 3: RAF Benson Load Park Circuit profile RW01RH.

Following review of RAF Benson's Defence Aerodrome Manual both the Merlin and Tutor were operating in accordance with the policy at the time of Airprox. Figure 3⁵ above represents the profile expected of a helicopter conducting an underslung load circuit, however, as stated in the Defence Aerodrome Manual these are notional circuits and may be amended to suit wind conditions.
