AIRPROX REPORT No 2022216

Date: 17 Sep 2022 Time: 1237Z Position: 5048N 00213W Location: Winterborne Whitechurch

PART A: SUMMARY OF INFORMATION REPORTED TO UKAB

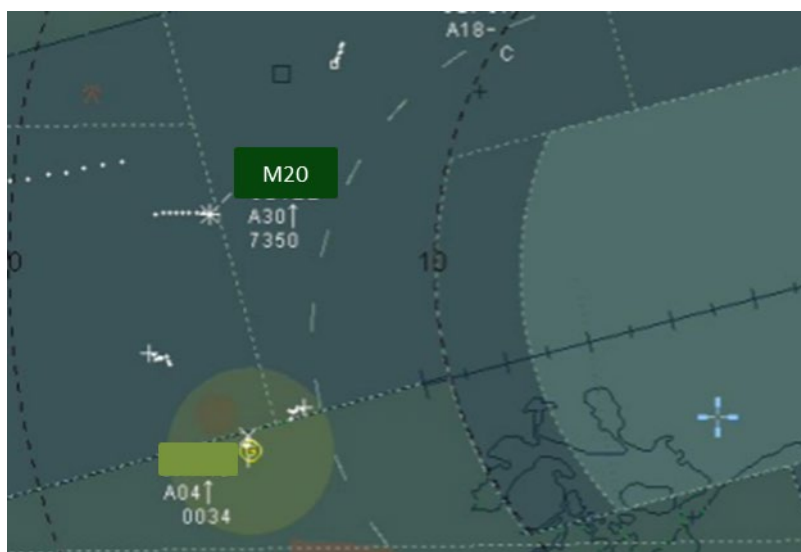
Figure 1

The recordings available commence at 1236 at which time [M20 C/S] could be seen 15NM west of Bournemouth outside controlled airspace. At this time, the controller commenced vectoring [M20 C/S] for an approach to RW26. At 1237 the pilot reported that "*there's a paraglider just in front of me*". The screenshot below (Figure 1) shows the position of the aircraft at the time. The controller told the pilot that nothing was showing on the radar and that they could turn left or right off the vector heading to avoid. The pilot responded that they had "just avoided". There is no evidence on the radar replay of deviation from the assigned heading of 090° or altitude of 3000ft. The response from the pilot was not entirely clear but the investigator believes the pilot said the paraglider was now behind them.

The radar display did not depict any contacts ahead of the aircraft and would not be expected to produce a radar return for a paraglider. There were a number of PSR¹ contacts around Eyres Field gliding, which was active at the time, but none which would be considered as relevant Traffic Information. The site is not used by paragliders to the best of the investigator's knowledge. The controller would have had no way of knowing that there was paragliding activity in this location which is situated in Class G airspace.

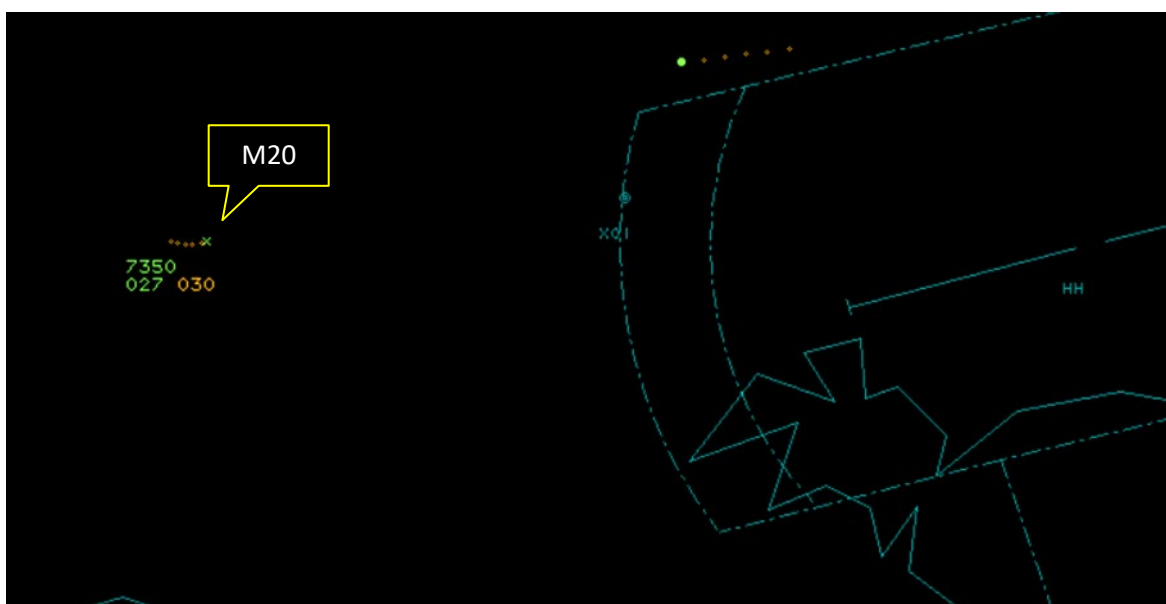
Figure 2 – 1235:40

At 1235:40 the Bournemouth controller advised the M20 pilot that they were identified, that it was a Traffic Service and requested their level on the Bournemouth QNH (reported as 3000ft), Figure 2.

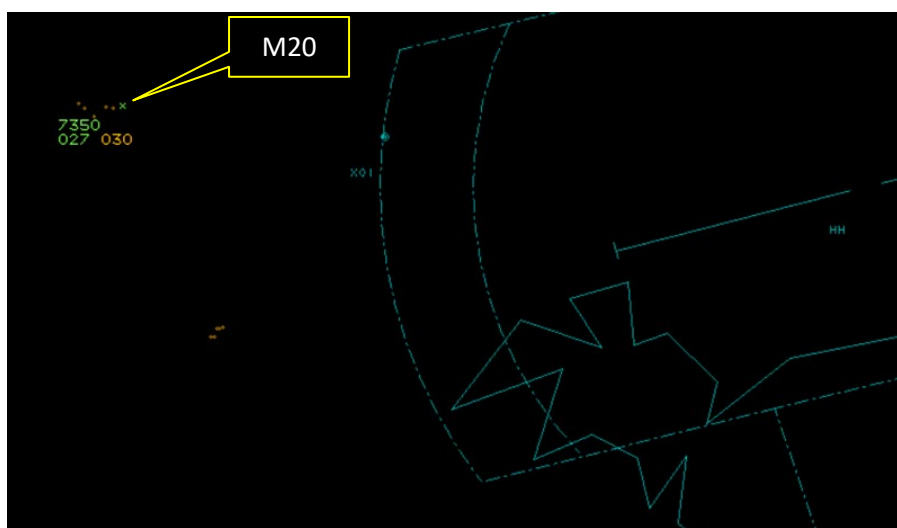
Figure 4 – 1237:22

At 1237:22 the M20 pilot reported “*there’s a paraglider just in front of me*” (Figures 4 & 5).

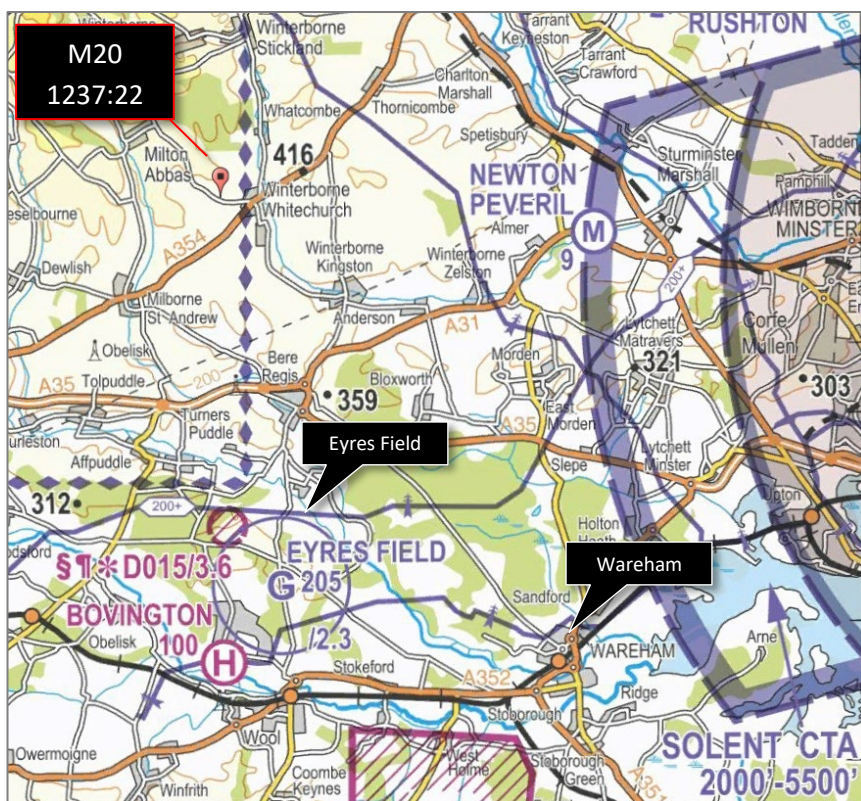
Figure 5 - 1237:22 locations

The Bournemouth controller replied: *“Roger. You are nearby Eyres Field gliding site. You can turn left or right to avoid as you wish”*, to which the pilot responded: *“just avoiding”*. The controller then confirmed *“there’s nothing observed on radar”*, to which the pilot replied *“just passing, er, just about a mile behind”*.

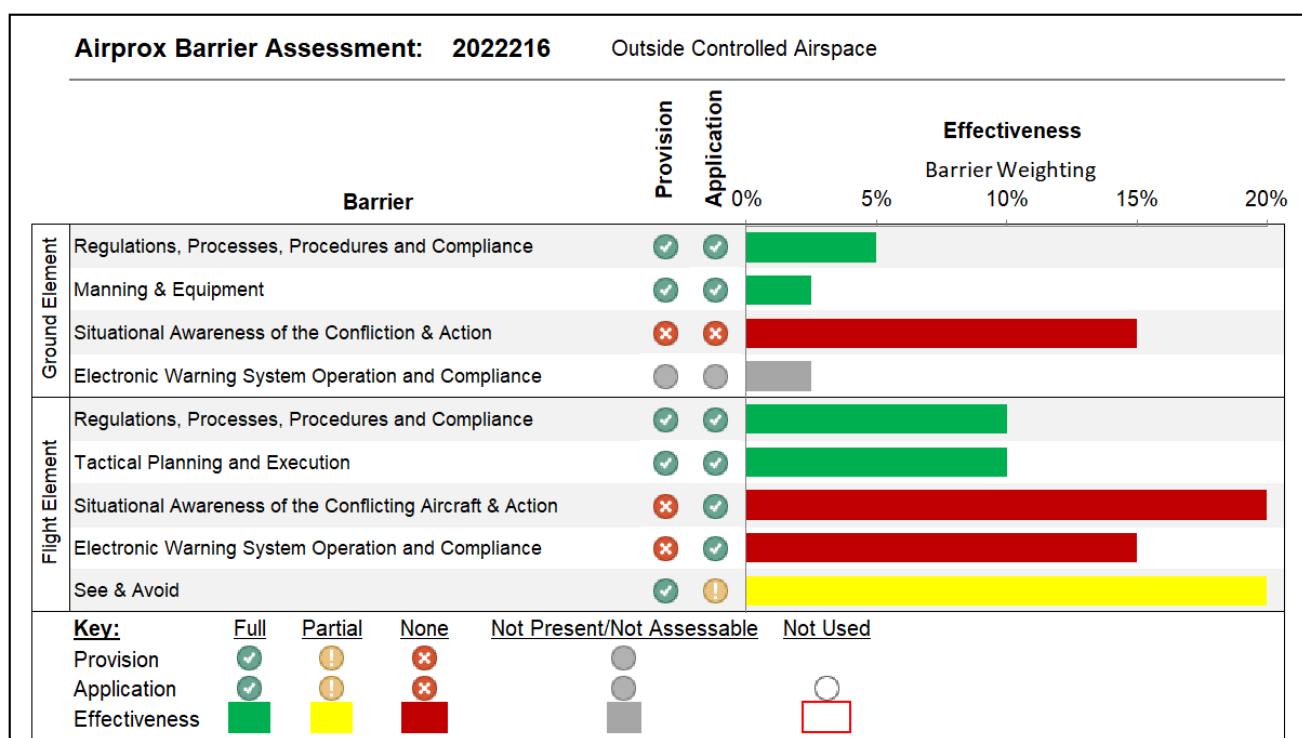
Situational Awareness of the Confliction and Action were assessed as **ineffective** because the Bournemouth radar could not detect the paraglider.

Situational Awareness of the Conflicting Aircraft and Action were assessed as **ineffective** because neither pilot had any prior situational awareness about the presence of the other.

Electronic Warning System Operation and Compliance were assessed as **ineffective** because neither aircraft had EC equipment that could detect the other.

See and Avoid were assessed as **partially effective** because, had the M20 pilot had turned to avoid the paraglider before reporting it to ATC, there may have been a greater margin of separation.
