AIRPROX REPORT No 2022215

Date: 18 Sep 2022 Time: 1700Z Position: 5216N 00013E Location: 3.5NM NNE Cambridge

PART A: SUMMARY OF INFORMATION REPORTED TO UKAB

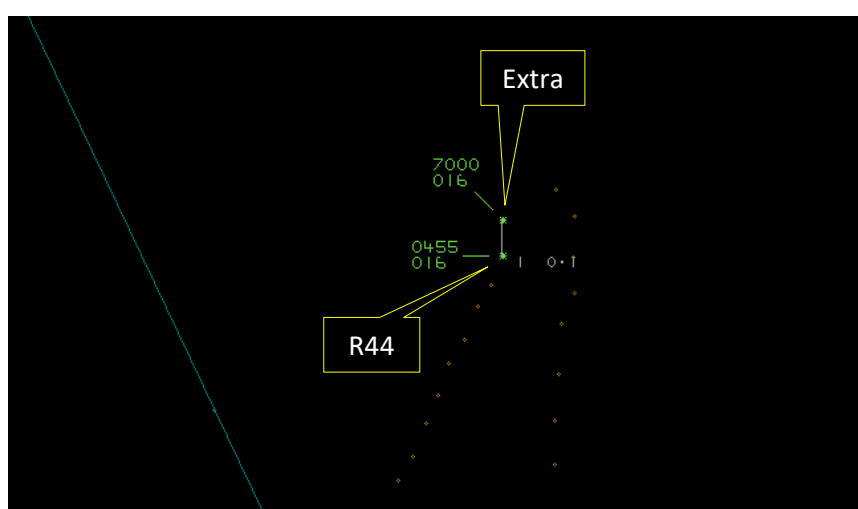
Figure 1 – CPA at 1700:28

An analysis of the NATS radar replay was undertaken and both aircraft could be identified from Mode S data. The diagram was constructed and the CPA determined from the radar data. The aircraft were observed on radar to be at Flight Levels. The QNH passed to the R44 pilot was 1019hPa.

The R44 and Extra pilots shared an equal responsibility for collision avoidance and not to operate in such proximity to other aircraft as to create a collision hazard.¹ If the incident geometry is considered as overtaking then the R44 pilot had right of way and the Extra pilot was required to keep out of the way of the other aircraft by altering course to the right.²

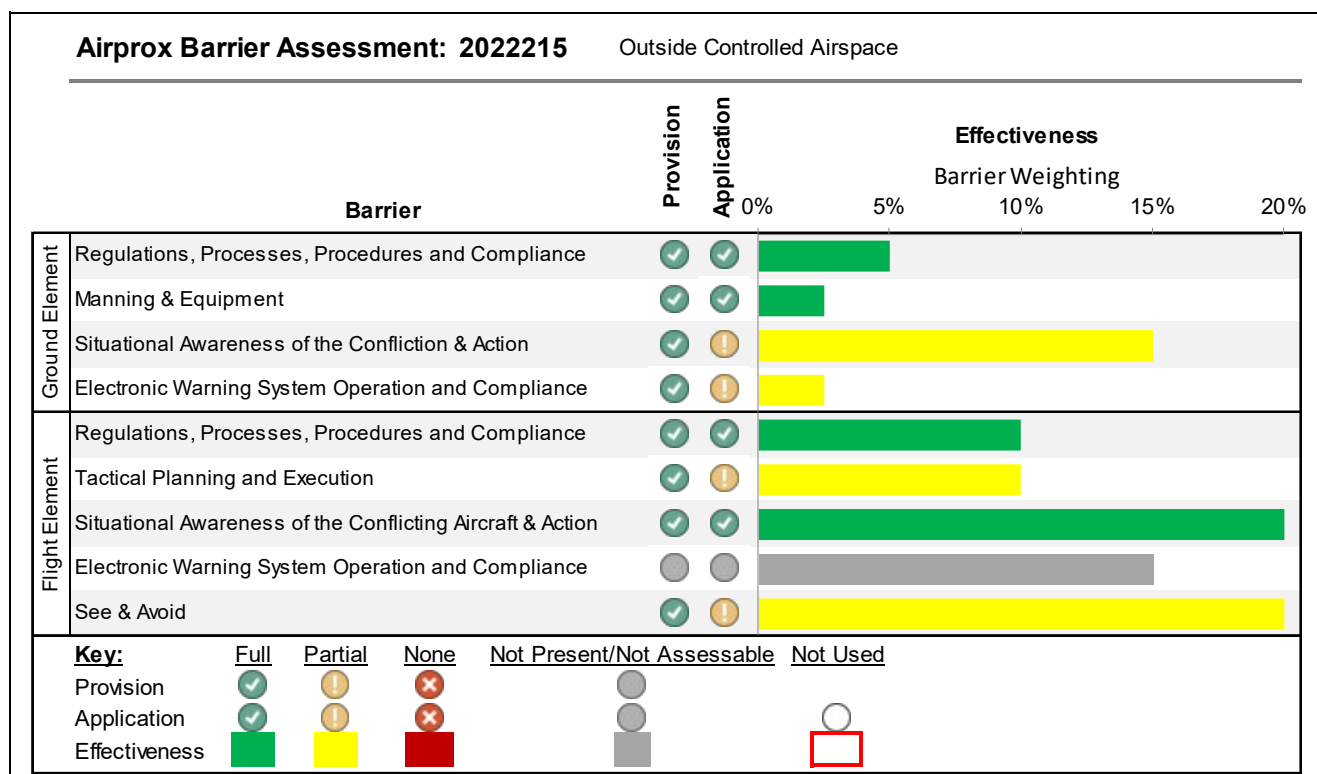
Safety Barrier Assessment³

Situational Awareness of the Confliction and Action were assessed as **partially effective** because Traffic Information had been passed late to the pilot of the R44.

Electronic Warning System Operation and Compliance were assessed as **partially effective** because the Lakenheath controller had not acted upon the second activation of the STCA in a timely manner.

Tactical Planning and Execution was assessed as **partially effective** because the Extra pilot had conducted an overtaking manoeuvre but had not sufficiently kept out of the way of the R44 pilot.

See and Avoid were assessed as **partially effective** because the pilot of the Extra had flown close enough to the R44 to have caused its pilot concern.
