AIRPROX REPORT No 2022224

Date: 15 Sep 2022 Time: 1132Z Position: 5058N 00213W Location: 2.5NM W Compton Abbas

PART A: SUMMARY OF INFORMATION REPORTED TO UKAB

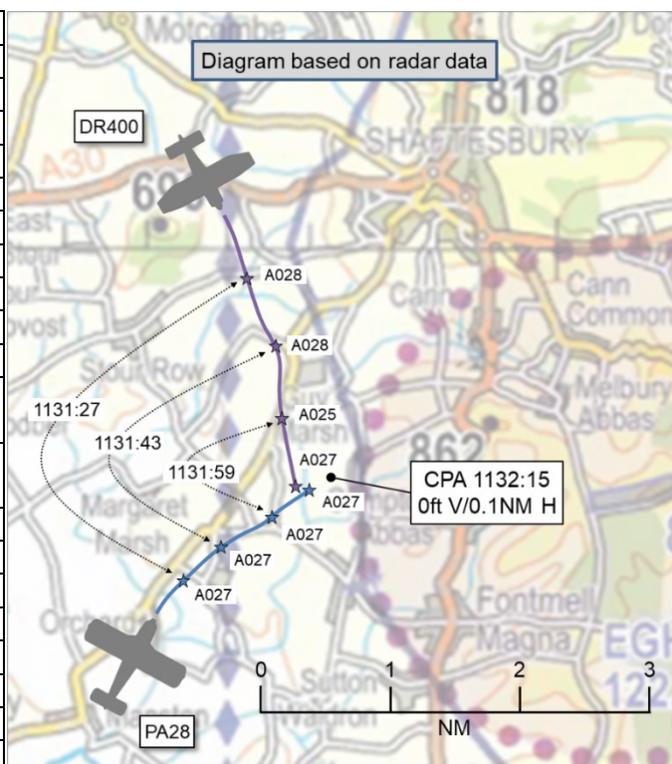
Recorded	Aircraft 1	Aircraft 2
Aircraft	PA28	DR400
Operator	Civ FW	Civ FW
Airspace	London FIR	London FIR
Class	G	G
Rules	VFR	VFR
Service	AGCS	AGCS
Provider	Compton Radio	Compton Radio
Altitude/FL	2700ft	2700ft
Transponder	A, C	A, C, S
Reported		
Colours	White, orange, yellow	White, grey, yellow
Lighting	Nav, beacon, strobe	Anti-col
Conditions	VMC	VMC
Visibility	>10km	>10km
Altitude/FL	2000ft	3000ft
Altimeter	QFE (984hPa)	RPS (NK hPa)
Heading	045°	180°
Speed	97kt	90kt
ACAS/TAS	Not fitted	Not fitted
Separation at CPA		
Reported	0ft V/30m H	50ft V/80m H
Recorded	0ft V/0.1NM H

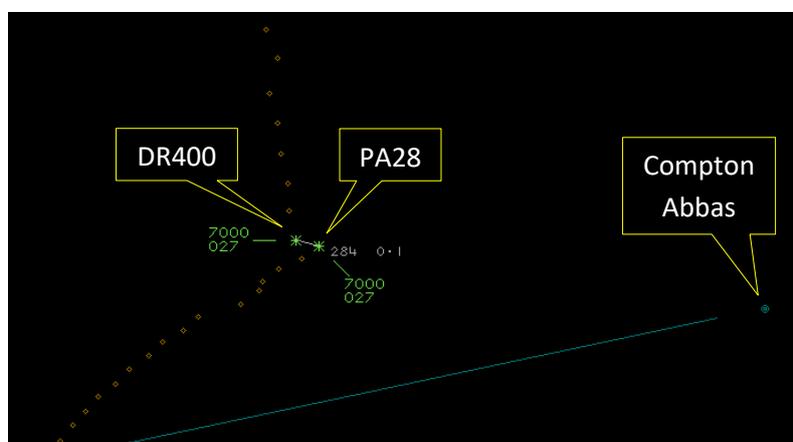
Figure 1 – CPA at 1132:15

An analysis of the NATS radar replay was undertaken and the DR400 could be positively identified from Mode S data. The PA28 was also observed on radar but there had been no Mode S data available. The aircraft was identified with reference to the pilot's reported position (see Figure 1).

The diagram was constructed and the CPA determined from the radar data. Both aircraft were observed on radar to have been at FL027 at CPA. The Boscombe Down QNH had been recorded as 1014hPa, therefore the altitude of both aircraft has been assessed to have been approximately

2700ft QNH at CPA. The elevation of Compton Abbas is 811ft and therefore both aircraft had been at approximately 1900ft Compton Abbas QFE.

After CPA, and after entering the ATZ just south of the RW26 extended centreline, the pilot of the DR400 made a left turn on the dead-side of the circuit, and crossed the upwind end of RW26 to join the circuit on a RH crosswind-leg for RW26.
