AIRPROX REPORT No 2022231

Date: 25 Sep 2022 Time: 1226Z Position: 5320N 00317W Location: 6.5NM WSW WAL VOR

PART A: SUMMARY OF INFORMATION REPORTED TO UKAB

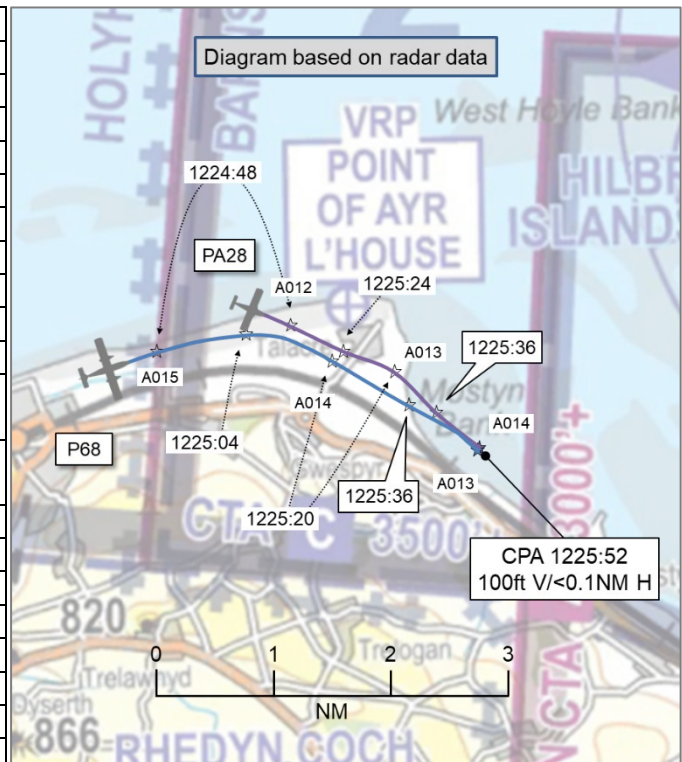
Recorded	Aircraft 1	Aircraft 2
Aircraft	P68	PA28
Operator	Civ Comm	Civ FW
Airspace	London FIR	London FIR
Class	G	G
Rules	VFR	VFR
Service	Basic	Basic
Provider	London Info	Hawarden Radar
Altitude/FL	1300ft	1400ft
Transponder	A, C, S+	A, C, S
Reported		
Colours	White, Blue, Green	White
Lighting	Beacon, Nav, Strobe	Nil
Conditions	VMC	VMC
Visibility	>10km	>10km
Altitude/FL	1500ft	1500ft
Altimeter	QNH (NK hPa)	QNH (1019hPa)
Heading	'Eastbound'	145°
Speed	120kt	95kt
ACAS/TAS	TAS	Not fitted
Alert	None	N/A
Separation at CPA		
Reported	100ft V/100m H	200ft V/300m H
Recorded	100ft V/<0.1NM H

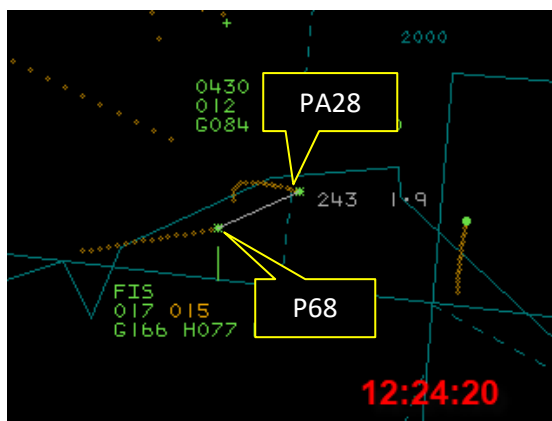
Figure 1.

At approximately 1224:20, [the P68] commenced descent, with a Mode S SFL of FL015, whilst [the PA28] appeared to be enacting general handling manoeuvres in the vicinity, on a Hawarden conspicuity squawk of 0430 (see Figure 1).

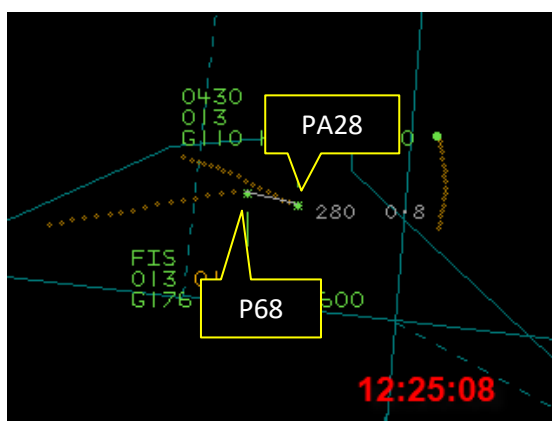
Figure 2.

At 1225:08, abeam Prestatyn on the North Wales coast, [the P68] was observed to change track onto a subsequent track of 120°, at FL013, following a similar track to [the PA28] that was ahead by 0.8NM and also at a Mode C displayed FL013 (see Figure 2).

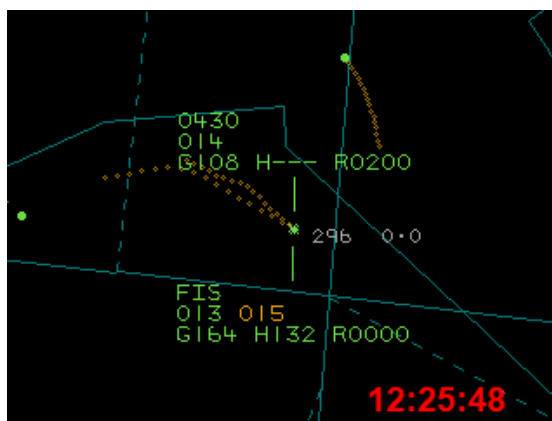
Figure 3.

[The P68] displayed a groundspeed 66kt faster than [the PA28] and subsequently passed underneath [the PA28], 100ft below, due to the speed differential.

The Closest Point of Approach between [the P68] and [the PA28] occurred at 1225:48 and was recorded on Multi-Track Radar as 0.0NM and 100ft (see Figure 3).

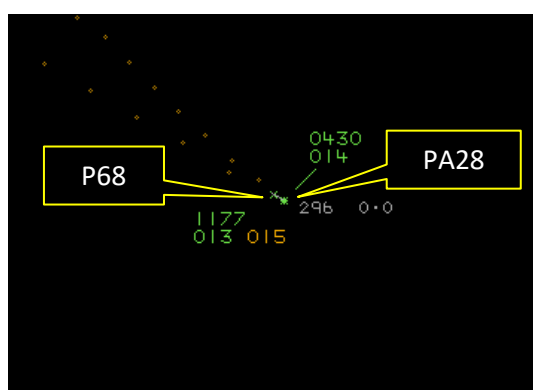
Figure 4 - 1225:48

An analysis of the NATS radar replay was undertaken and both aircraft were detected and identified using Mode S data. The minimum measured separation between the aircraft occurred on consecutive radar sweeps at 1225:48 (Figure 4), which NATS Safety Investigations has taken to be CPA, and at 1225:52 (Figure 5), when, although the measured separation is the same, the radar returns appear to be visually closer, and so this is the CPA upon which the diagram has been based.
