AIRPROX REPORT No 2022238

Date: 08 Oct 2022 Time: 1355Z Position: 5206N 00210W Location: 1.5NM NW Croft Farm

PART A: SUMMARY OF INFORMATION REPORTED TO UKAB

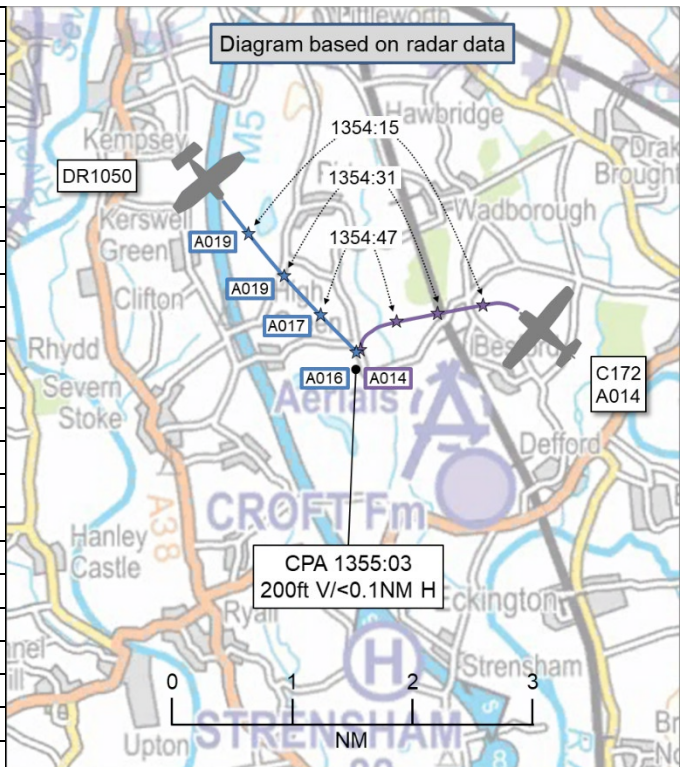
Recorded	Aircraft 1	Aircraft 2
Aircraft	DR1050	C172
Operator	Civ FW	Civ FW
Airspace	London FIR	London FIR
Class	G	G
Rules	VFR	NK
Service	Listening Out	NK
Provider	Safetycom	NK
Altitude/FL	1600ft	1400ft
Transponder	A, C	A, C, S
Reported		
Colours	Blue, white	NR
Lighting	Nil	NR
Conditions	VMC	NR
Visibility	>10km	NR
Altitude/FL	1500ft	NR
Altimeter	QFE (1021hPa)	NR
Heading	130°	NR
Speed	100kt	NR
ACAS/TAS	SkyEcho	NR
Alert	None	NR
Separation at CPA		
Reported	100ft V/50m H	NR V/ NR H
Recorded	200ft V/<0.1NM H

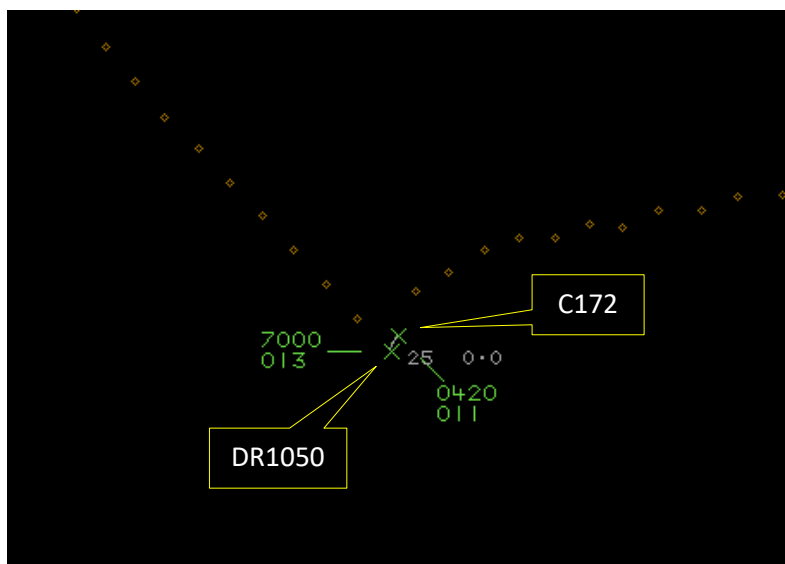
Figure 1 – CPA at 1355:03

An analysis of the NATS radar replay was undertaken. The DR1050 was observed on radar and could be identified from the reported position and pilot's narrative. The C172 could be positively identified from Mode S data. The DR1050 and C172 were observed on radar to have been at FL013 and FL011 respectively. The QNH recorded at Gloucestershire airport had been recorded as 1024hPa a few minutes earlier, therefore the altitudes of the aircraft had been approximately 1600ft and 1400ft respectively. The diagram was constructed and the CPA assessed from the radar data.

When determining the risk of collision, members concluded that the separation of the aircraft at the point of CPA had reduced safety margins to much below the norm and that neither pilot had seen the other aircraft in time to have taken avoiding action. Safety had not been assured and there had been a risk of collision (**CF4**). As such, the Board assigned Risk Category B to this event.

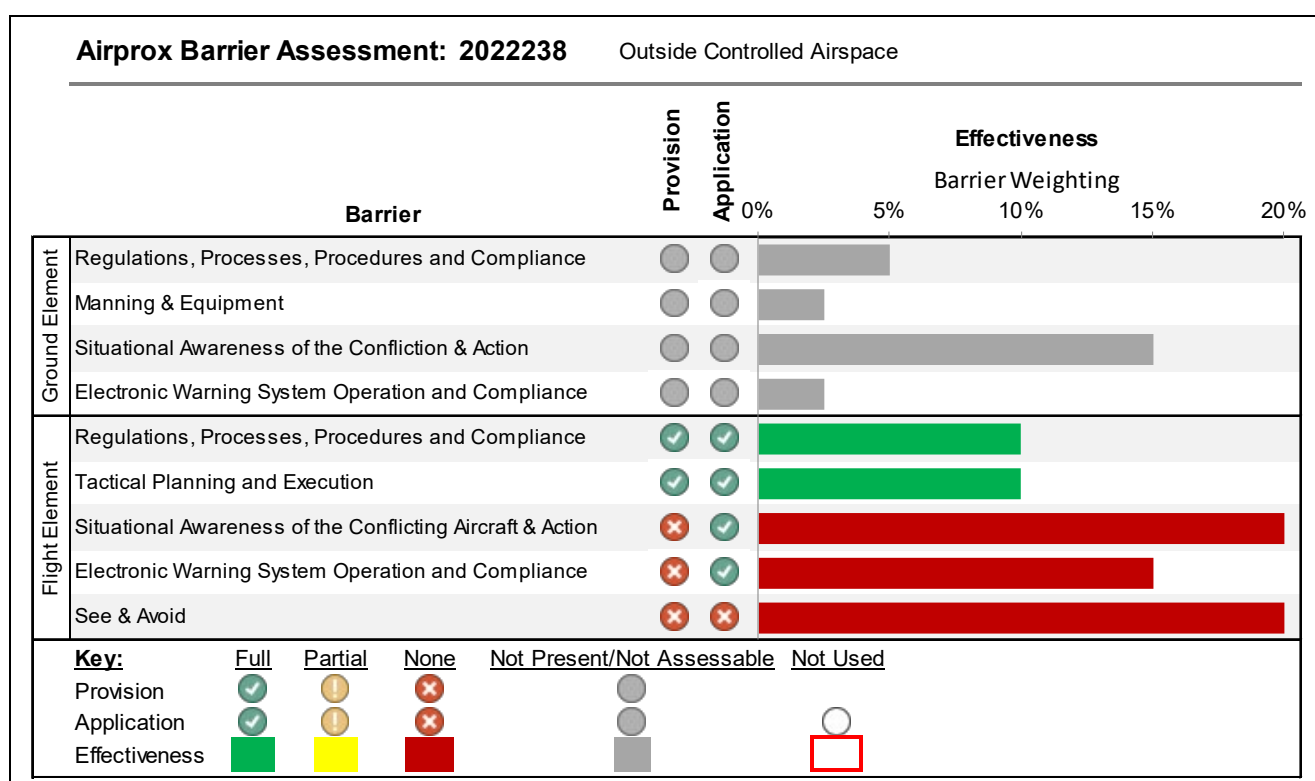
Situational Awareness of the Conflicting Aircraft and Action were assessed as **ineffective** because the pilot of the DR1050 had not had situational awareness of the C172 until it had been visually acquired.

Electronic Warning System Operation and Compliance were assessed as **ineffective** because the EC equipment fitted to the DR1050 had not detected the presence of the C172.

See and Avoid were assessed as **ineffective** because the pilot of the DR1050 had not seen the C172 in time to have taken effective avoiding action.
