AIRPROX REPORT No 2022248

Date: 03 Oct 2022 Time: 1213Z Position: 5205N 00042W Location: 3NM W Cranfield

PART A: SUMMARY OF INFORMATION REPORTED TO UKAB

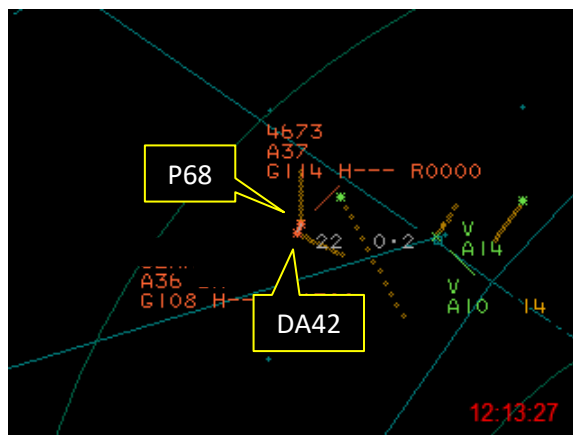
Figure 1.

[The P68 pilot] had completed a number of north-south survey runs and was turning onto a southerly track when, at 1211:23, [the DA42] displayed on radar and turned onto a northwesterly track. [The DA42] was climbing whilst [the P68] remained at an altitude of 3700ft. A low-level STCA activated between [the P68] and [the DA42] at 1212:52, changing to a high-level alert at 1213:12. The closest

point of approach between [the P68] and [the DA42] occurred at 1213:27 and was measured on the Multi-track radar system as 0.2NM and 100ft (Figure 1).

The Airprox occurred when [the P68] and [the DA42] flew into close proximity whilst operating outside controlled airspace. Closest Point of Approach occurred at 1213:27 and was recorded on Multi-Track Radar as 0.2NM and 100ft. The pilot of [the P68] reported turning hard left to eliminate any chance of collision.
