AIRPROX REPORT No 2022246

Date: 13 Oct 2022 Time: 1227Z Position: 5308N 00404W Location: Cwm Dudodyn

PART A: SUMMARY OF INFORMATION REPORTED TO UKAB

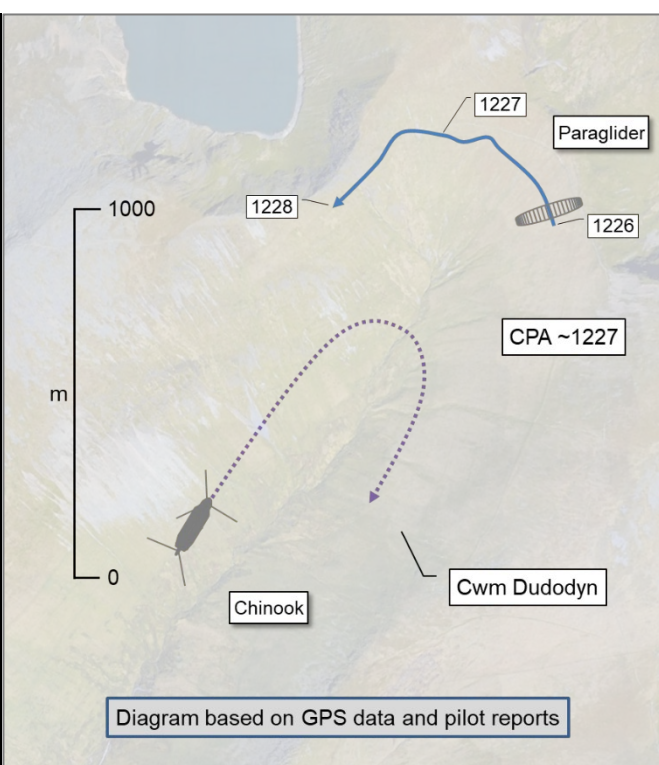
The Chinook was being operated below the base of radar cover and as such did not appear on the NATS Ltd radar replay. The Chinook track shown on the diagram is included to illustrate the reported

right turn, is purely speculative based on the pilot reports and Paraglider pilot GPS track, and does not necessarily depict the actual track flown.

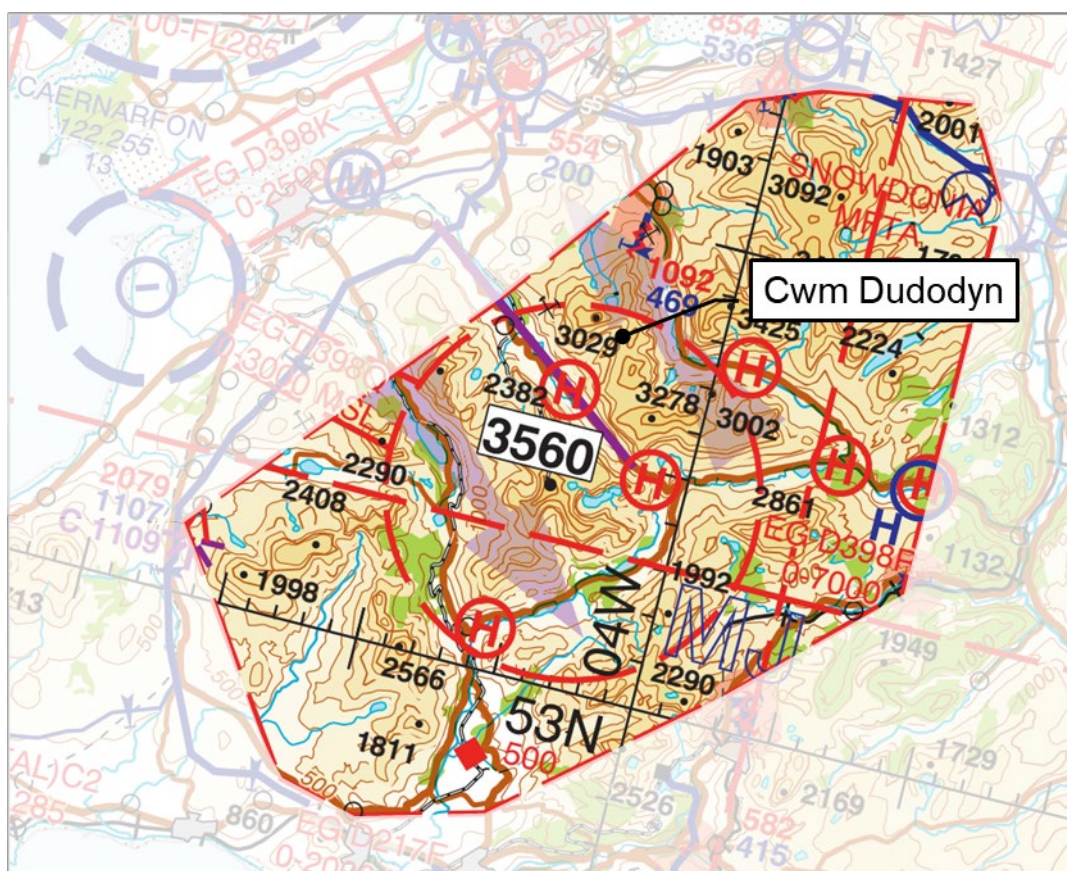
Snowdonia Dedicated Helicopter Mountain Flying Training Area (MFTA)

The Snowdonia Dedicated Helicopter Mountain Flying Training Area (MFTA). The MFTA is a dedicated helicopter training area that extends from ground level to 500ft AGL. RW aircrew should listen out on Valley Low Level frequency [...] and UKLFS Safety Frequency whenever possible when operating in the MFTA. FW aircrew should blind call their intentions to enter the A5 Pass or A4085 Pass to Valley Low Level.²
