AIRPROX REPORT No 2022257

Date: 18 Oct 2022 Time: 1136Z Position: 5553N 00424W Location: Glasgow ATZ

PART A: SUMMARY OF INFORMATION REPORTED TO UKAB

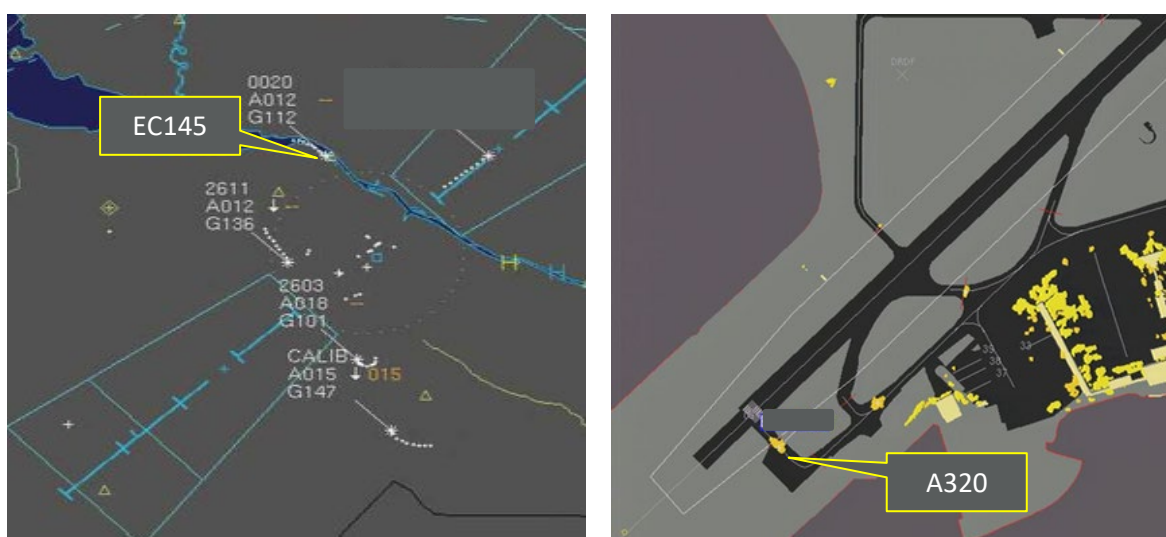
([The A320] was crossing the G1 holding point when take-off clearance was issued. [The EC145] was still north of the RW05 climb-out) Figure 1.

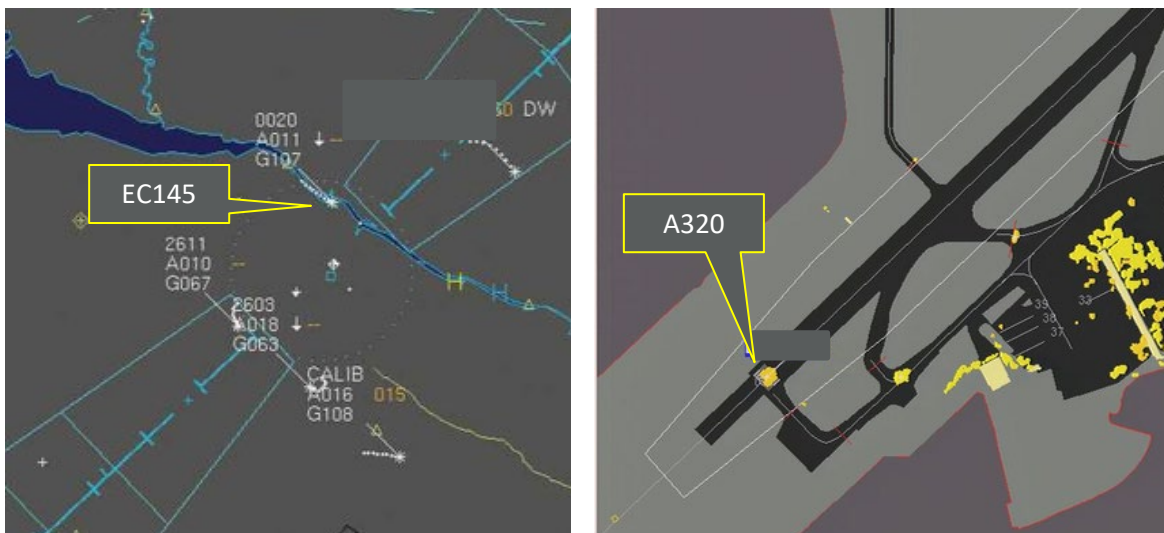
(At this point the [A320] aircraft was on the piano keys commencing the take-off roll. [The EC145] was still north of the extended centreline by approximately 0.5NM indicating altitude 1100ft) Figure 2.

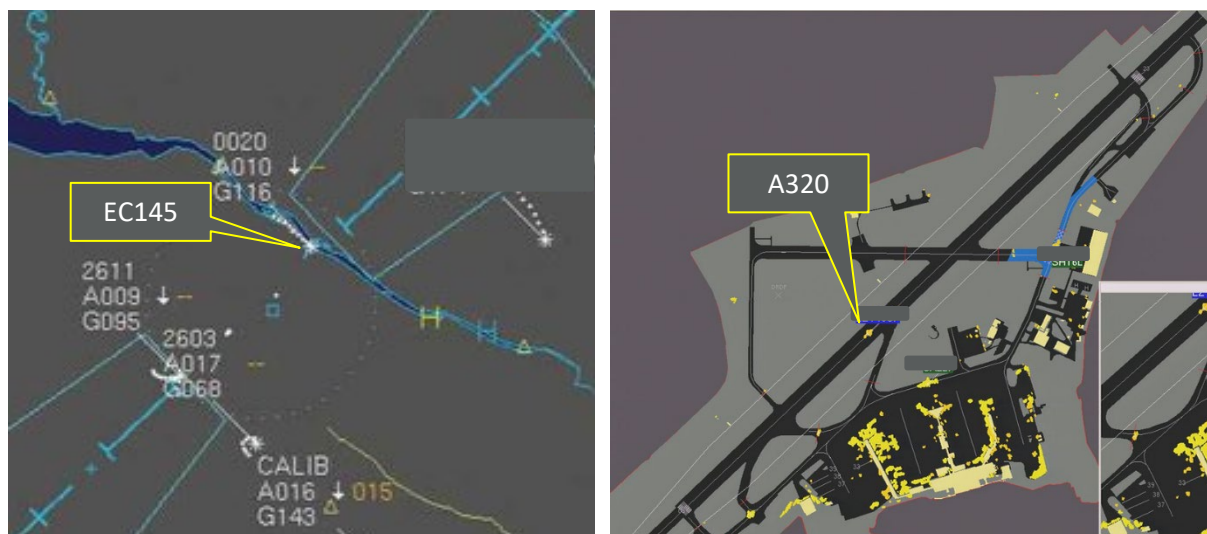
([The EC145] appeared to be directly on the climb-out as they report clear) Figure 3.
