AIRPROX REPORT No 2022253

Date: 20 Oct 2022 Time: ~1500Z Position: 5115N 00158W Location: D125 Salisbury Plain

PART A: SUMMARY OF INFORMATION REPORTED TO UKAB

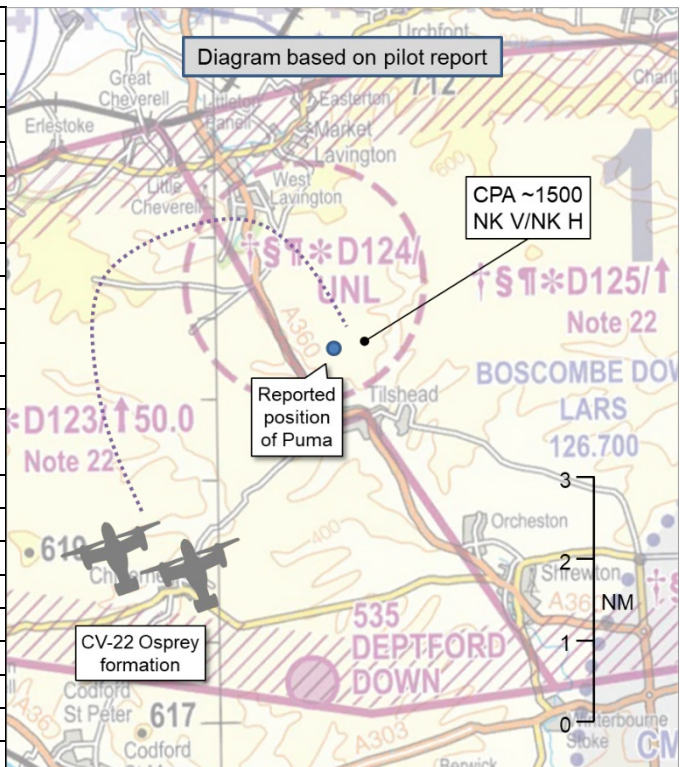
An analysis of the NATS radar replay was undertaken. The Puma RPAS was not observed on radar. Neither of the CV-22 Ospreys were observed on radar until approximately 10min after CPA when they had been 10NM southwest of the Puma RPAS's reported position. The diagram was constructed from the Puma RPAS pilot's report. The separation at CPA could not be determined.
