AIRPROX REPORT No 2022258

Date: 02 Nov 2022 Time: 0941Z Position: 5303N 00029W Location: RAF Cranwell

PART A: SUMMARY OF INFORMATION REPORTED TO UKAB

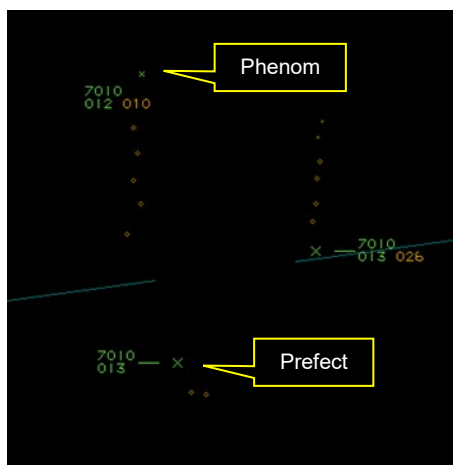
Figure 1 - Prefect pilot reported Downwind.

At 0940:03 the Prefect pilot reported turning downwind to land, Figure 1, and the Cranwell Aerodrome controller stated one ahead. 7sec later, the Phenom pilot reported 'final, gear down', having previously requested a touch-and-go at 0939:20. The touch-and-go was approved.

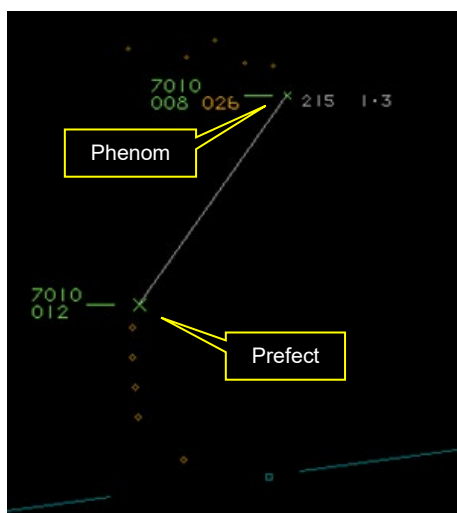
Figure 2 - Prefect pilot reported Final.

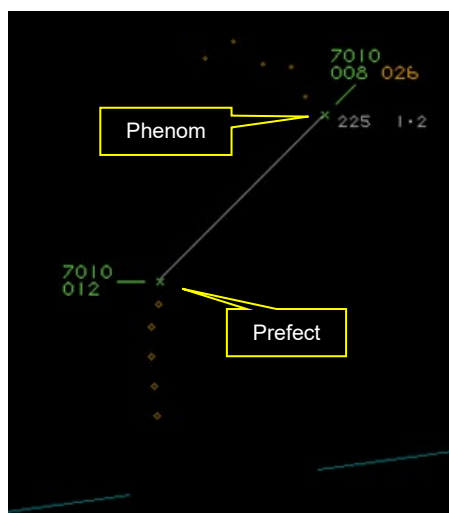
Figure 3 – Prefect pilot instructed to continue approach.

At 0940:44 the Prefect pilot reported 'final, gear down', with the Cranwell Aerodrome controller instructing the Prefect pilot to continue their approach. At Figure 3, the measured separation was 1.2NM and 400ft.

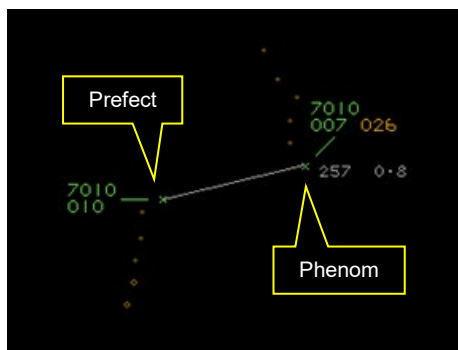
Figure 4 – Prefect pilot not visual with the Phenom.

At 0940:59, the Phenom pilot asked the Cranwell Aerodrome controller if the Prefect pilot was visual with the Phenom, to which the Prefect pilot reported "not seen". The measured separation had

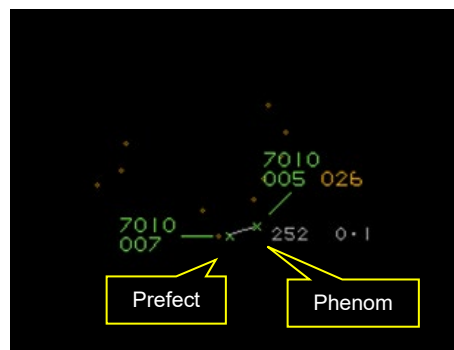
Figure 5 - Phenom pilot instructed to go around.

reduced to 0.8NM and 300ft, Figure 4. Figure 5 illustrates the moment the Phenom pilot was instructed to go around, with separation reduced to 0.1NM and 200ft. Whilst the Phenom pilot was initiating the go-around, separation continued to reduce to a minimum of 0.0NM and 100ft at CPA, Figure 6.

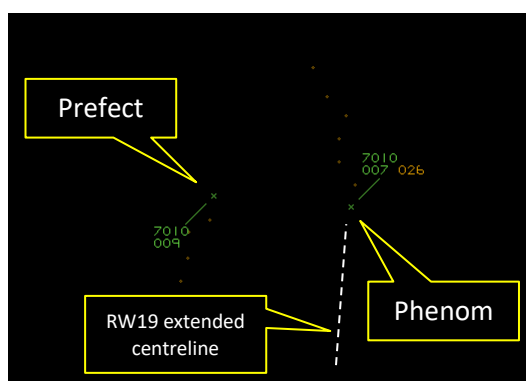
Figure 7 – 0941:03.

At 0941:03, the Prefect was downwind right-hand for RW19 and the Phenom was passing abeam the Prefect on final for RW19. At this time the Prefect was 200ft above the Phenom at a range of 0.7NM, Figure 7.

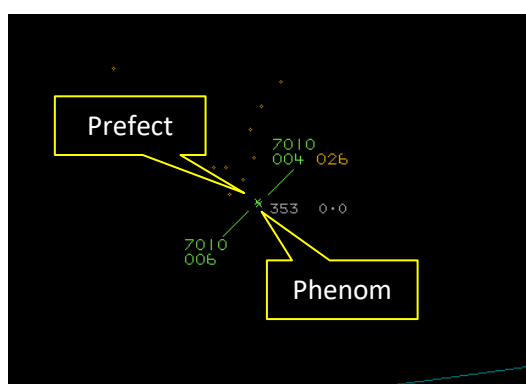
Figure 8 – 0941:23.

As the aircraft continued in the circuit, the radar return for the Prefect became subject to a small amount of radar jitter, until it once again stabilised with both aircraft on final. At 0941:23, the lateral separation between the aircraft had reduced to less than 0.1NM and the vertical separation was recorded as 200ft, Figure 8.

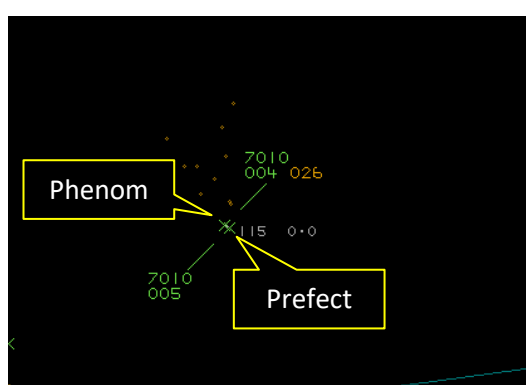
Figure 9 – 0941:27: CPA.

CPA occurred on the next radar sweep, at 0941:27 when, although the lateral separation between the aircraft remained at less than 0.1NM, the Prefect was recorded as having been ahead of the Phenom and the vertical separation had reduced to 100ft. This was as a result of the Phenom pilot remaining level whilst the Prefect had continued to descend, Figure 9.
