AIRPROX REPORT No 2022262

Date: 13 Nov 2022 Time: 1413Z Position: 5144N 00117W Location: 11NM E RAF Brize Norton

PART A: SUMMARY OF INFORMATION REPORTED TO UKAB

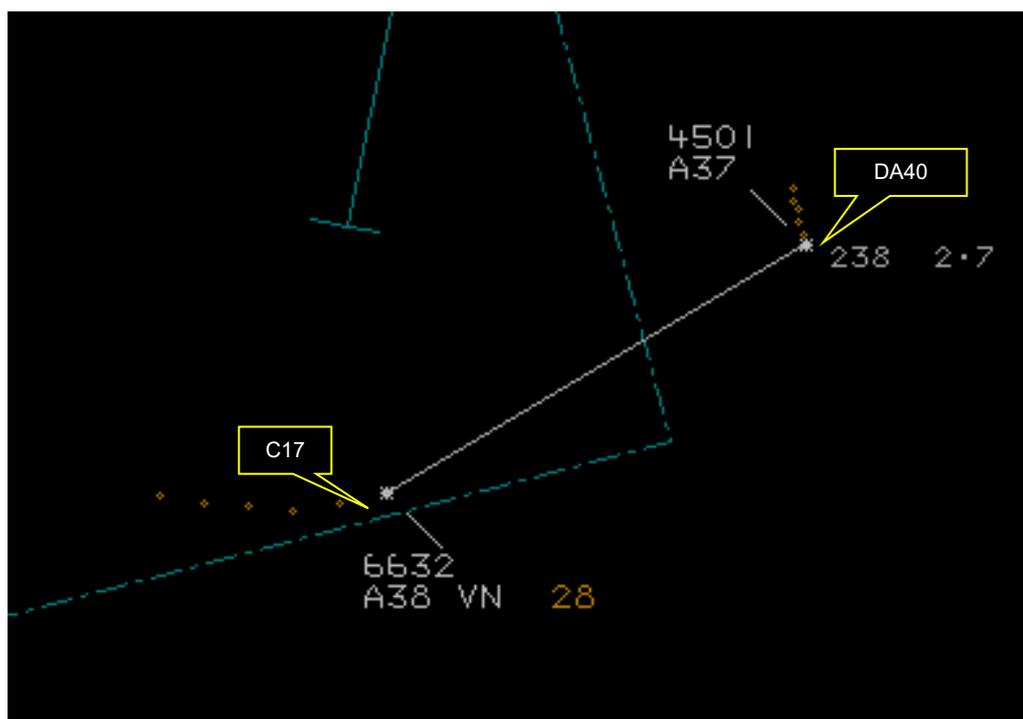
Figure 1: 1413:09 - Controller queries C17 procedure

At 1413:09 the Brize Norton Approach controller questioned the C17 pilot on their procedure “*just confirm you’re doing the procedure for 07*”. Prior to this transmission, the Brize Norton Approach controller warned-in the C17 aircraft with the Brize Norton Aerodrome controller, stating “*going outbound on the procedure in a second*”. The Brize Norton Aerodrome controller acknowledged this and then questioned “*for 07 yeah*”. Measured separation was 2.7NM and 100ft.

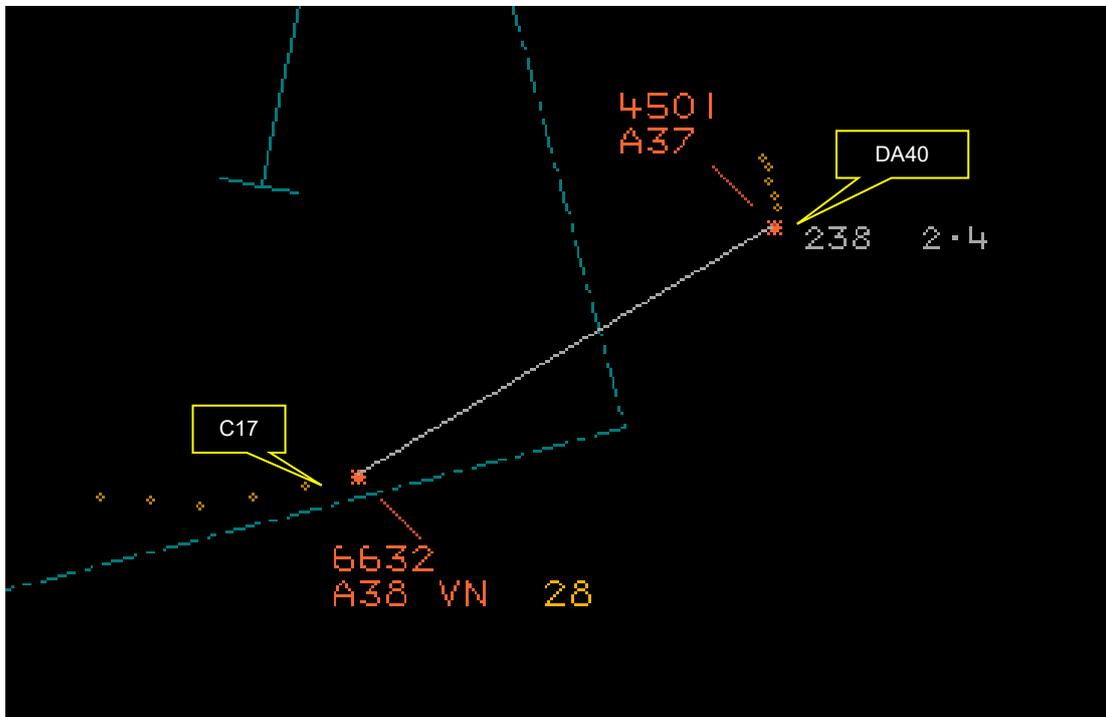
Figure 2: C17 initiates avoiding action

At 1413:12 the C17 pilot reported “*we’re just having to make er avoiding action from traffic er same alt, on er*”. The Brize Norton Approach controller reported “*that traffic appearing outside of controlled airspace*”. Measured separation reduced to 2.4NM and 100ft.

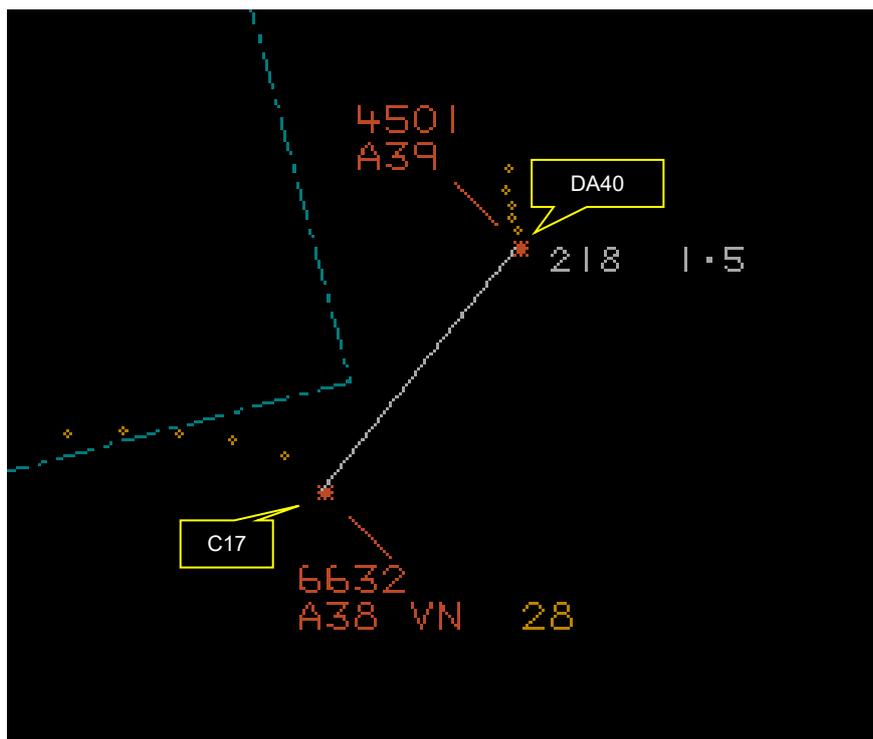
Figure 3: CPA

CPA timed at 1413:32 and measured separation 1.5NM and 100ft.

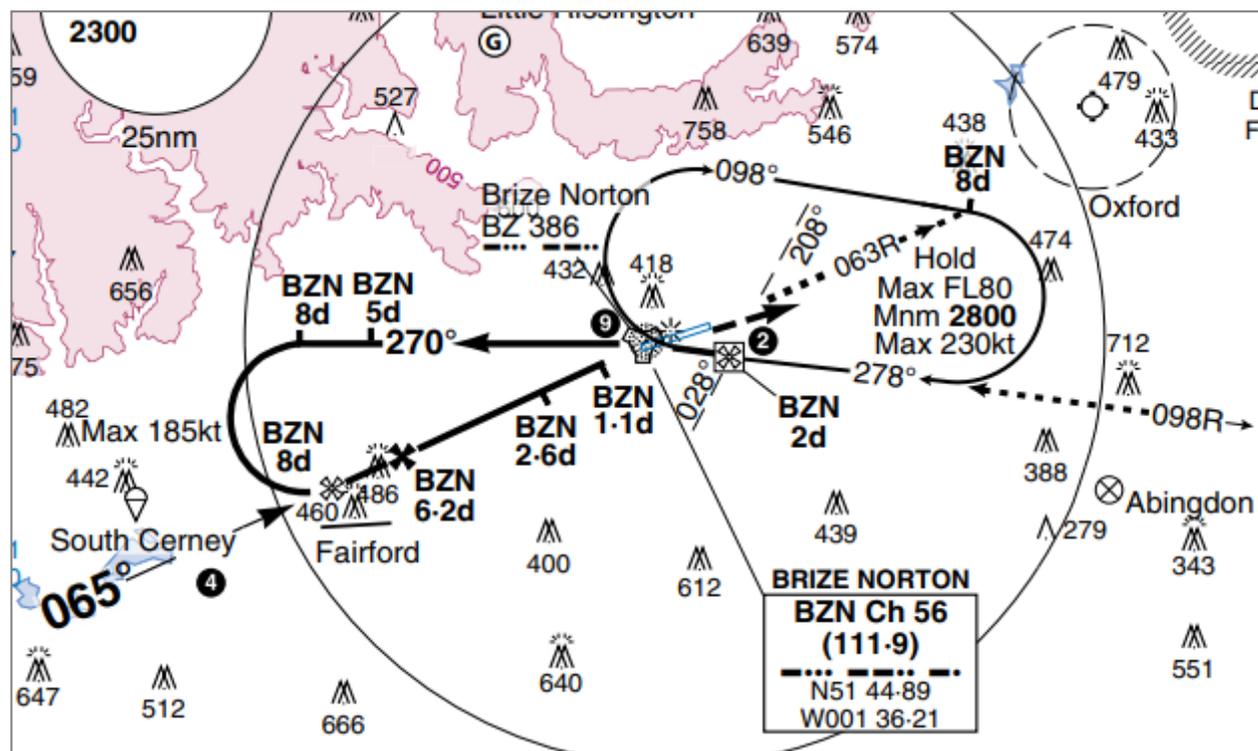
Figure 4: Runway 07 TACAN procedure and Hold

The above figure 4 is taken from the published Terminal Approach Plates for a TACAN approach into Brize Norton for RW07. The C17 pilot reported they were cleared to make a positioning parallel join at the BZN 2d TAC 07 hold, before proceeding immediately outbound for the procedure (a non-standard join with no full hold).

Due to the non-standard approach conducted by the C17 crew, this took the aircraft outside controlled airspace. With the DA40 appearing as a spurious radar contact, the Brize Norton Approach controller was unable to provide early Traffic Information to the C17 crew. The Brize Norton Approach controller appeared to lack awareness of the type of approach the C17 was conducting, with the Brize Norton Aerodrome controller questioning the type of approach due to the C17 position at the time, shortly to leave controlled airspace.
