**AIRPROX REPORT No 2022274**

Date: 09 Dec 2022 Time: 1227Z Position: 5154N 00211W Location: Gloucestershire Airport

**PART A: SUMMARY OF INFORMATION REPORTED TO UKAB**

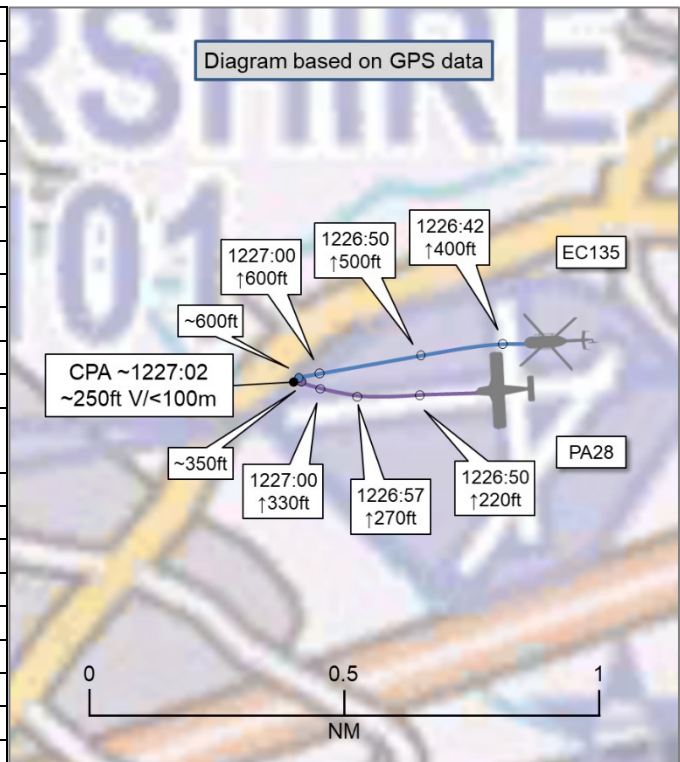
An analysis of the NATS radar replay was undertaken and, due to restrictions on radar coverage in that locality, did not detect the aircraft involved until after the Airprox. However, the PA28 pilot kindly supplied a GPS data file detailing their flight and the UKAB Secretariat was also able to obtain GPS data relating to the flight of the EC135. These files have been combined to produce the diagram and to measure the separation, however, as the timings of the data points did not align exactly,

some interpolation was required and, as such, the separation at CPA and the time has been recorded as an approximation.

After lifting from the north side of RW27, the EC135 pilot initially routed approximately parallel to the runway centreline, with a slight drift toward the runway observed immediately prior to CPA. The PA28 pilot became airborne and, although they turned to their right in accordance with the noise abatement procedures, their GPS track shows that this was initiated before reaching the upwind end of the runway.

At CPA, the tracks of the aircraft crossed, with the EC135 crossing above the PA28, putting the EC135 to the south of the PA28, following which, due to the higher groundspeed of the PA28, lateral spacing between the aircraft increased.
