**AIRPROX REPORT No 2022272**

Date: 03 Dec 2022 Time: 1335Z Position: 5220N 00130W Location: Coventry ATZ

**PART A: SUMMARY OF INFORMATION REPORTED TO UKAB**

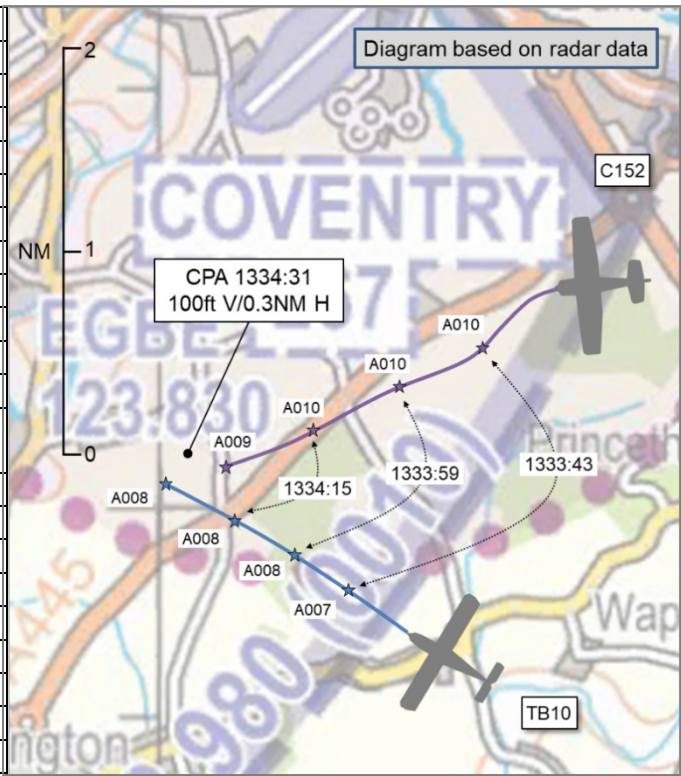
Recorded	Aircraft 1	Aircraft 2
Aircraft	TB10	C152
Operator	Civ FW	Civ FW
Airspace	Coventry ATZ	Coventry ATZ
Class	G	G
Rules	VFR	VFR
Service	AFIS	AFIS
Provider	Coventry Info	Coventry Info
Altitude/FL	800ft	900ft
Transponder	A, C, S	A, C, S
<b>Reported</b>		
Colours	White, blue	White, blue
Lighting	Nav, beacon, landing	Landing, nav, Anti-col, HISL, beacon
Conditions	VMC	VMC
Visibility	>10km	>10km
Altitude/FL	1300ft	1000ft
Altimeter	QNH (1022hPa)	QNH (1022hPa)
Heading	320°	310°
Speed	90kt	70kt
ACAS/TAS	SkyEcho	Not fitted
Alert	None	N/A
<b>Separation at CPA</b>		
Reported	0ft V/200ft H	200ft V/250m H
Recorded	100ft V/0.3NM H

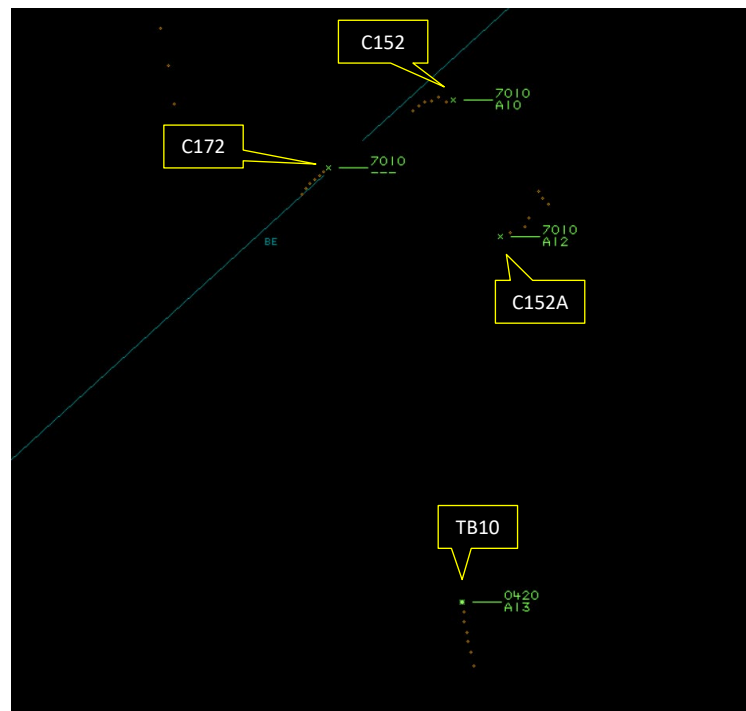
Figure 1 – 1332:03

The C172 pilot then reported final to land and was given the runway followed by, at c1332:03, the pilot of C152A reporting downwind also for a full-stop landing. The AFISO instructed the C152A pilot to report final, advising them that there was a TB10 to report base-leg. The pilot of C152A acknowledged the call to report final but not the Traffic Information which was not challenged by the AFISO (Figure 1).

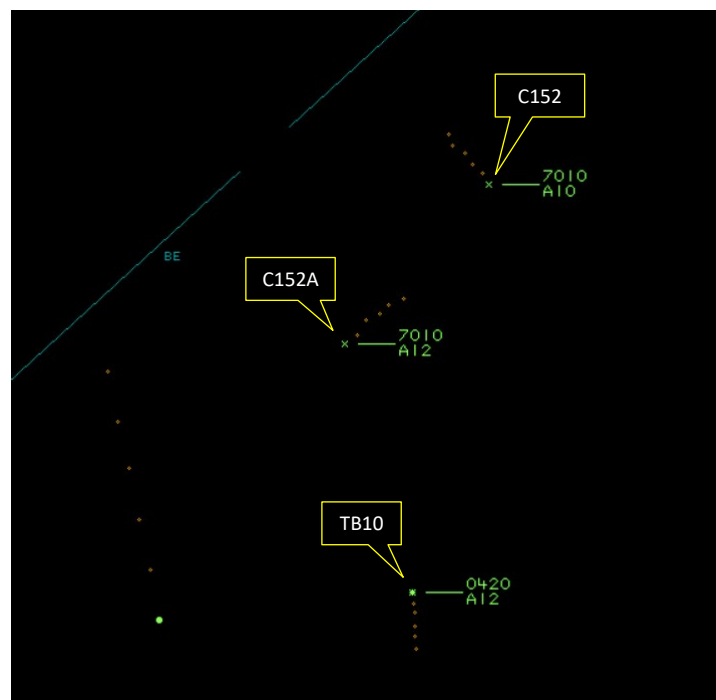
Figure 2 – 1332:45

The pilot of C152A then reported 'late downwind' and was instructed to report final by the AFISO at c1332:45. No reminder was given by the AFISO to the C152A pilot about the TB10 joining on base-leg, the pilot of which had yet to report in that position (Figure 2).

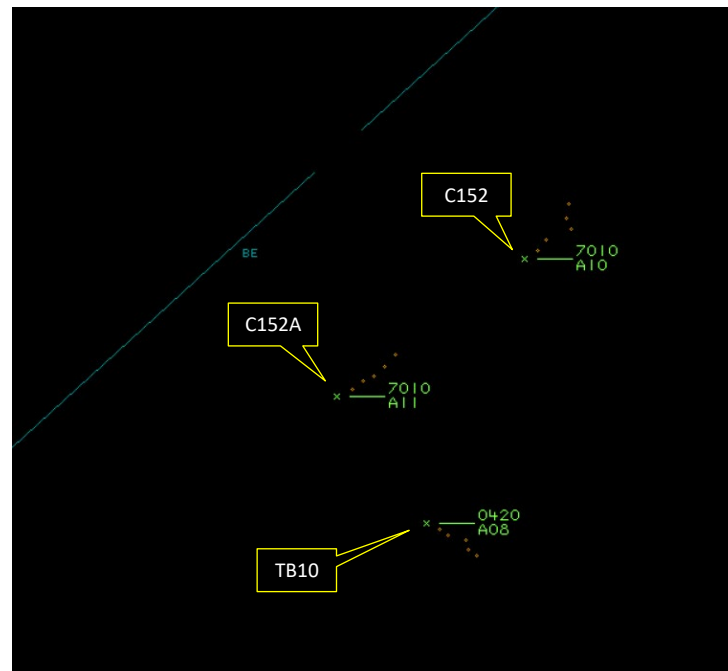
Figure 3 – 1333:12

At c1333:12, the pilot of the C152 reported downwind for a full-stop landing. The AFISO replied “*report final – you’ve got 2 ahead, a C152 and a TB10 to report base-leg*”. The C152 pilot acknowledged the final call but not the Traffic Information which went unchallenged by the AFISO (Figure 3).

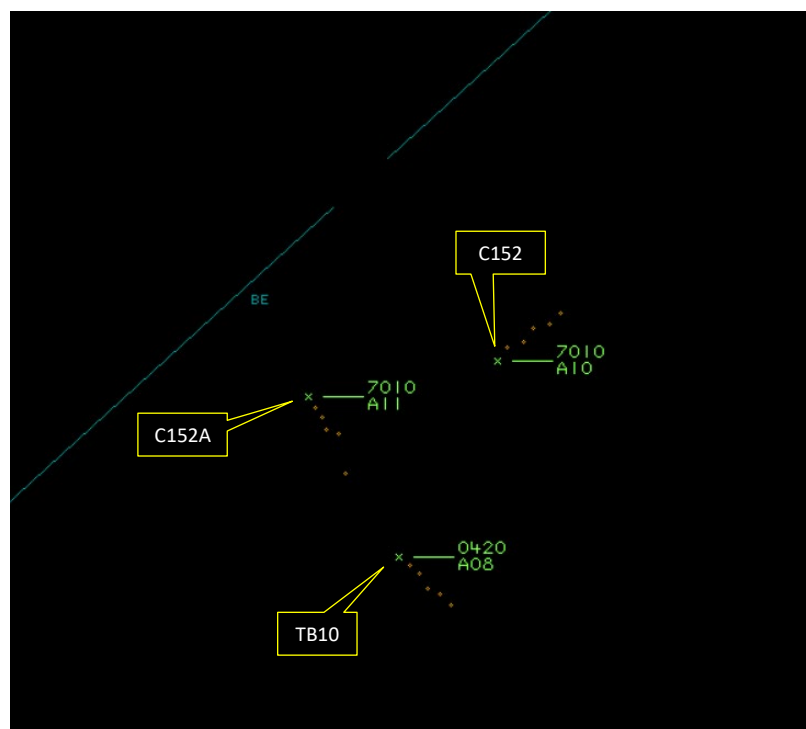
Figure 4 – 1333:38

Two pilots then called simultaneously followed by, at c1333:38, the pilot of the TB10 reporting right-base. The AFISO instructed the pilot to report final but did not pass Traffic Information on C152A ahead of them, nor the C152 downwind (Figure 4).

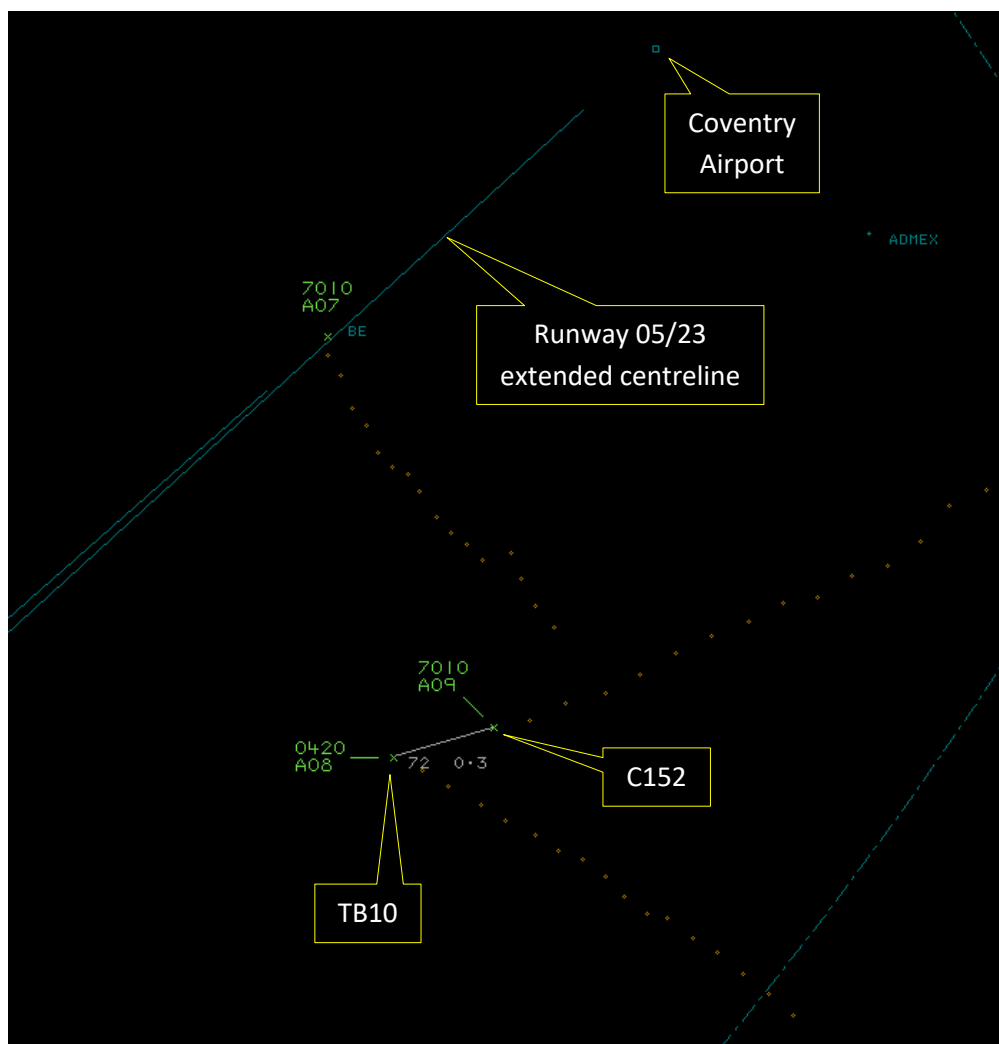
Figure 6 – CPA at 1334:31

The CPA occurred at 1334:31 with the TB10 and C152 separated by 0.3NM and 100ft (Figure 6).

At approximately the point of CPA, the pilot of the TB10 was observed to turn left by 50° and position onto an extended downwind leg outside the ATZ. Meanwhile, the pilot of the C152 turned right onto base-leg inside the ATZ with one aircraft ahead.
