**AIRPROX REPORT No 2023009**

Date: 29 Jan 2023 Time: 0947Z Position: 5414N 00114W Location: 1NM W Sutton Bank

**PART A: SUMMARY OF INFORMATION REPORTED TO UKAB**

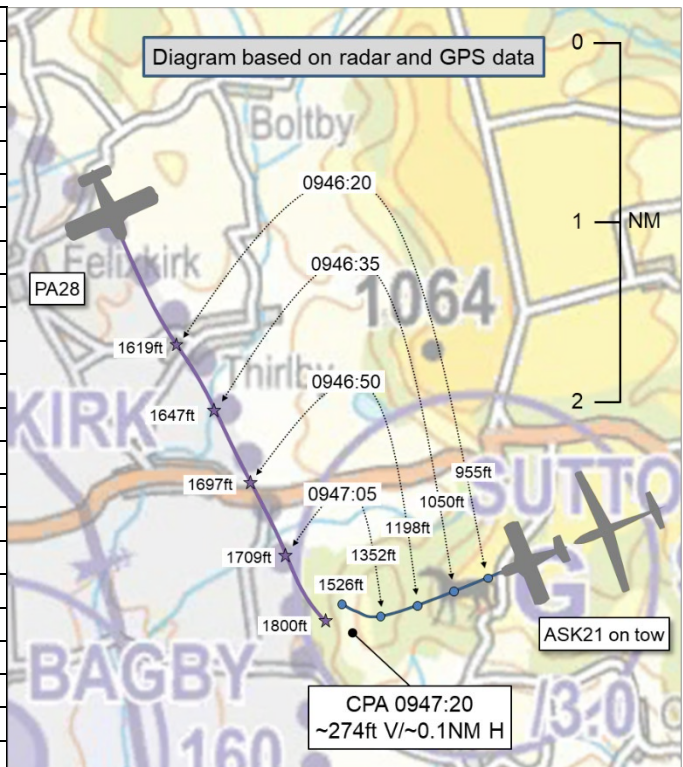
Recorded	Aircraft 1	Aircraft 2
Aircraft	ASK21	PA28
Operator	Civ Gld	Civ FW
Airspace	London FIR	London FIR
Class	G	G
Rules	VFR	VFR
Service	None	Basic
Provider	N/A	Teesside Radar
Altitude/FL	~1800ft	~1526ft
Transponder	Not fitted	A, C, S
<b>Reported</b>		
Colours	White, blue	White, blue
Lighting	None	Landing, taxi
Conditions	VMC	VMC
Visibility	>10km	>10km
Altitude/FL	400ft	1500ft
Altimeter	QFE (0987hPa)	QNH (NR hPa)
Heading	270°	160°
Speed	65kt	95kt
ACAS/TAS	FLARM	Not fitted
Alert	None	N/A
<b>Separation at CPA</b>		
Reported	100ft V/100m H	400ft V/300m H
Recorded	~274ft V/~0.1NM H

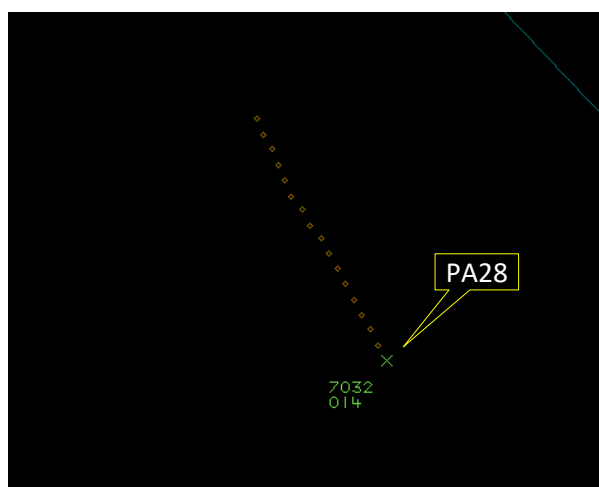
Due to the lack of radar data on the unknown aircraft, and intermittent primary contact only being visible after [the PA28] had passed the location of the contact when it displayed on radar, there is no indication as to how close the two aircraft came.

An analysis of the NATS radar replay was undertaken. The PA28 could be positively identified from Mode S data. Neither the tug aircraft nor the ASK21 were observed on radar (see Figure 1).

Figure 1 – CPA at 0947:20. No other aircraft were observed on radar in the vicinity of the PA28.
