## **AIRPROX REPORT No 2023006**

Date: 20 Jan 2023 Time: 1329Z Position: 5252N 00204W Location: 4NM NE Stafford

### **PART A: SUMMARY OF INFORMATION REPORTED TO UKAB**

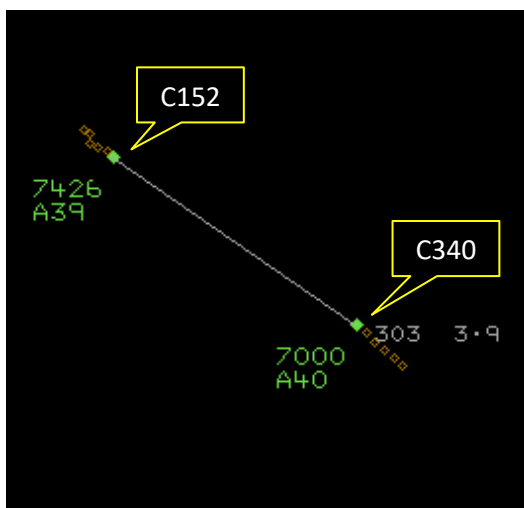
At 1327:41 the pilot advised the controller, *"I'd like to change to Liverpool on 119.855 please."* The controller responded with *"roger, squawk conspicuity and free-call en-route."*

Figure 1 – 1327:41 squawk changes to 7000

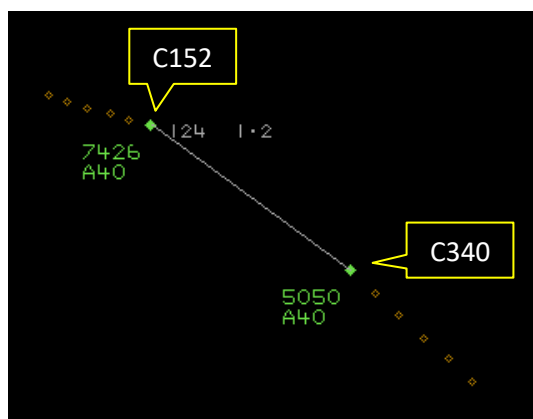
At 1327:50, when the pilot made initial contact with the Liverpool radar controller, they were told to squawk 5050 and standby while the ATCO focused on inbound traffic. When the ATCO went back to the pilot, the primary radar contact of the C340 was displaying at the extremity of the controller display, 35NM from Liverpool, with the SSR code not yet displayed. The primary contact was seen converging with another contact which was right on the edge of the display, this conflicting contact was tracking off the edge of the display to the southeast. The squawk of 5050 eventually appeared (at 1328:21) and the C340 continued north-bound towards Liverpool controlled airspace.

Figure 2 – 1328:21 the C340 7000 Squawk changes to 5050 (Liverpool).

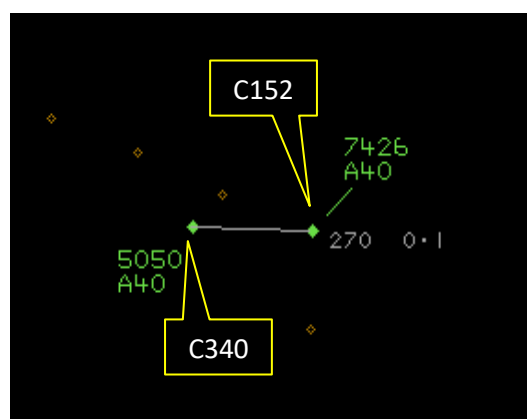
Figure 3 – 1328:40 CPA.

The C340 pilot had left the East Midlands frequency in direct conflict with the C152, with the SSR data indicating that the aircraft were 3.9NM and 100ft apart. The C340 was 25NM from East Midlands at the time, and the C152 would have been approximately 30NM from East Midlands and on the extremity of the controller display. Under the terms of a Basic Service, the East Midlands controller was not required to monitor the flight of the C340; they had been vectoring IFR inbounds and dealing with local VFR flights and controlled airspace transit flights in the lead-up to the pilot requesting to change frequency to Liverpool. The pilot had left the East Midlands frequency and was not yet in receipt of a service from the Liverpool controller when the Airprox occurred.

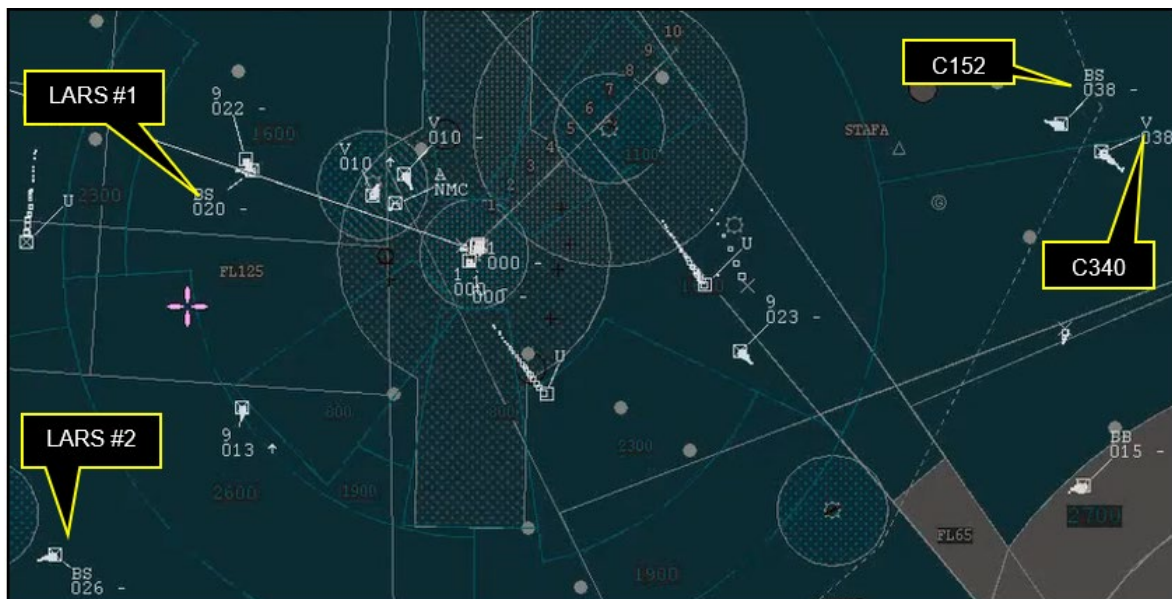
Figure 4 (1328:05): Traffic information provided to LARS #1.

36sec prior to the Airprox CPA at 1328:05, the Shawbury Zone controller provided Traffic Information to the LARS #1 pilot regarding a Shawbury-based helicopter, “*traffic believed to be you has got traffic overhead erm indicating three hundred feet above, Shawbury rotary conducting PFLs*”. Following acknowledgment of the Traffic Information and reporting visual, LARS #1 then requested an en-route change to [their next frequency].

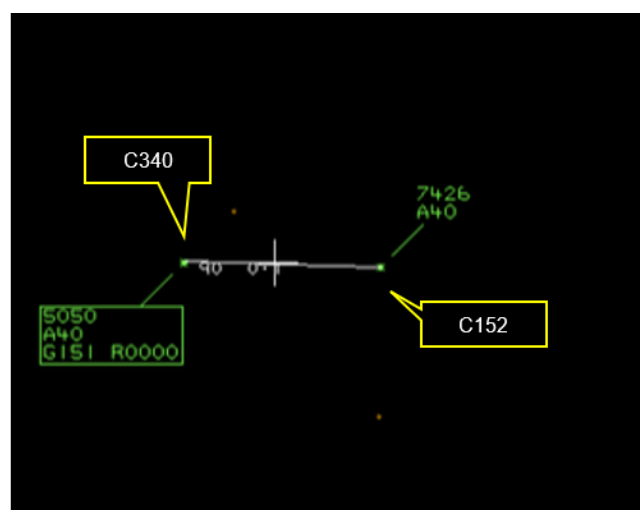
Figure 5 (13:28:41): CPA.

CPA was measured at 0.1NM and 0ft separation. No Traffic Information was provided to the C152 pilot regarding the C340.

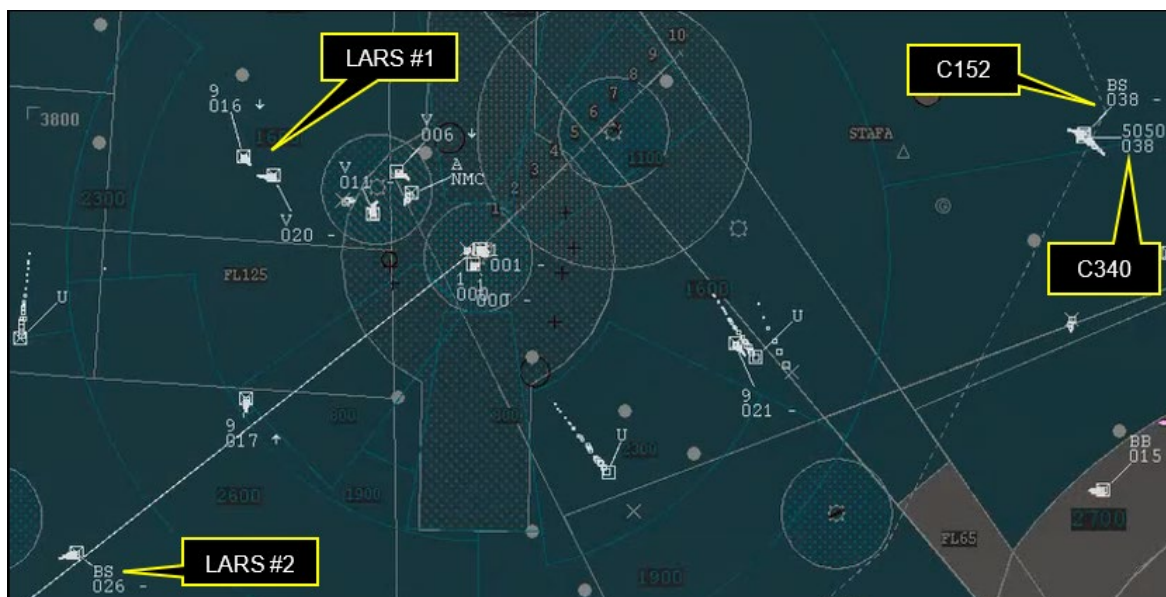
Figure 6 (13:28:42): Response to routing update from LARS #2.

Coincidental with the Airprox was a transmission from, and to, the LARS #2 pilot. Prior to the CPA, at 1328:39 the LARS #2 pilot updated their routing to which the Shawbury Zone controller responded at 1328:42.

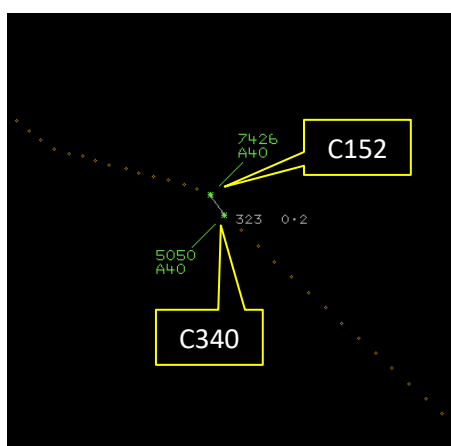
Figure 7 – 1328:37

An analysis of the NATS radar replay was undertaken and both aircraft were detected and identified using Mode S data. At 1328:37, the aircraft were separated by 0.2NM horizontally and were at the same altitude, Figure 7.

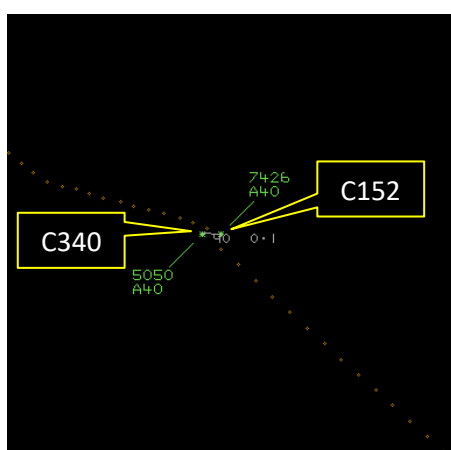
Figure 8 – 1328:41

On the next radar sweep, at 1328:41, the aircraft had passed and the recorded separation was 0.1NM horizontally and 0ft vertically, Figure 8. However, following their respective tracks, in the time between the radar sweeps, the aircraft would have passed closer than 0.1NM and so the separation at CPA has been recorded as <0.1NM which would have occurred at approximately 1328:40.
