## AIRPROX REPORT No 2023013

Date: 12 Feb 2023 Time: 1351Z Position: 5215N 00253W Location: Shobdon ATZ

### PART A: SUMMARY OF INFORMATION REPORTED TO UKAB

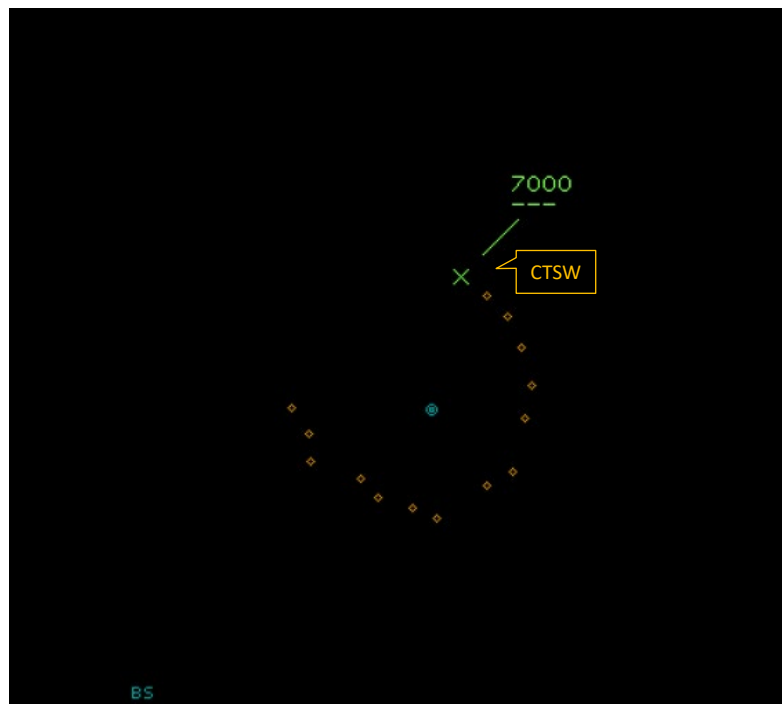
Figure 1 - 1310:10

The FISO then requested a position report from the pilot of the CTSW, to which the pilot replied "*now on the deadside going into the right-hand circuit for 08*" which was acknowledged by the FISO (Figure 1).

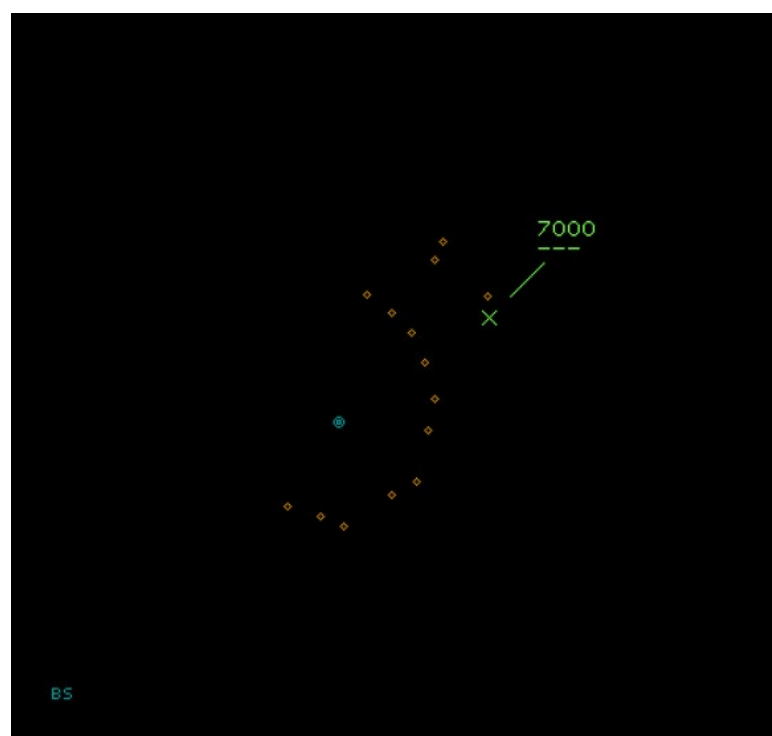
Figure 2 – 1351:25

At 1351:25 the pilot of the C42 called “*we’ve just noticed the CTW very low on the deadside*” to which the FISO replied with just the abbreviated callsign of the C42. Another call was heard, believed to be the CTSW pilot “*yeah I see him*”, again acknowledged by the FISO with only the CTSW’s abbreviated callsign (Figure 2).
