## AIRPROX REPORT No 2023025

Date: 26 Feb 2023 Time: 1225Z Position: 5250N 00248W Location: Sleep ATZ

### PART A: SUMMARY OF INFORMATION REPORTED TO UKAB

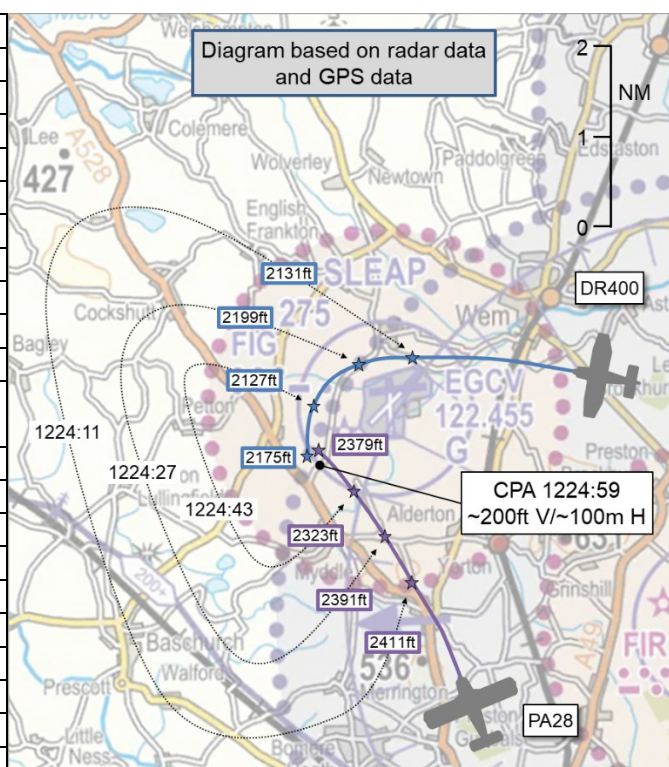
Recorded	Aircraft 1	Aircraft 2
Aircraft	DR400	PA28
Operator	Civ FW	Civ FW
Airspace	Sleep ATZ	London FIR
Class	G	G
Rules	VFR	VFR
Service	AGCS	AGCS
Provider	Sleep Radio	Sleep Radio
Altitude/FL	2175ft	2379ft
Transponder	A, C, S	A, C, S
Reported		
Colours	Red, white	White, orange, grey
Lighting	"Yes"	Strobes, landing
Conditions	VMC	VMC
Visibility	>10km	5-10km
Altitude/FL	2000ft	NK
Altimeter	QFE (NK hPa)	NK
Heading	135°	NK
Speed	120kt	NK
ACAS/TAS	PilotAware	SkyEcho
Alert	None	None
Separation at CPA		
Reported	50ft V/0NM H	NK V/NK H
Recorded	~200ft V/~100m H

An analysis of the NATS radar replay was undertaken. Both aircraft could be positively identified from Mode S data and were observed on radar with vertical information displayed as flight levels. The atmospheric pressure at Shawbury had been recorded as 1020hPa and the altitudes were calculated by applying an appropriate conversion factor. Both pilots kindly supplied GPS data of their respective flights. This data was combined to construct the diagram above and to determine the separation at CPA.

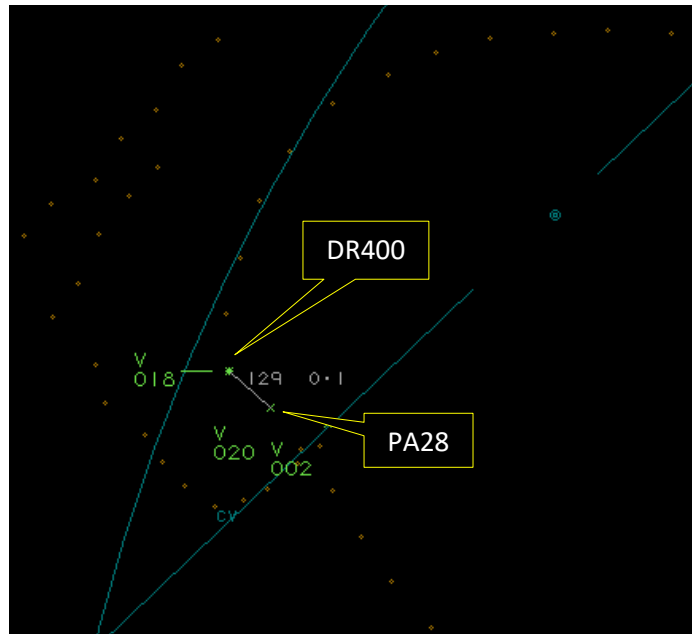
Figure 1 – CPA at 1224:59

The DR400 pilot had arrived from the east and had turned left when approximately 0.5NM north of the airfield. The airfield remained to their left, and they were no more than 1NM away from the centre of it, as they conducted a continuous left-turn to then descend on the deadside. The pilot of the

PA28 had arrived from the south and they had turned left when approximately 0.9NM southwest of the centre of the airfield which is where the CPA occurred (see Figure 1). They had then conducted a continuous left-turn between 1NM and 2NM to the southwest of the airfield to then descend on the deadside. When both aircraft were on the deadside, the DR400 pilot was approximately 1.5NM ahead of the PA28.
