## AIRPROX REPORT No 2023026

Date: 28 Feb 2023 Time: 1420Z Position: 5321N 00339W Location: 3.5NM NE Colwyn Bay

### PART A: SUMMARY OF INFORMATION REPORTED TO UKAB

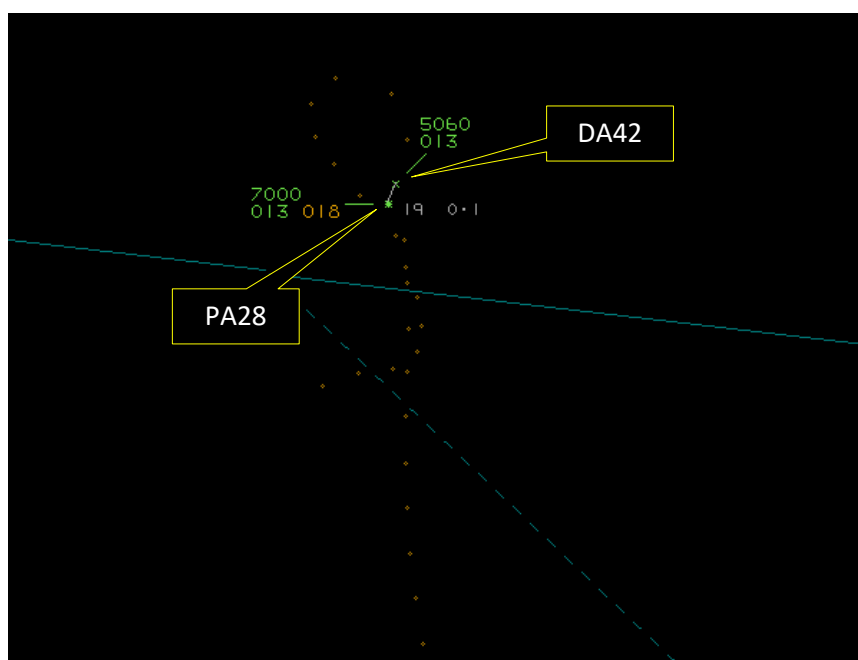
Figure 1 – CPA at 1419:56

An analysis of the NATS radar replay was undertaken. Both aircraft could be positively identified from Mode S data. At 1418, the DA42 was observed to be south of the coastline and tracking to the west. The PA28 was observed to be broadly north of the coastline, tracking to the east. The pilot of the DA42 then turned northwards and crossed the coastline. At 1419, the pilot of the PA28 also turned northwards, directly ahead of the DA42 by approximately 1NM. It had been after the pilot of the PA28 had commenced a steep turn to the right that the CPA occurred (see Figure 1). The separation at CPA was determined, and the diagram constructed, from the radar data.
